APPENDIX E.7.4
FOLLOW-UP SPILL REPORTS

Re: Follow-up to Spill 15-003 Reported on January 2nd, 2015
Mary River Project - Water Licence No. 2AM-MRY1325

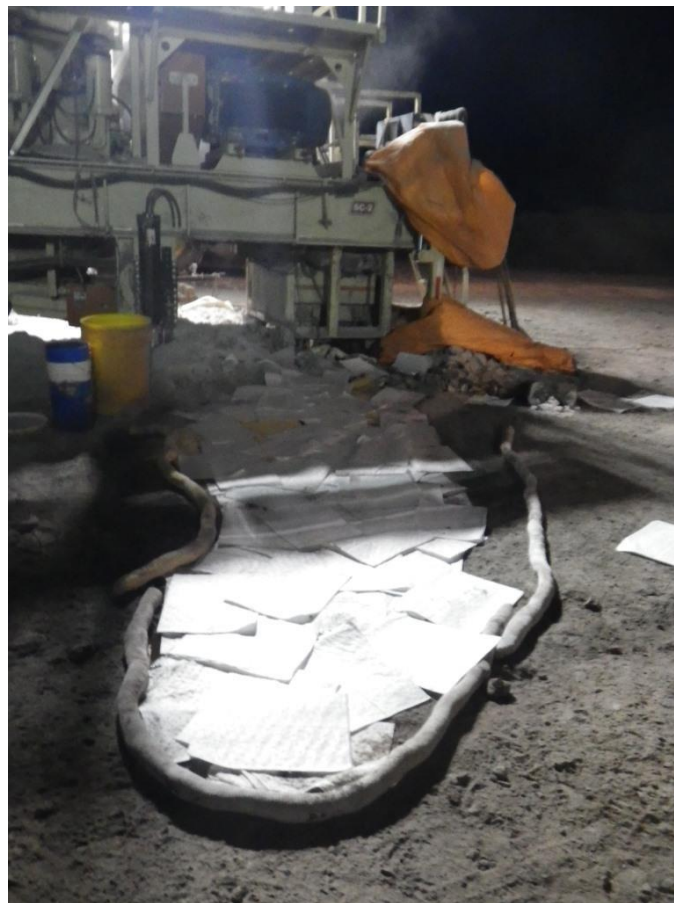
At approximately 8:30 AM on January 16, 2015, a crusher operator discovered a hydraulic oil spill underneath the secondary cone at the crusher located near QMR2. The investigation concluded that a seal on an oil filter failed due to low temperatures. It is estimated that 150 L of hydraulic oil spilled onto the ground and quickly froze, limiting the migration of the spill. The closest receiving waters are approximately 100 meters from the location of the spill and are presently frozen.

Photo 1 – Hydraulic Oil Spill

In order to avoid future occurrences, the oil reservoir is now required to be pre-heated with a frost fighter prior to engaging the lube pump during periods of extreme cold weather.

The crusher has been repaired and is back in service. Frost fighters have also been placed in proximity to the oil reservoir to be used for pre-heating prior to engaging the lube pump.

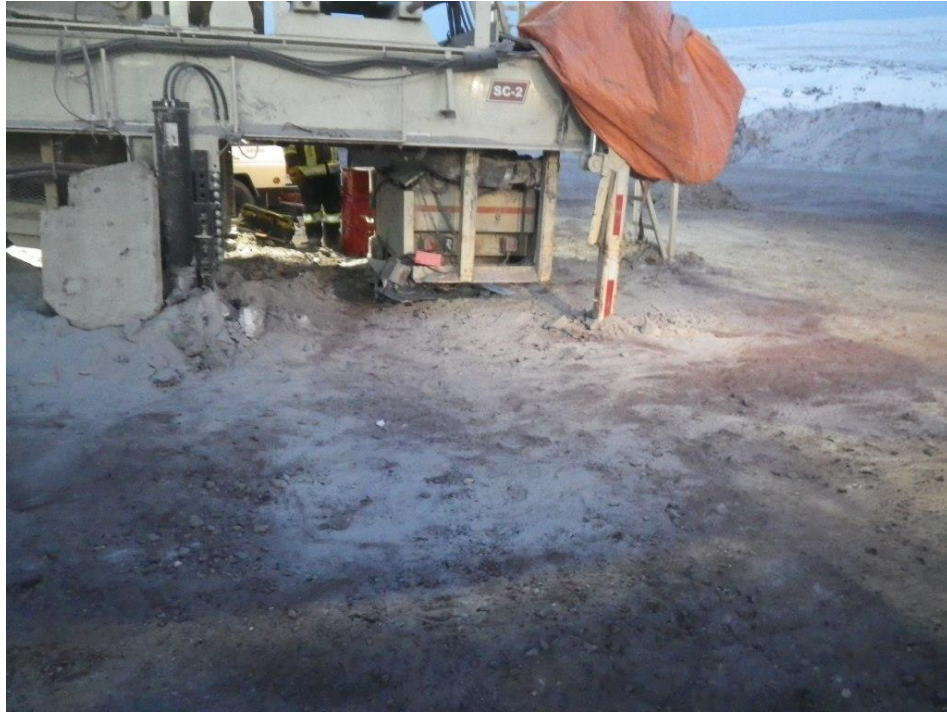
Photo 2 – Hydraulic Oil Spill Clean-up

The worker immediately shut off the crusher, placed spill pads to contain the spill and notified his Supervisor, who in turn notified the Environment Department. The spill was cleaned up and the impacted snow and soil was removed and placed into secondary containment. The oily snow and soil will be transported to the Milne Port Landfarm facility. Representatives from the Fixed Plant Maintenance Department then attended the scene to conduct their investigation and determine the cause of the spill.

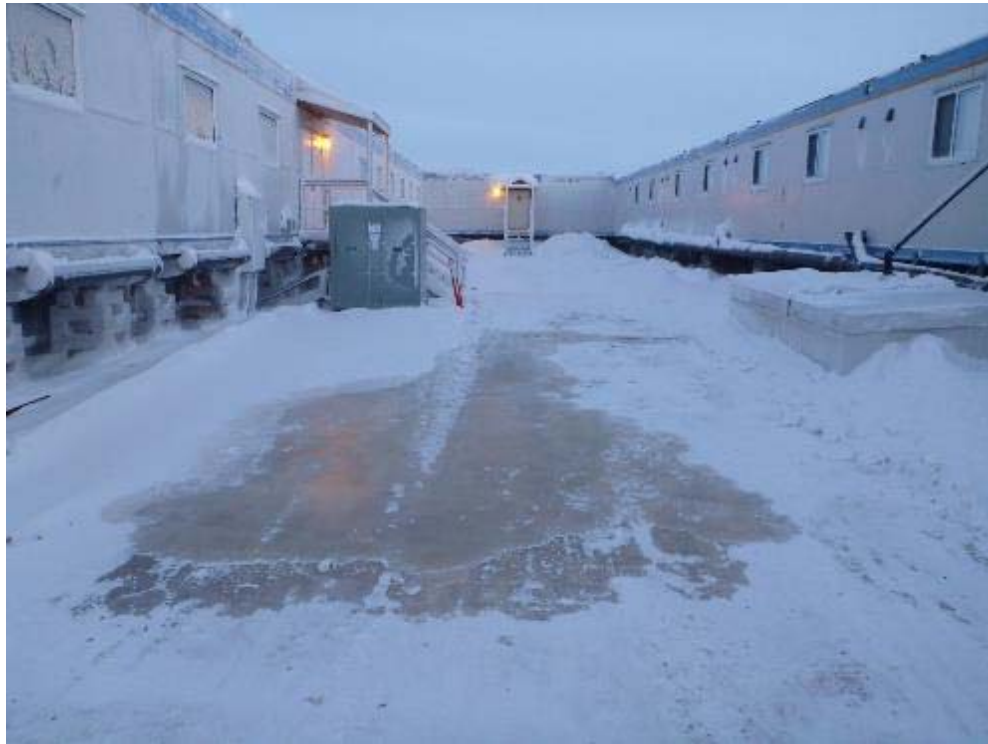
On January 30 2015 at 12:30 PM, a worker detected a leak at the Port Site Complex accommodations BD wing North Lift Station. Environment and Site Services investigated the report. On investigation, a significant amount of sewage had been released from the lift station. The 1.5" discharge pipe's O-ring rubber seal, that seals the piping to the containment tank, had unglued and separated from the fitting. This caused sewage to release underneath the tank and freeze, lifting the containment tank. This resulted in the 4" mechanical joint clamp on the gravity influent line separating from the tank, causing the spill. It was conservatively estimated that the volume of the spill was 2 m³, based on an area of contamination of approximately 50m². The sewage froze in place and did not migrate further. The closest water body, Milne Inlet, is more than 350 m away and is presently frozen.

Photo 1 - Spill location- BD North Wing Lift Station

A vacuum truck was mobilized to pump out any remaining sewage in the lift station and containment tank. The water was shut off to that side of the BD wing. The influent and discharge line connectors and fittings were replaced and reattached to the lift station. The contaminated material was removed and disposed of in the polishing waste stabilizing pond, a slight amount of contaminated material still remains under the wing.

Extreme temperature changes which cause the piping and fittings to expand and contract promotes leaks and pipe failures. Ongoing routine inspection of the piping systems are required to inspect for leaks and potential locations of failure. A longer term plan to solve this issue is in development.

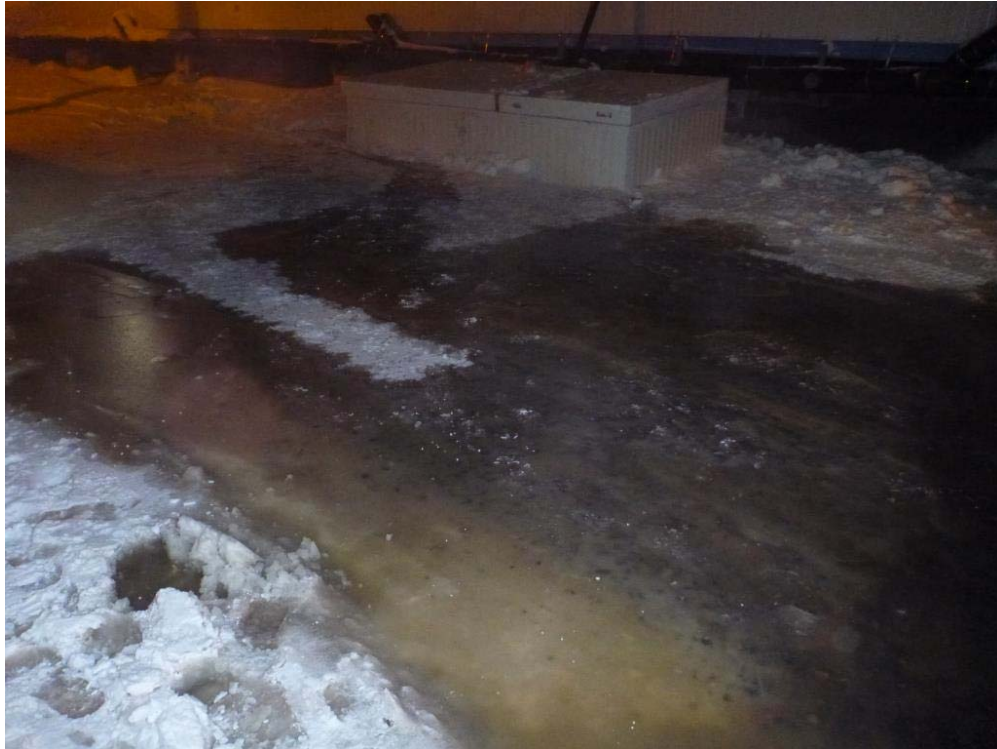
Photo 1 - Spill location- BD North Wing Lift Station

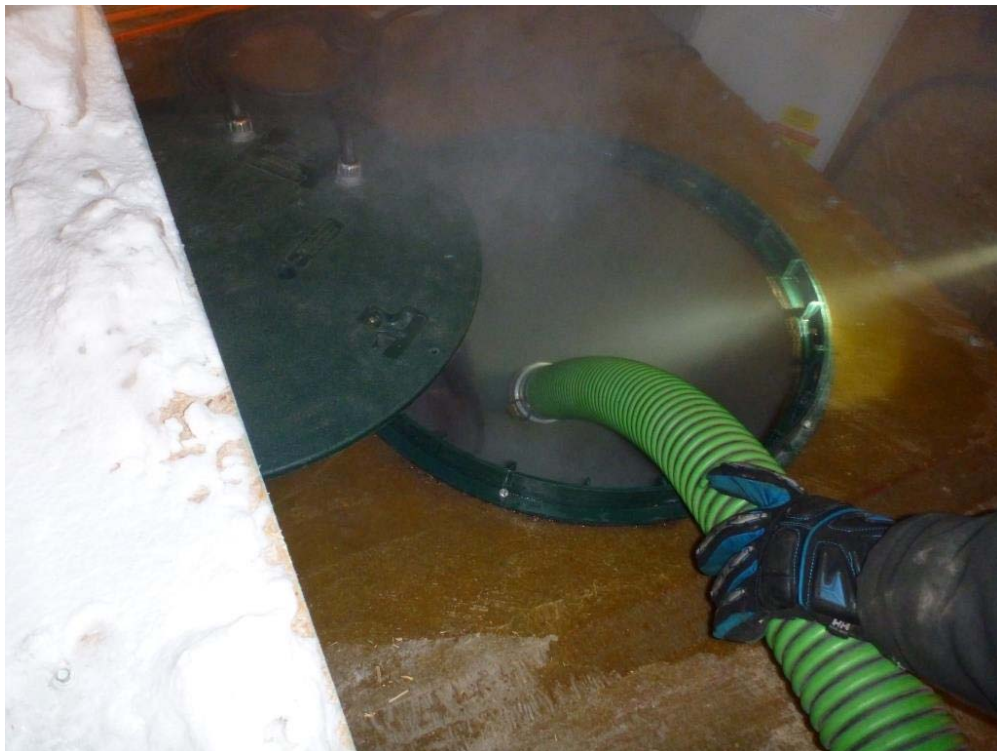
Photo 2 – Pumping out the lift station by vacuum truck

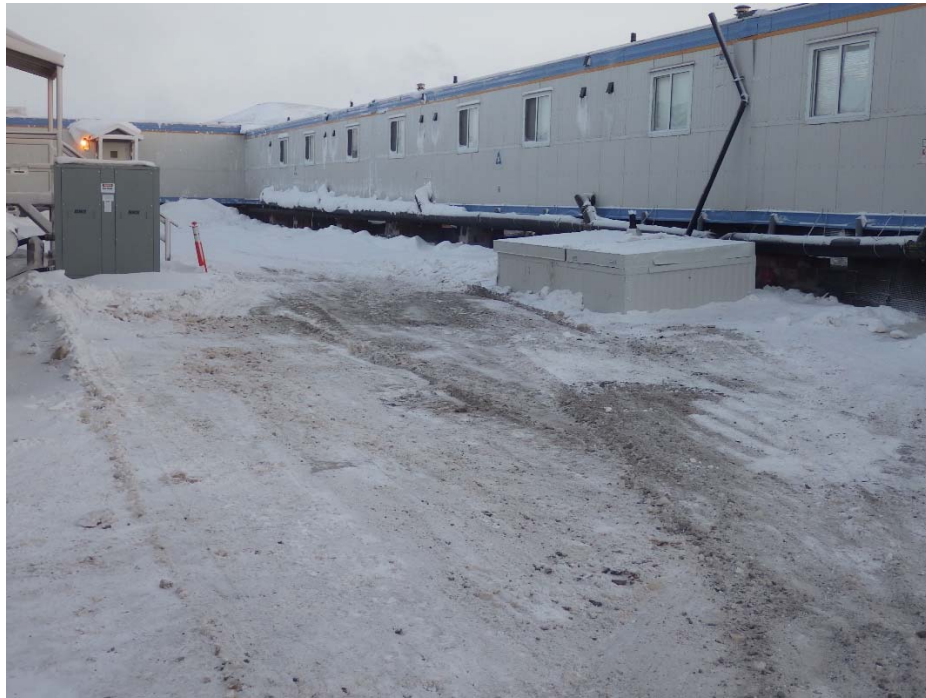
Photo 3 – Spill location post clean up

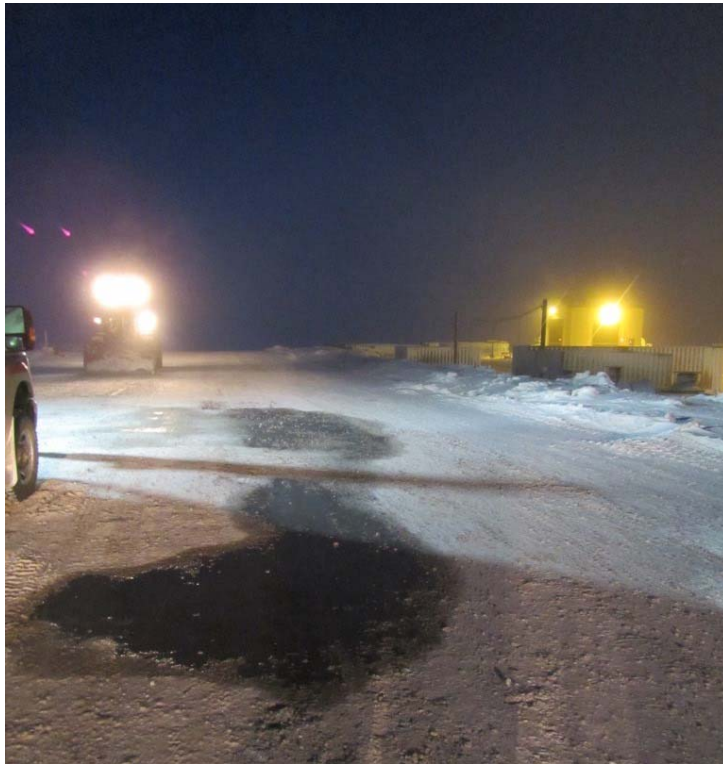
Photo 1 – Diesel Spill

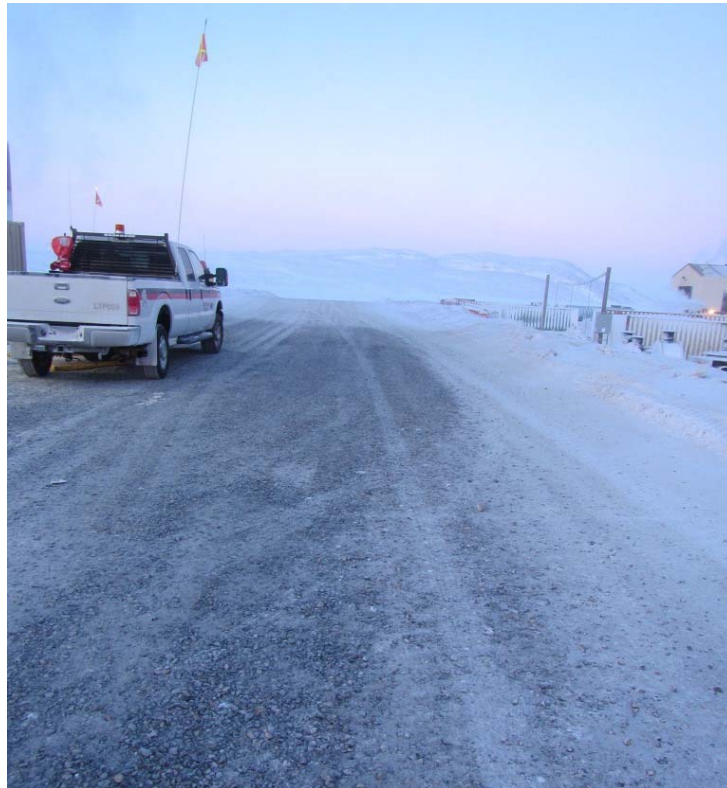
Photo 2 – After Spill Cleanup

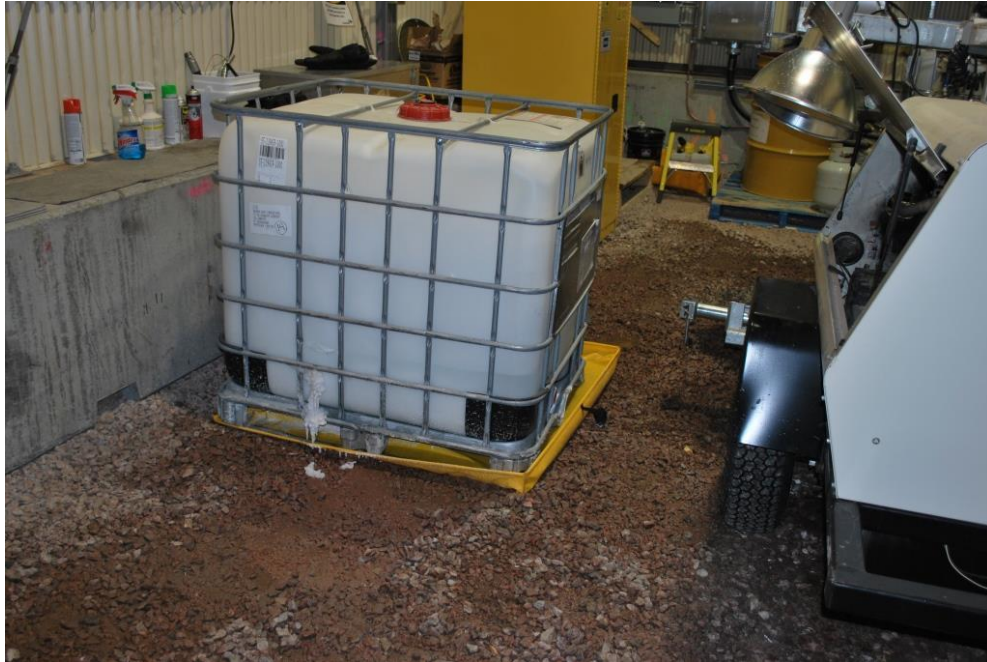
Photo 1 – Diesel Exhaust Fluid Spill

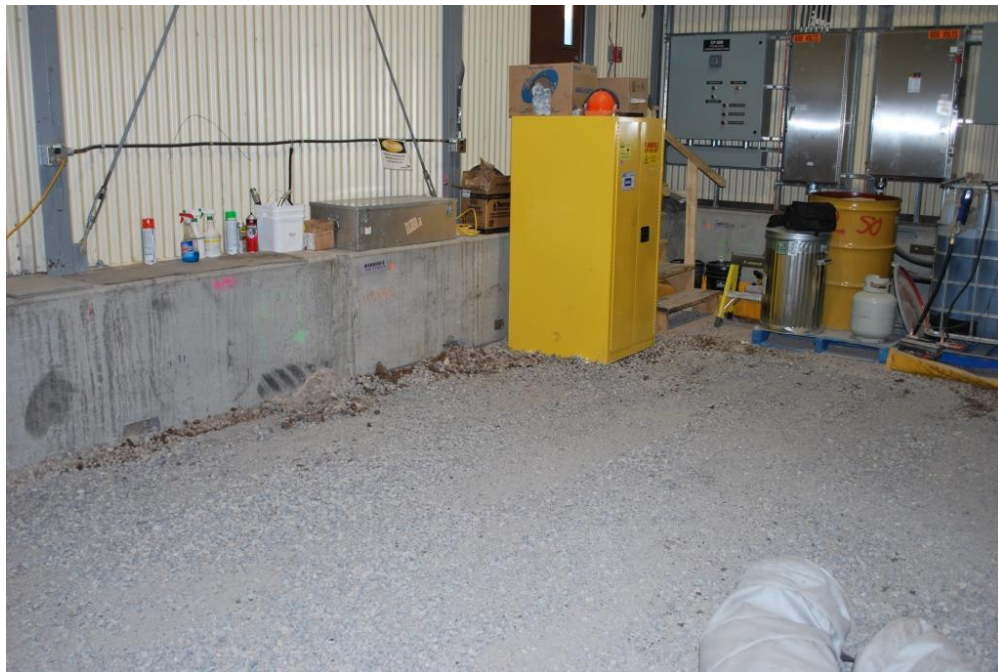
Photo 2 – After Spill Cleanup

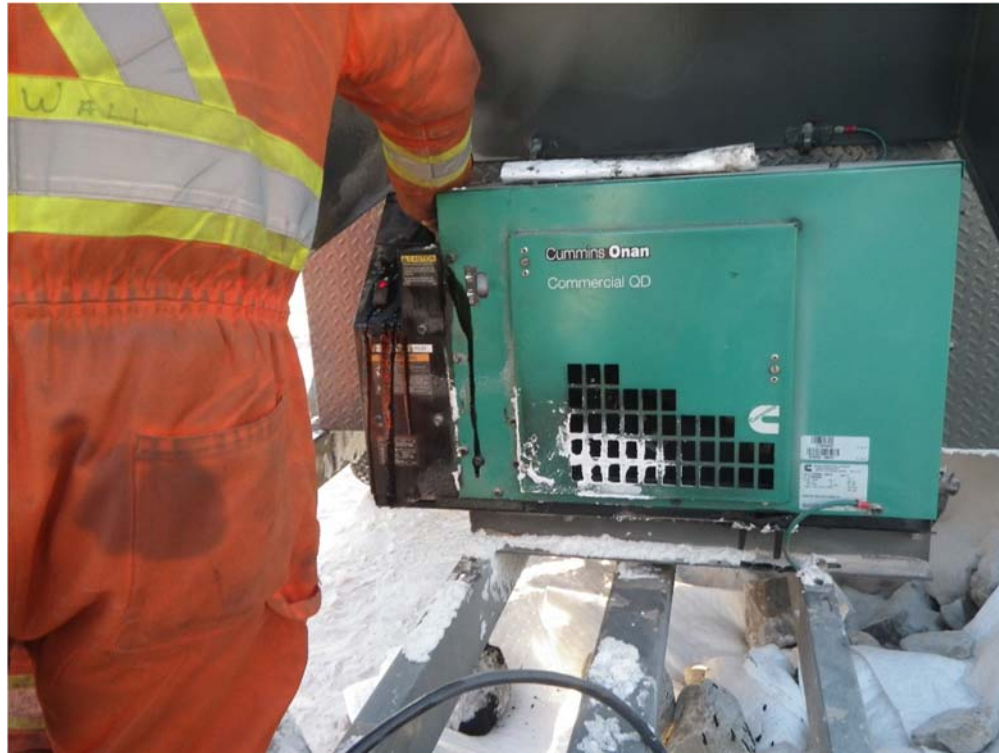
Photo 1 - Spill location- Oil dripping from the unit (left)

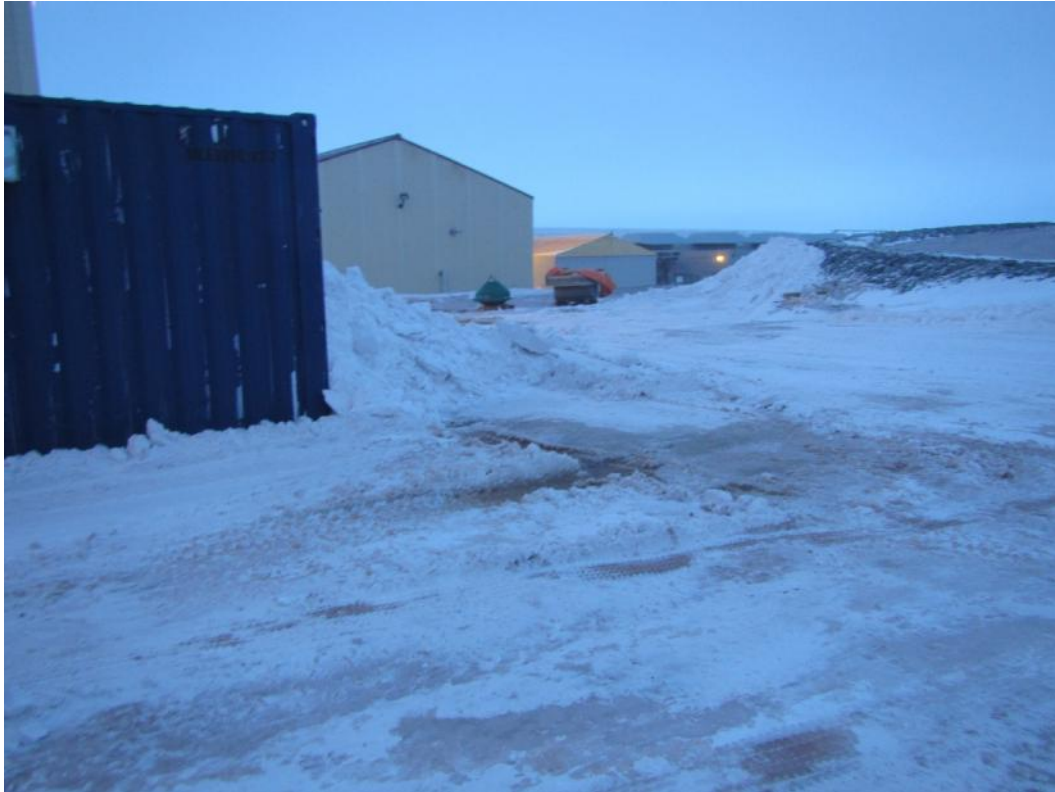
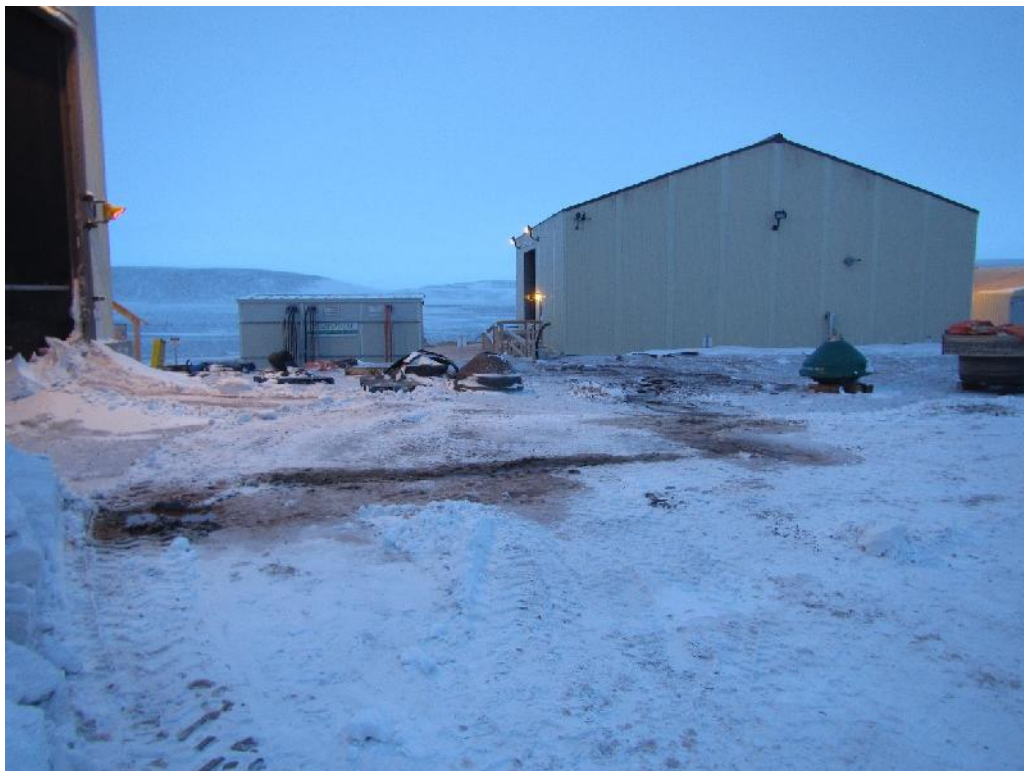
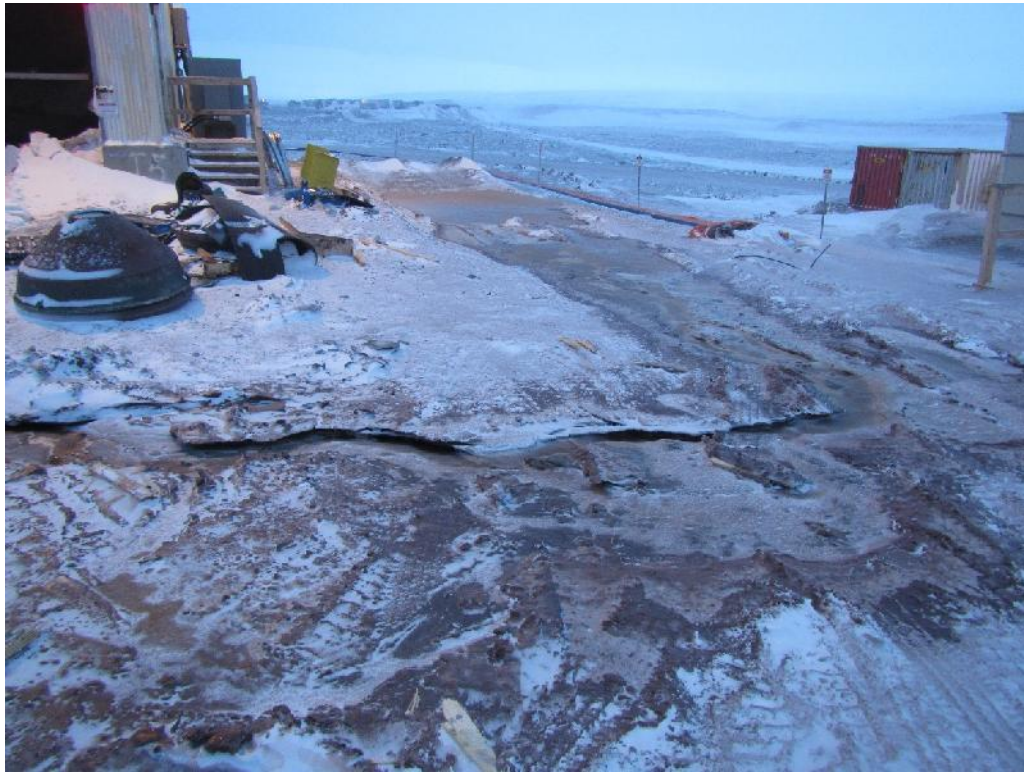
Photo 1 - Spill location - Mine Site WWTP

Photo 2 – Spill Location - Mine Site WWTP

Photo 3 – Spill Location - Mine Site WWTP

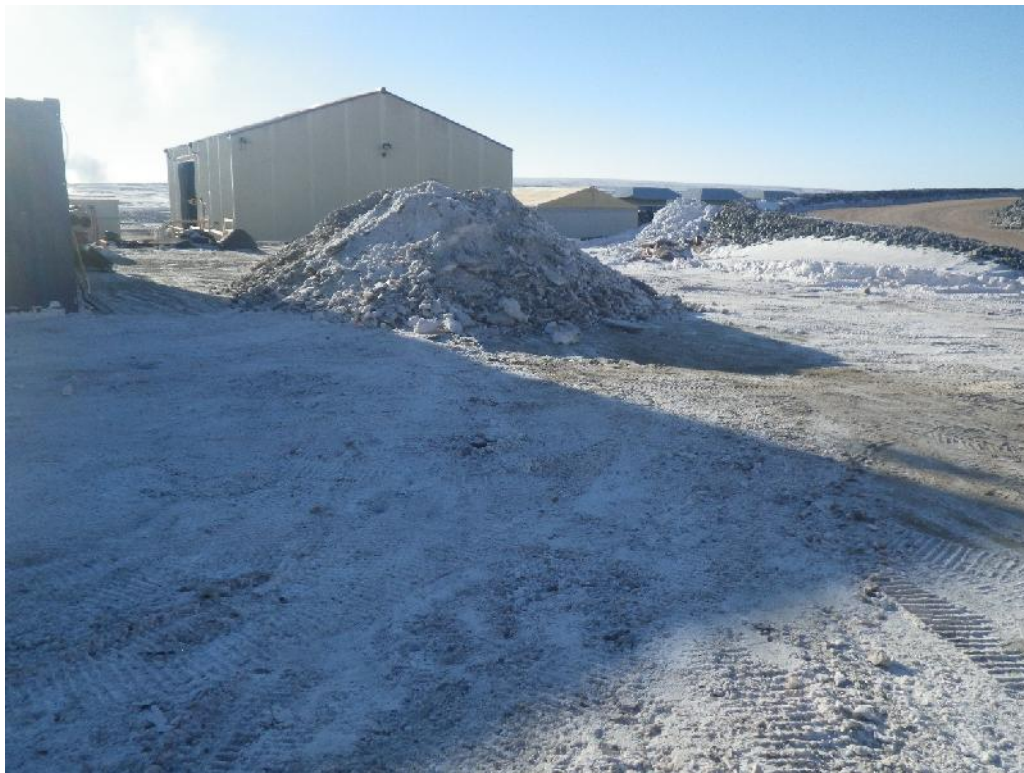
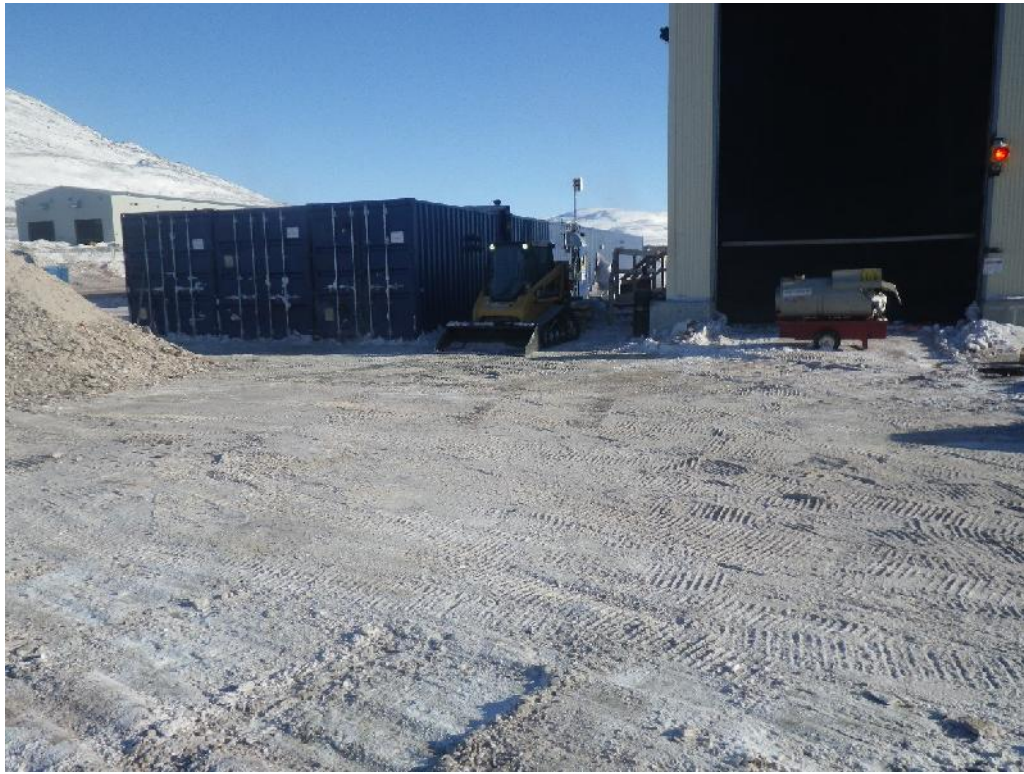
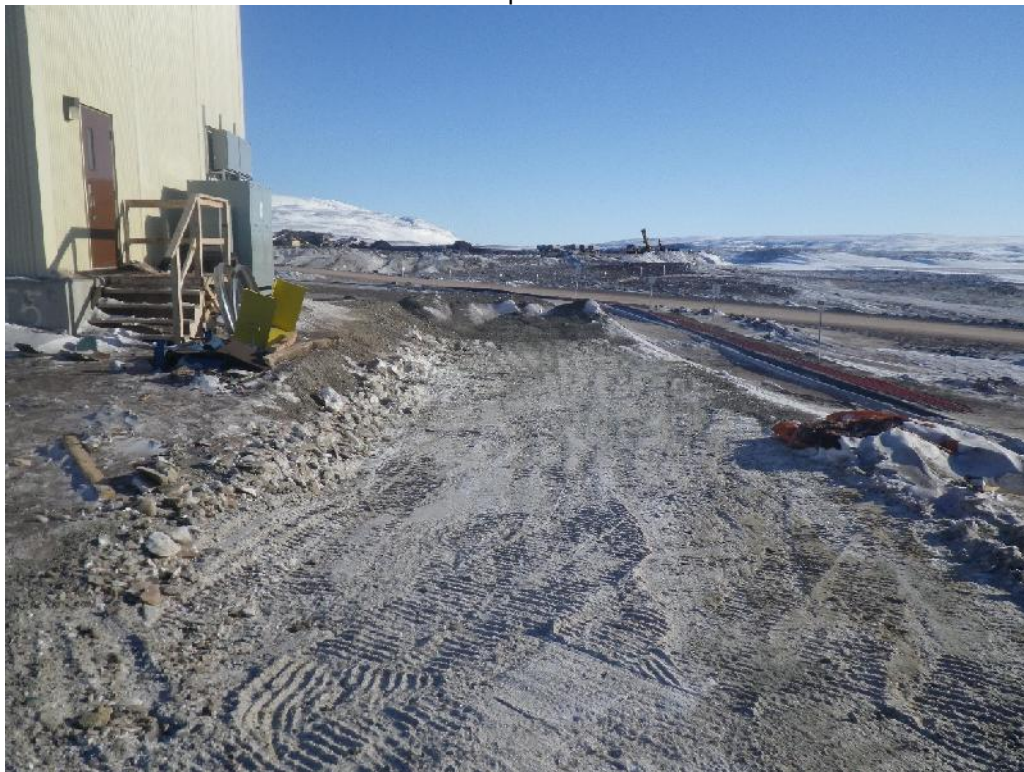
Photo 4 – Clean Up - Mine Site WWTP

Photo 5 – Clean Up - Mine Site WWTP

Photo 6 – Clean Up - Mine Site WWTP

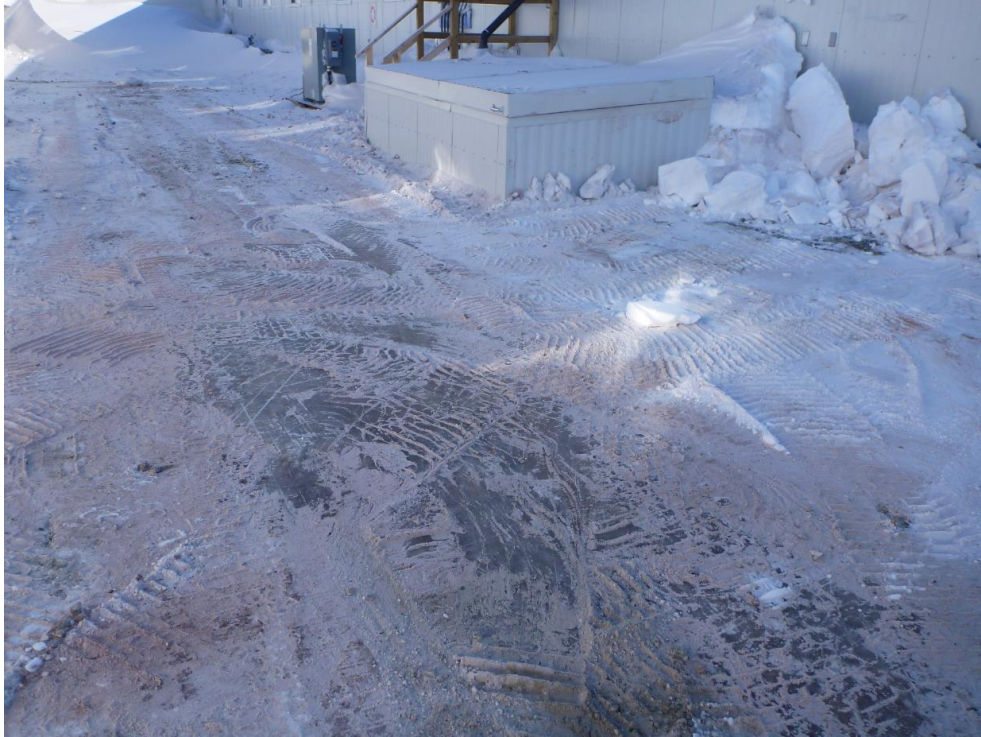
Photo 1 - Spill location- AF North Wing Lift Station Discharge Pipe

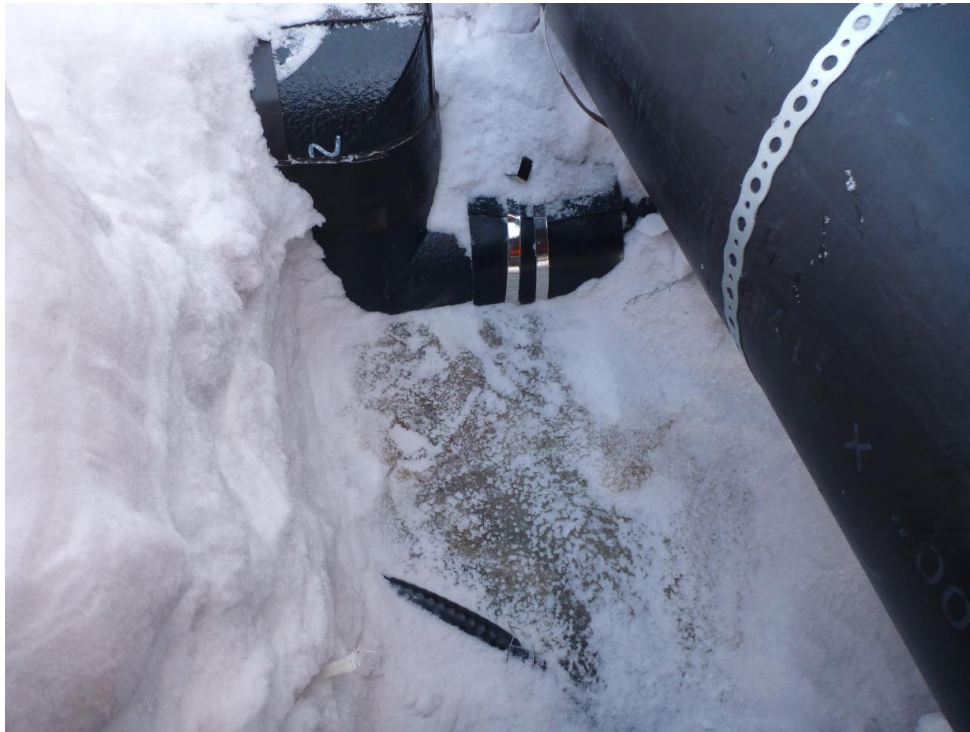
Photo 2 – Frozen sewage encasing half of the discharge pipe

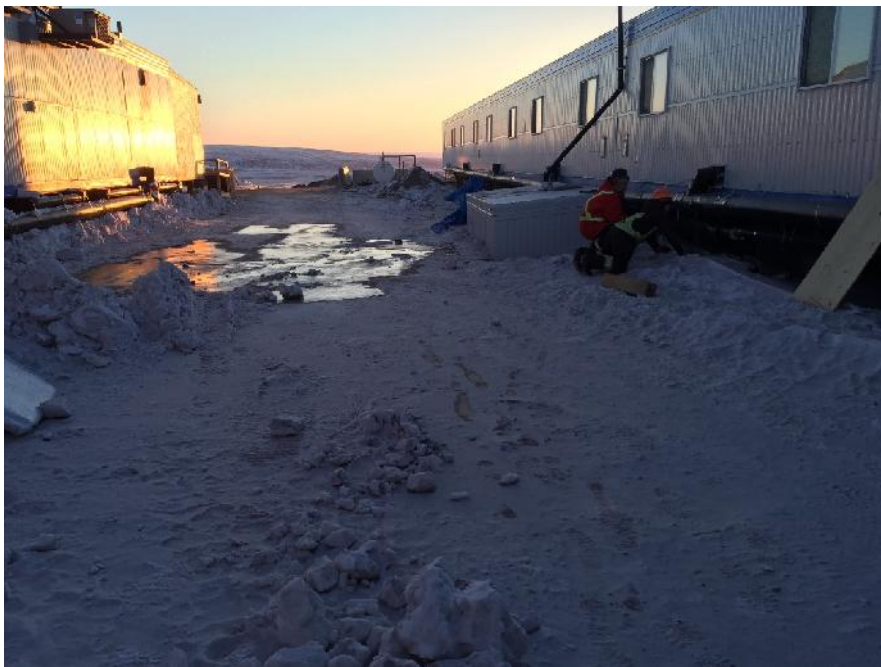
Photo 1 - Spill location- AG South Wing Lift Station Discharge Pipe

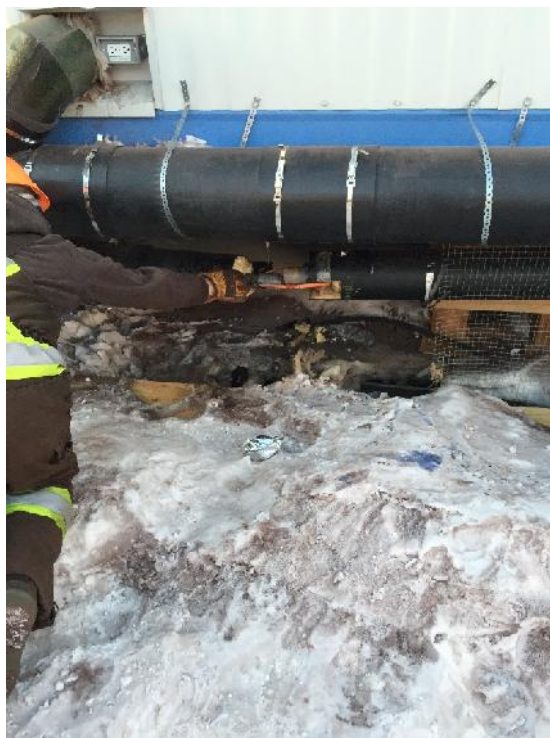
Photo 2 – Discharge Pipe Being Repaired

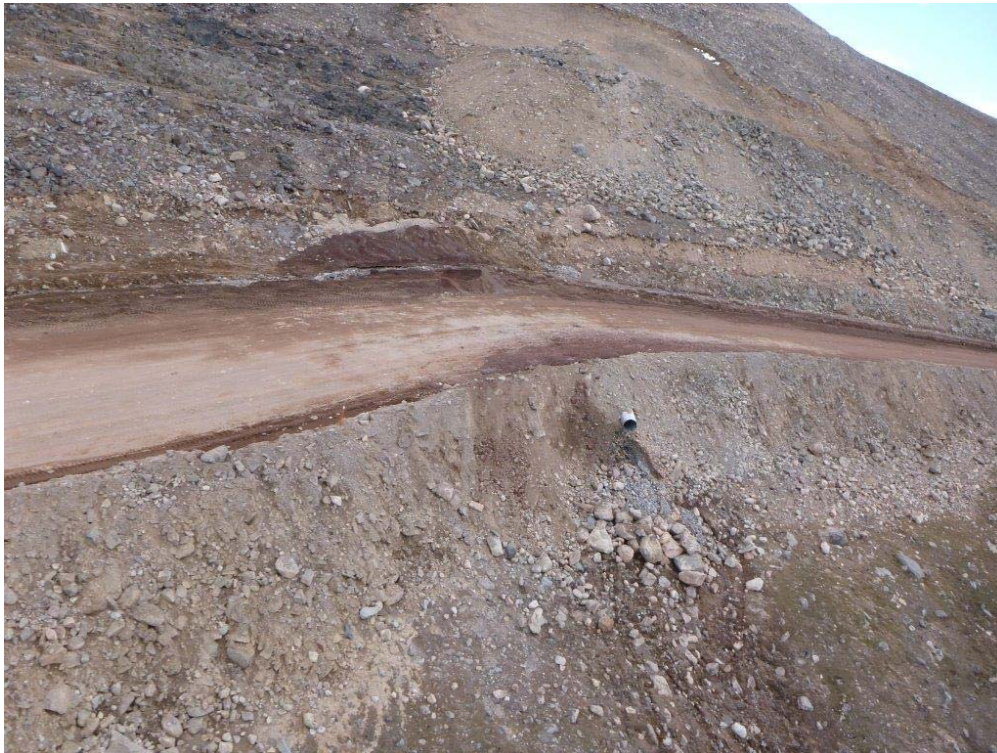
Photo 1: Culvert at Km 107 of Mine Haul Road. Sediment released downstream from this location on June 26 and 27 from erosion of road embankment and upstream ditches.

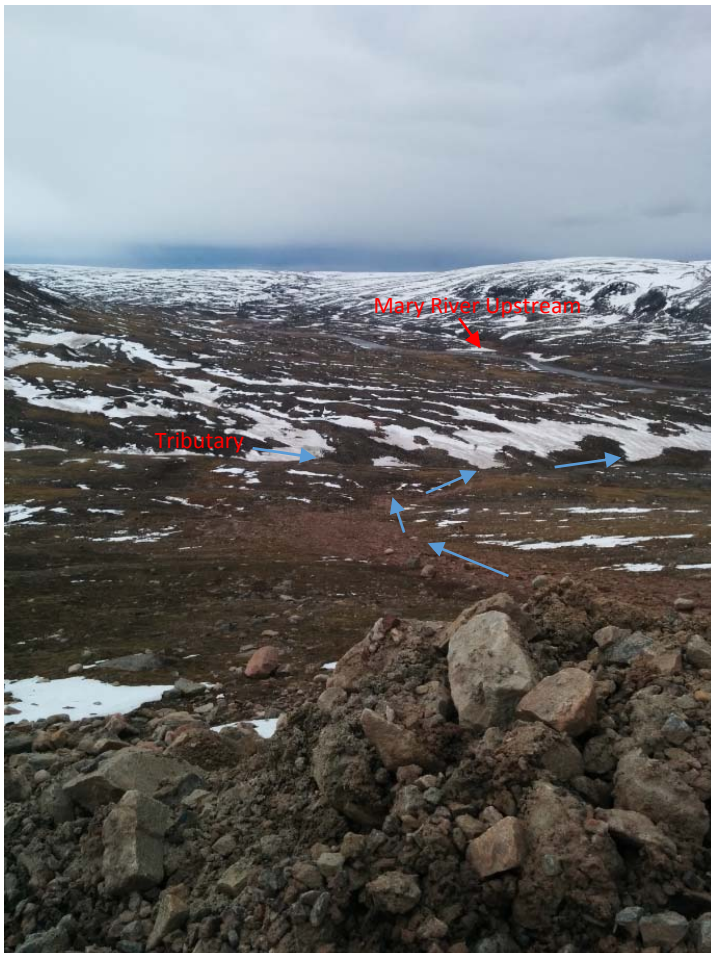
Photo 2: View downstream on June 26 from road embankment at Km 107 of Mine Haul Road showing drainage pathway to tributary that drains to Mary River. Mary River upstream in background.

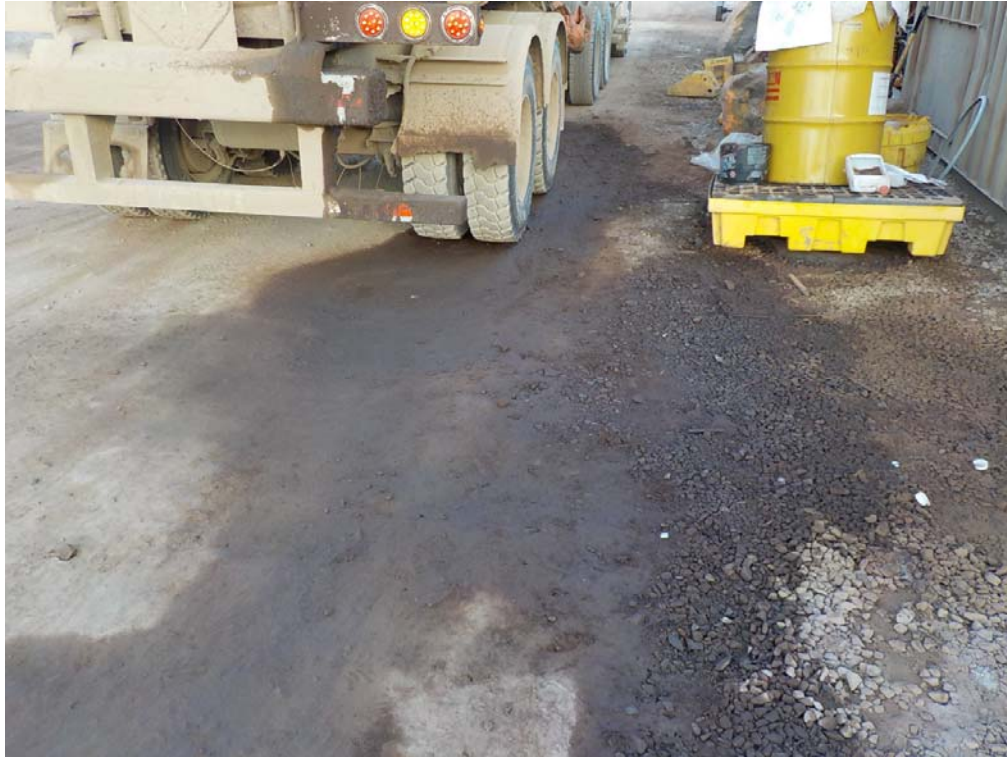
At 00:00 on June 9, 2015, a fuel tanker operator was refueling at the diesel refueling module at Milne Port. The operator misjudged the compartment capacity of the tanker he was currently operating with the compartment capacity of the tanker that he was previously driving which holds approx. 1,000 L more. As a result, approx. 150 L was released as an overfill from the top fill port before the operator observed the overfill and shut-down the fuel supply.

Photo 1 – Diesel Tanker Overfill Spill

Upon shut-down of the fuel supply, any fuel dripping from the side of the tanker compartment was wiped to prevent further spillage prior to removing it from the impacted area. The impacted ground cover (sand/gravel fill) was excavated and placed at the Milne Port Landfarm Facility. It was then replaced with clean fill material and inspected to confirm that residual fuel was not present. The clean-up was determined to be complete.

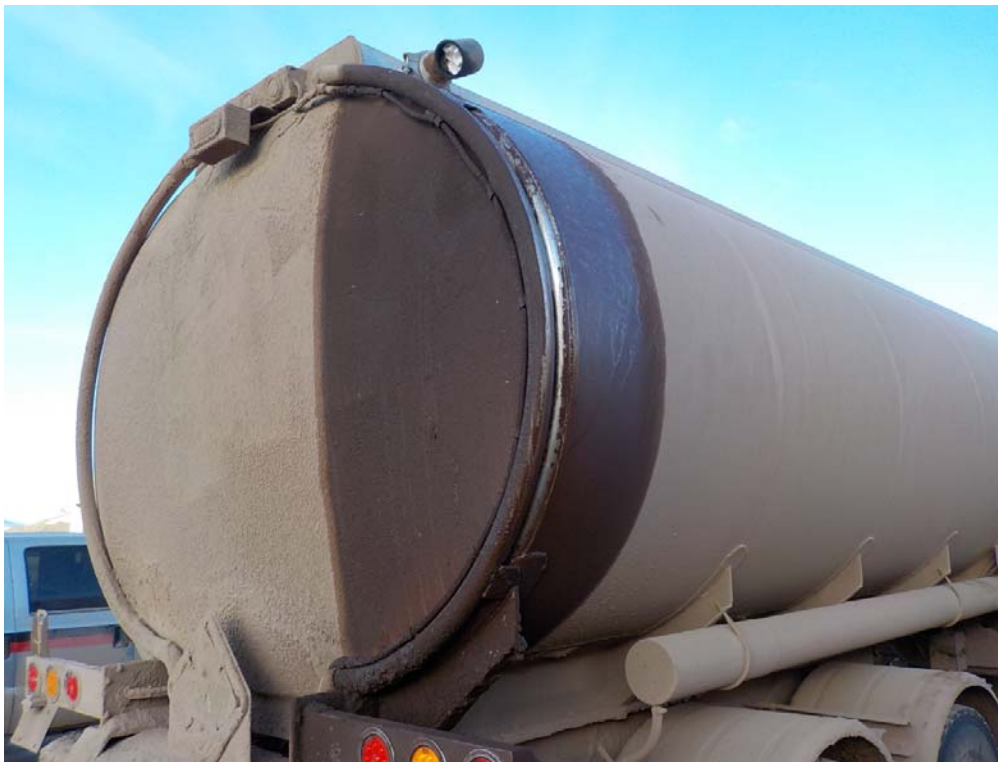
Photo 2 – Diesel Overfill of Tank

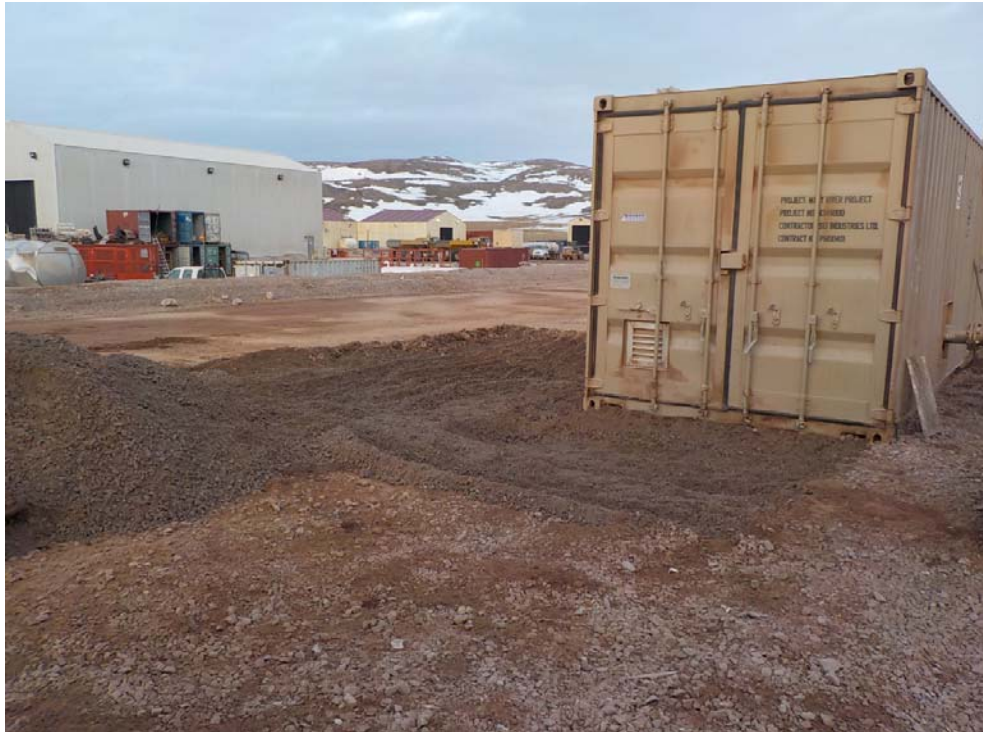
Photo 3 – Spill Clean-up in Progress

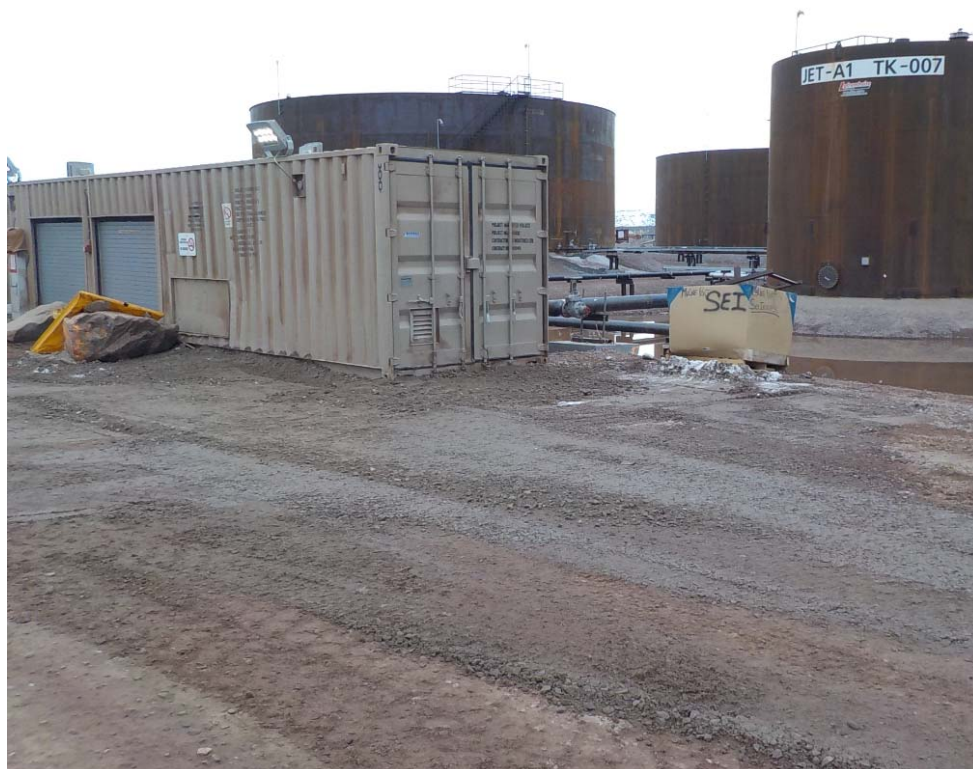
Photo 4 – Spill Clean-up Complete

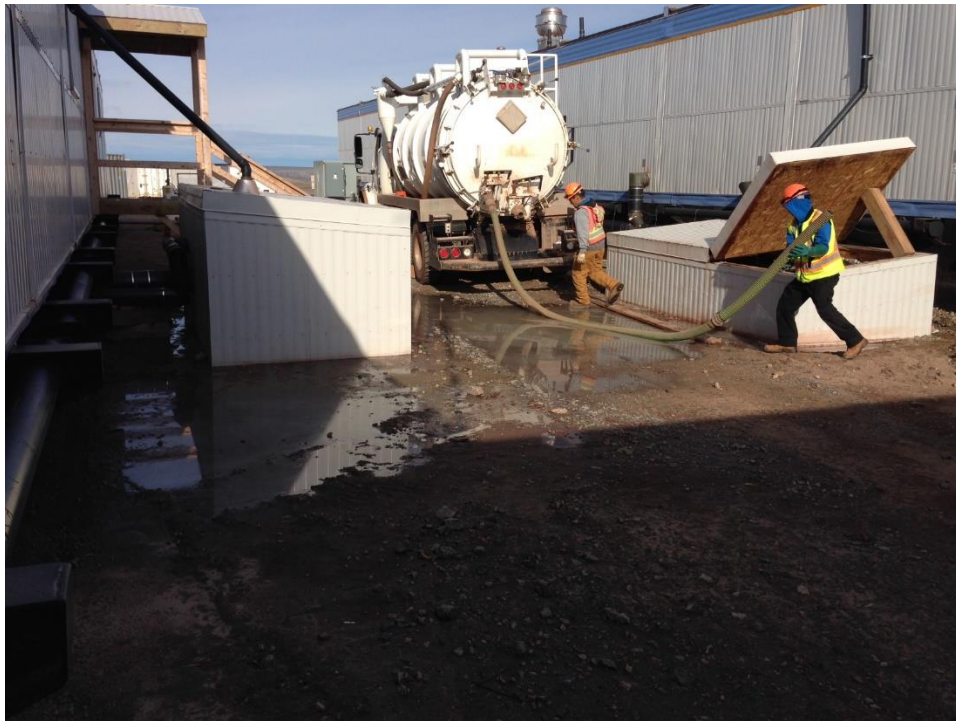
Photo 2 – Sewage Spill Response

The coupling has been repaired and the sewage line is back in service. Regular inspections are conducted on the sewage lift stations and sewage lines to verify the system is working as designed.

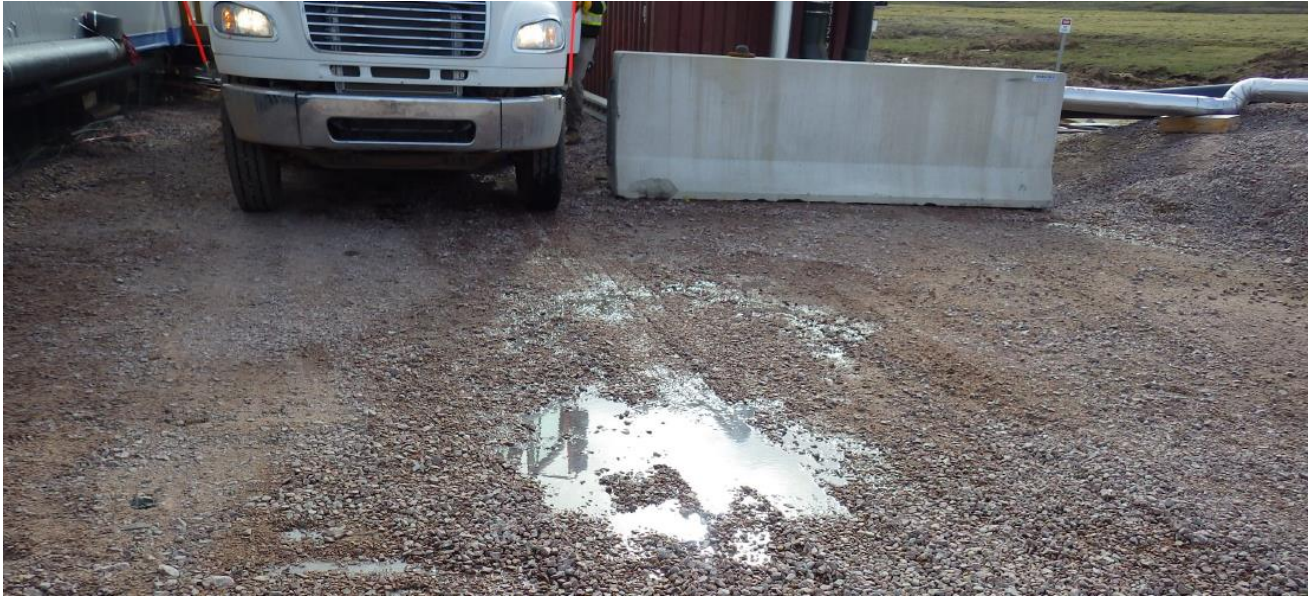
PHOTO 1 – Lift Station Spill

The float switch has been repaired and the system is back in service.

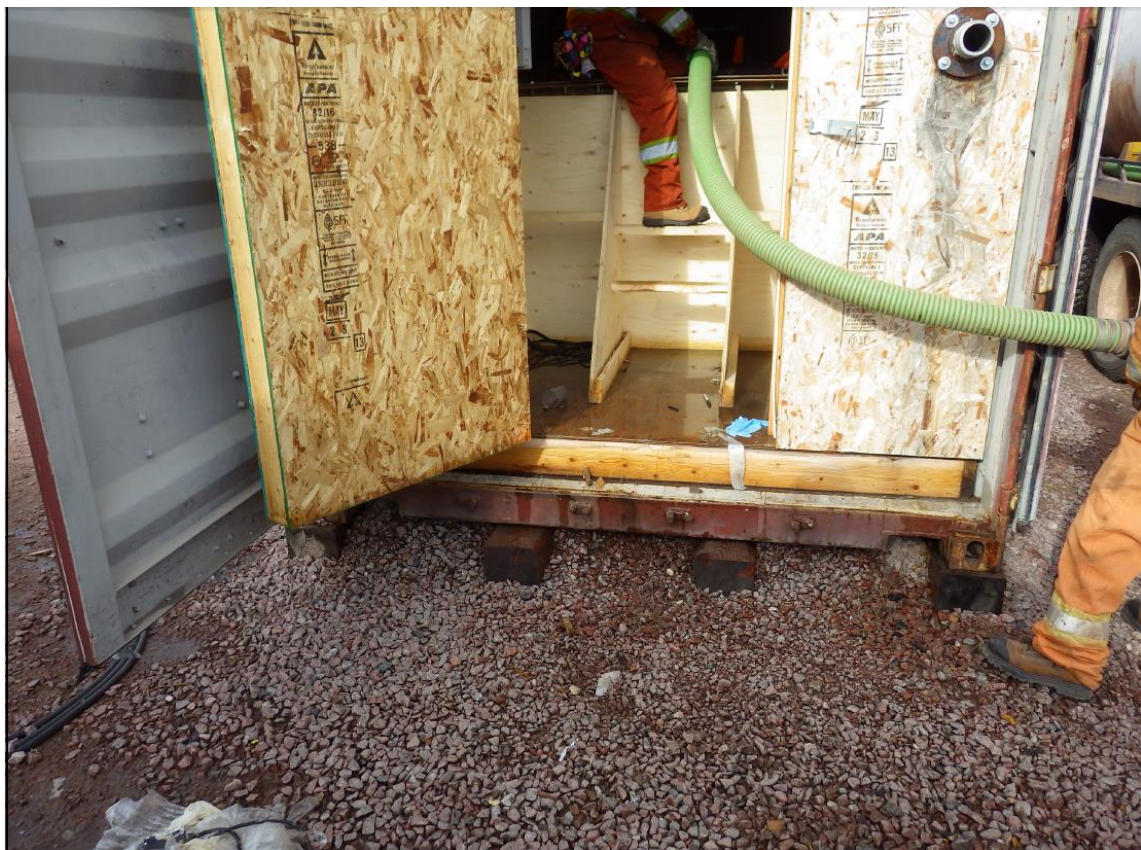
PHOTO 2 – Lift Station Spill Response
