APPENDIX E.7.4
FOLLOW-UP SPILL REPORTS

Re: Follow-up to Spill 15-003 Reported on January 2nd, 2015
Mary River Project - Water Licence No. 2AM-MRY1325

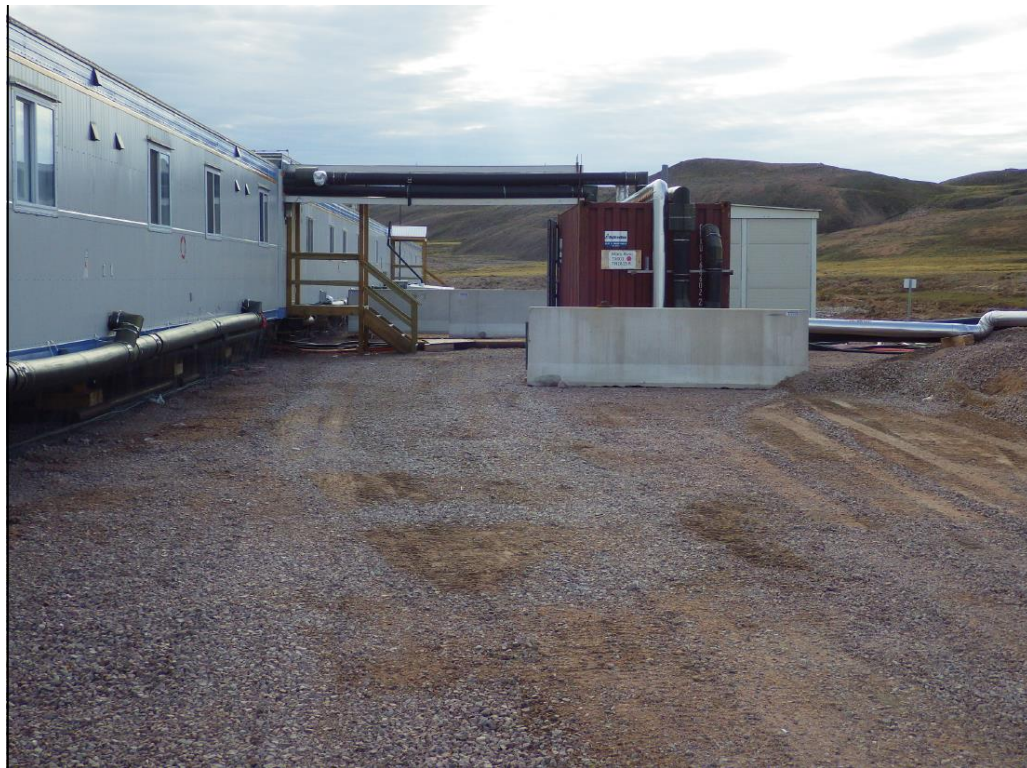
PHOTO 3 – Lift Station Spill Clean-up

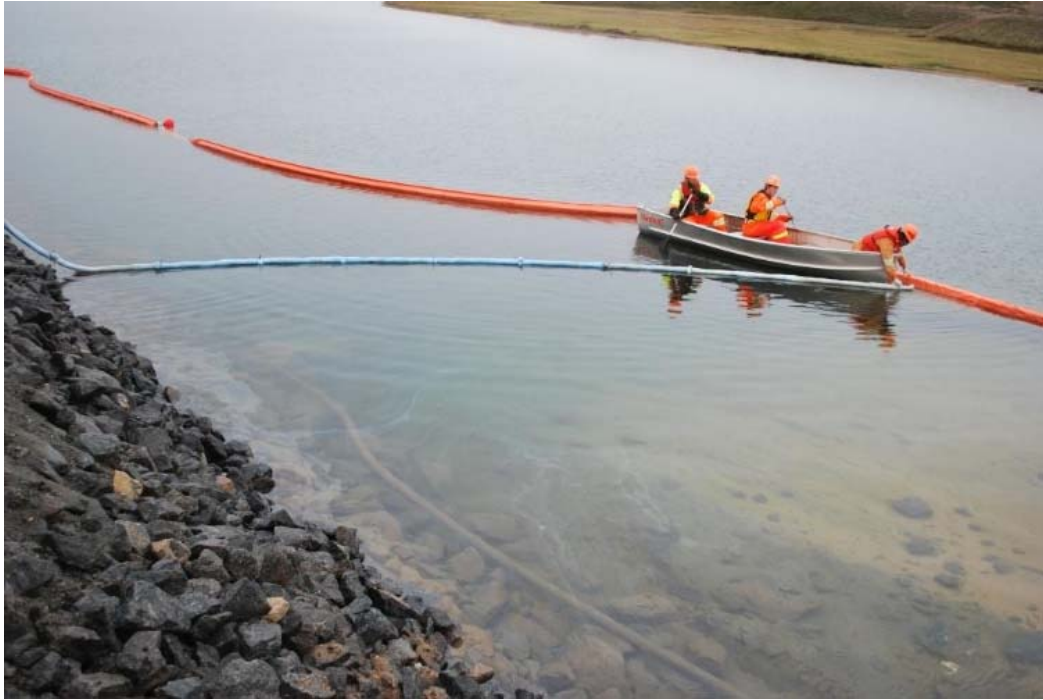
Photo 1 – Spill Response – Capturing Sheen with Booms

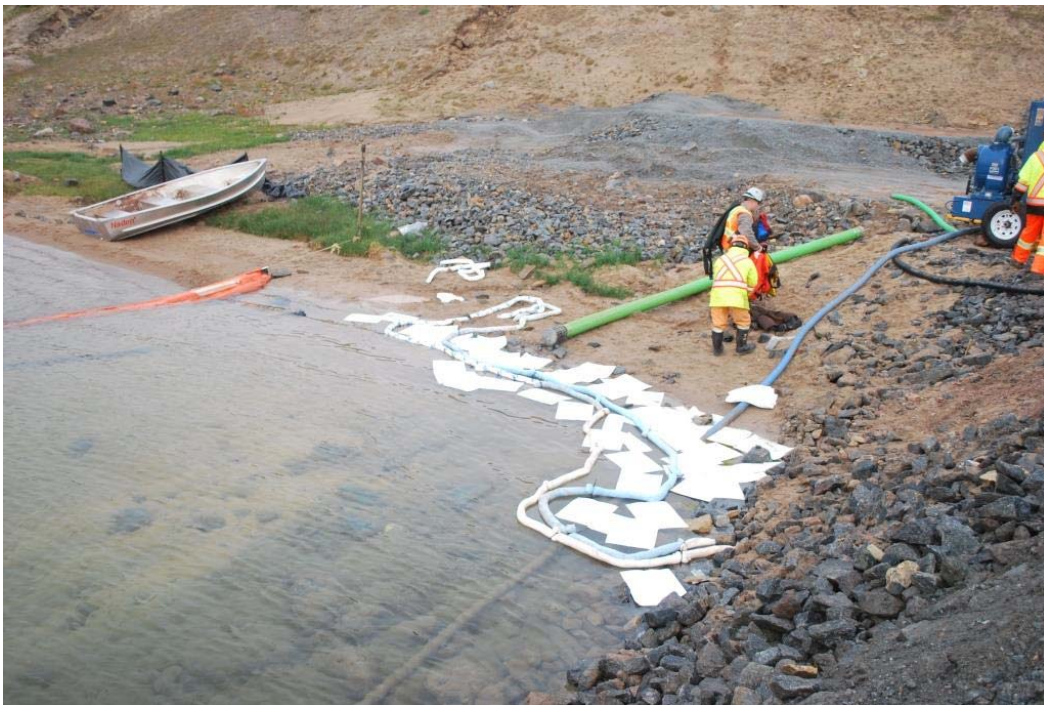
Photo 2 – Spill Clean up

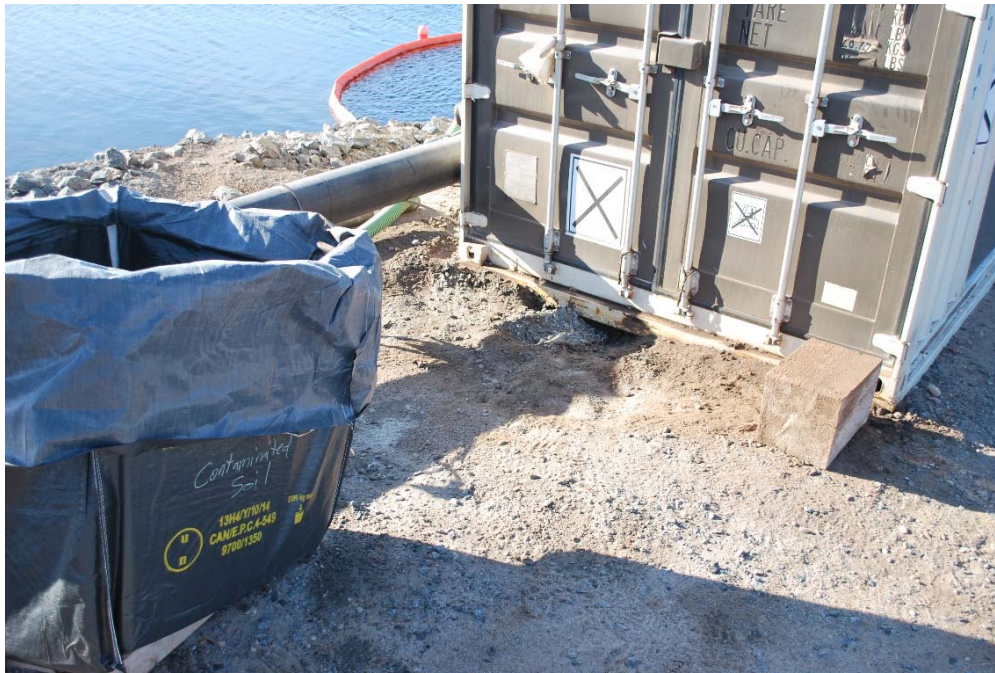
Photo 3 – Spill Cleanup – Contaminated Soil Removal on Jetty

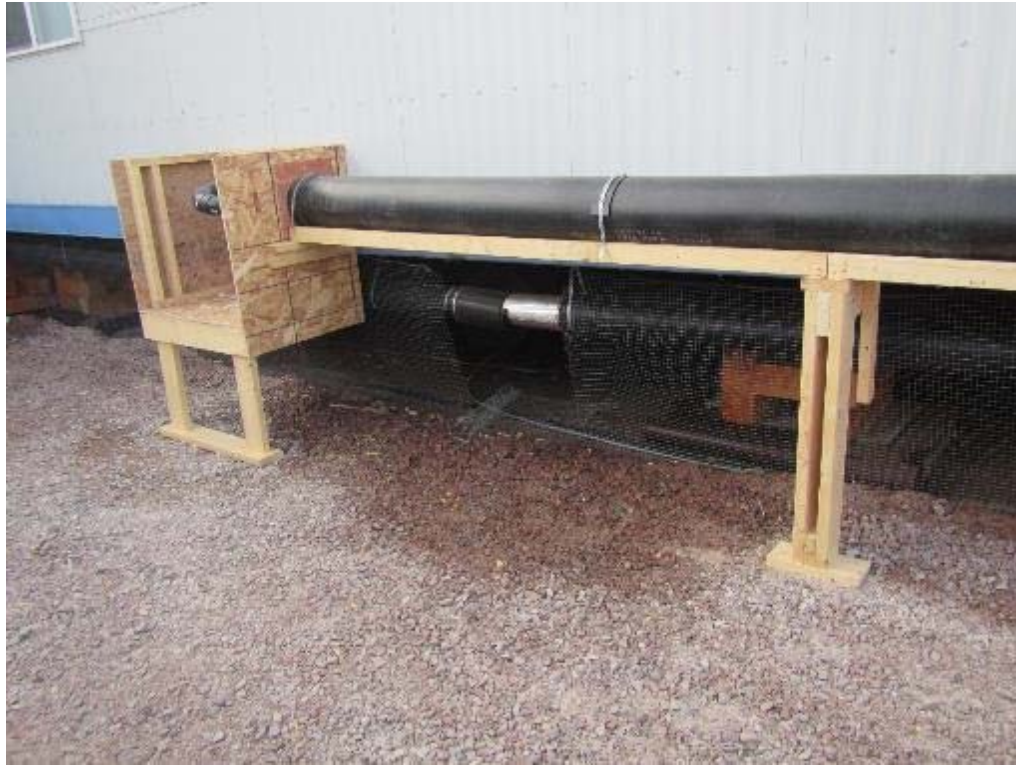
PHOTO 1 – Discharge Pipe Spill

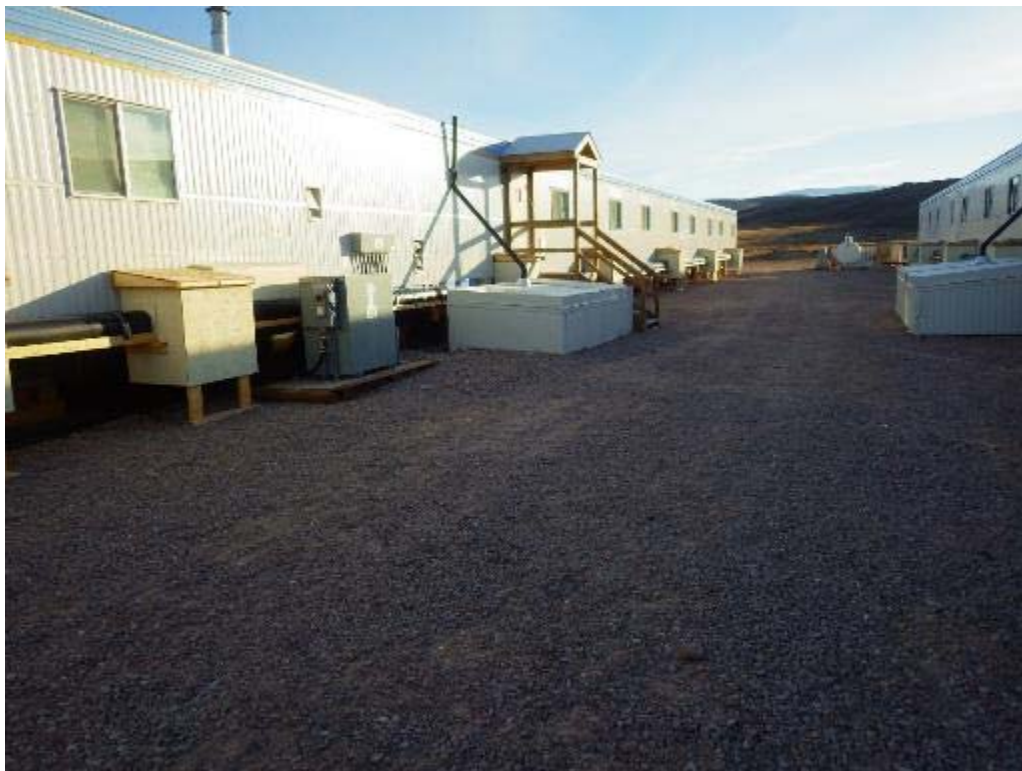
PHOTO 2 – Discharge Pipe Spill Clean-up

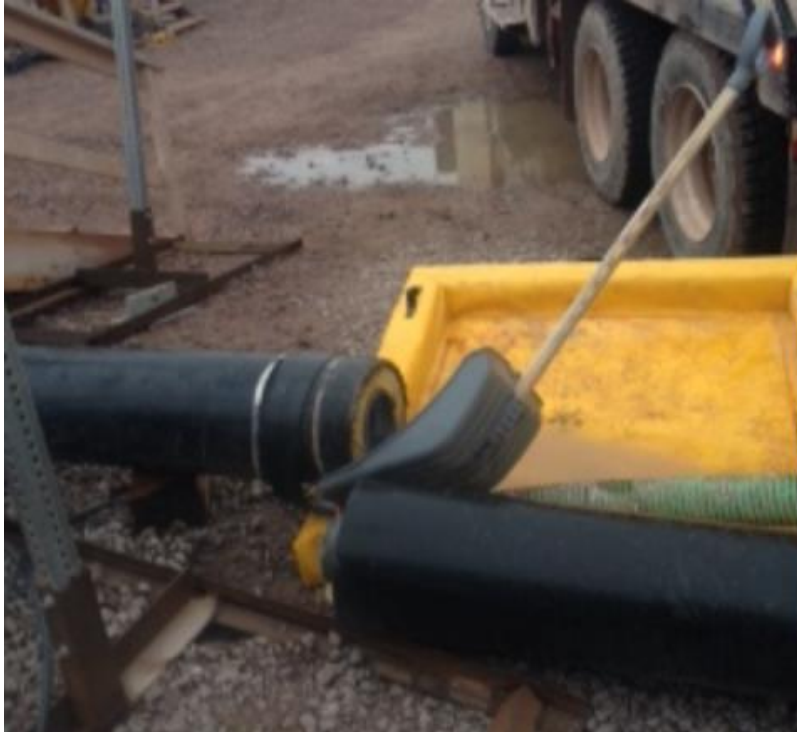
PHOTO 1 – Discharge Pipe Spill

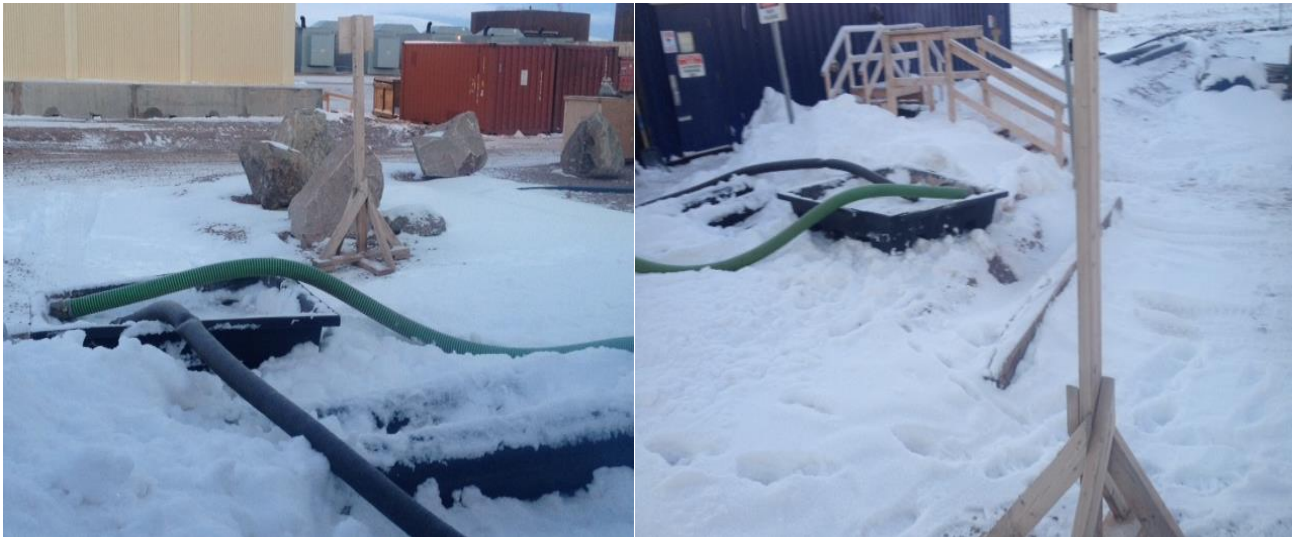
PHOTO 2/3 – Discharge Pipe Spill Clean-up and Berm Extension/Barricade

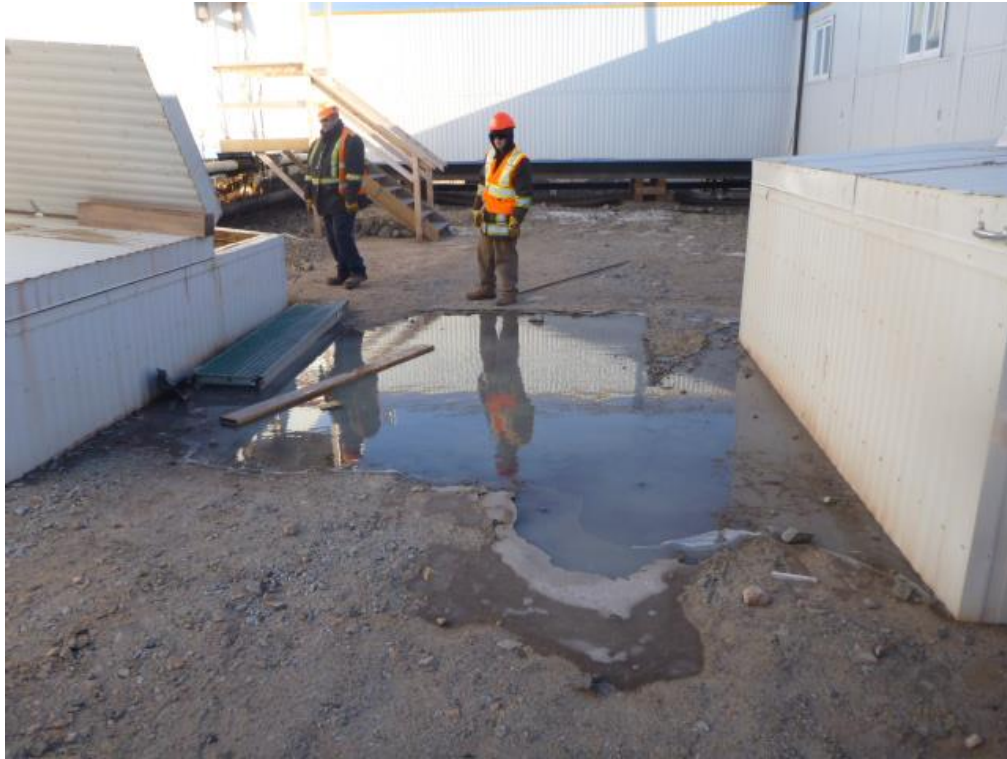
Photo 1 – First Sewage Spill (Approx. 500 L)

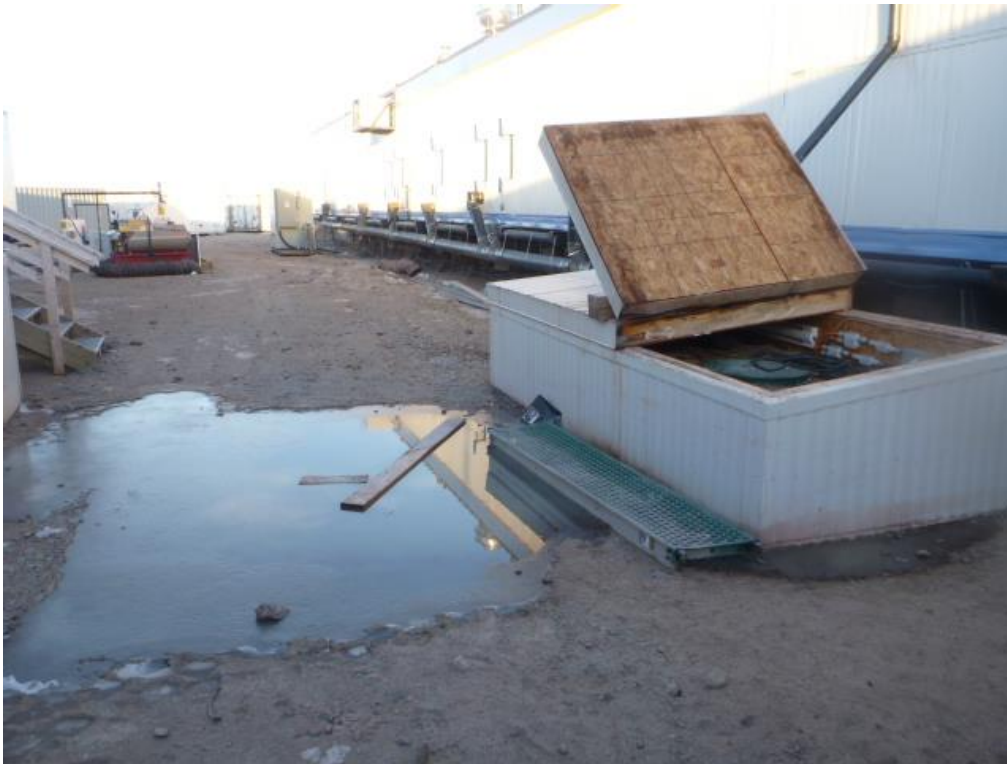
Photo 2 – Second Sewage Spill (Approx. 1000 L)

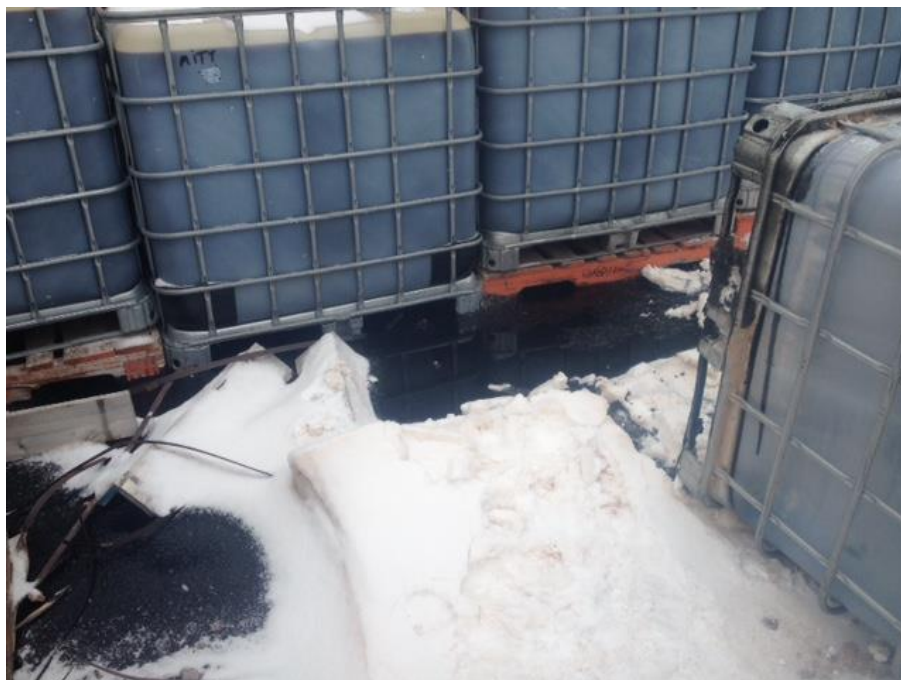
Photo 1 – Waste Oil Spill

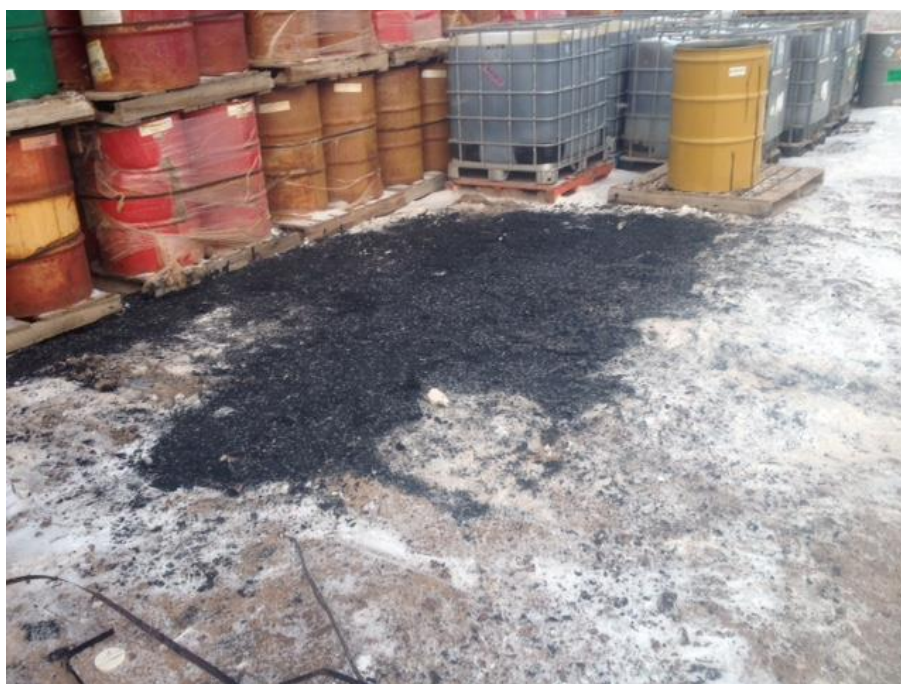
Photo 2 – Totes Removed and Cleanup Underway

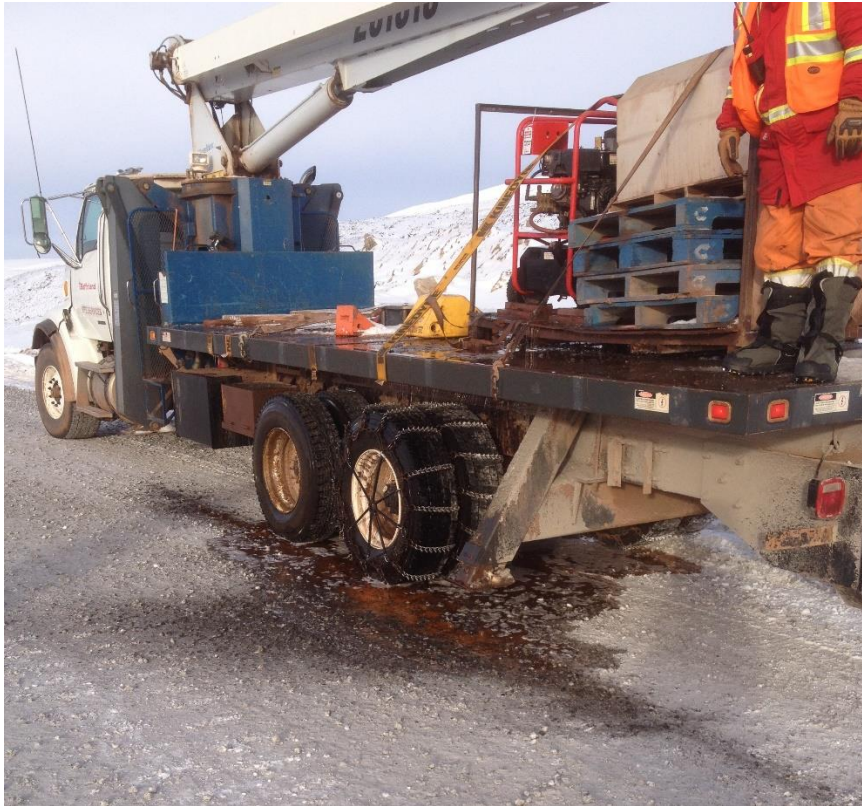
Photo 1 – De-icing Fluid Spill

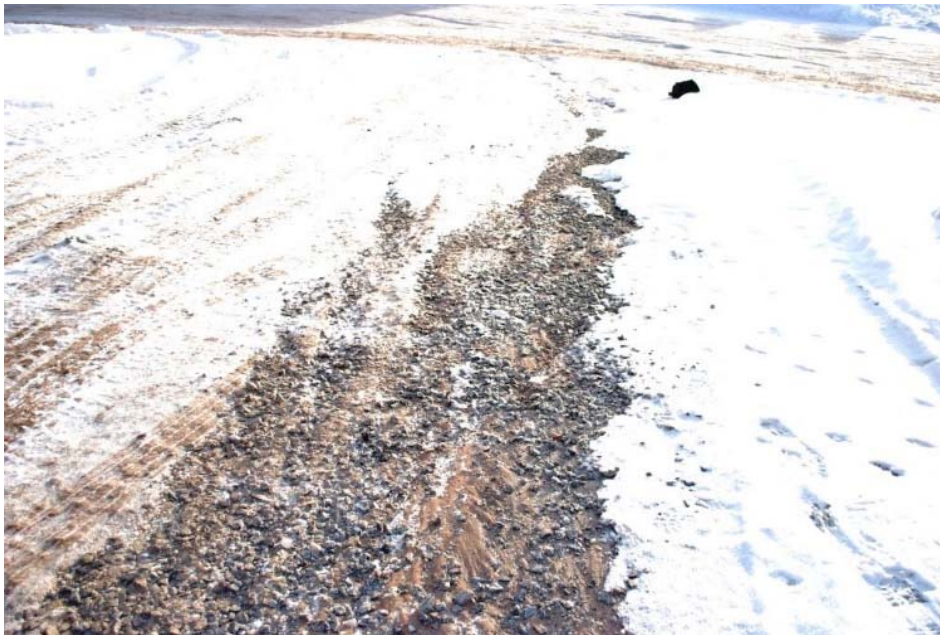
Photo 1 – Sump Water Spill

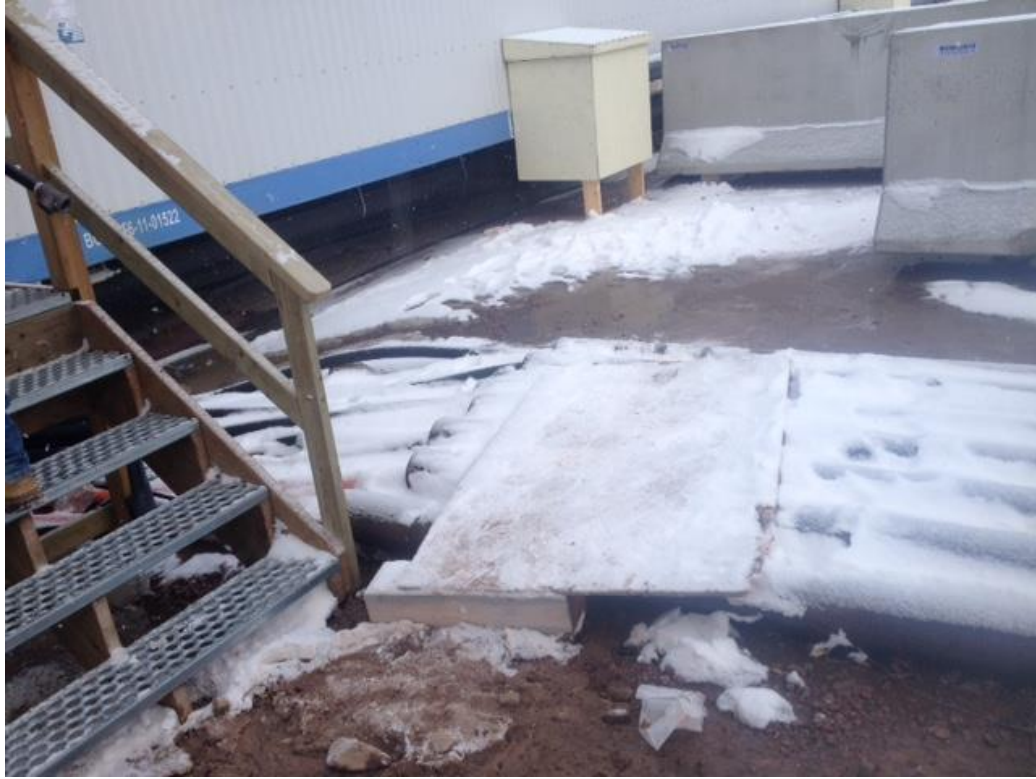
On October 12, 2015, at approximately 13:30, a worker discovered that sewage was coming out of the door of the main lift station of the Milne Port Site Complex. Upon further inspection it was determined that the floats that trigger the lift stations pumps had failed to activate, causing the lift station to overflow. It is estimated that approximately 1300L of sewage was discharged to the ground surface adjacent to the lift station, impacting an area of roughly 16 m². Soil infiltration was minimized due to the frozen ground conditions. The location of the spill was on the camp pad and is greater than 100 metres from the closest water body, which is currently frozen.

Photo 1 – Sewage Spill

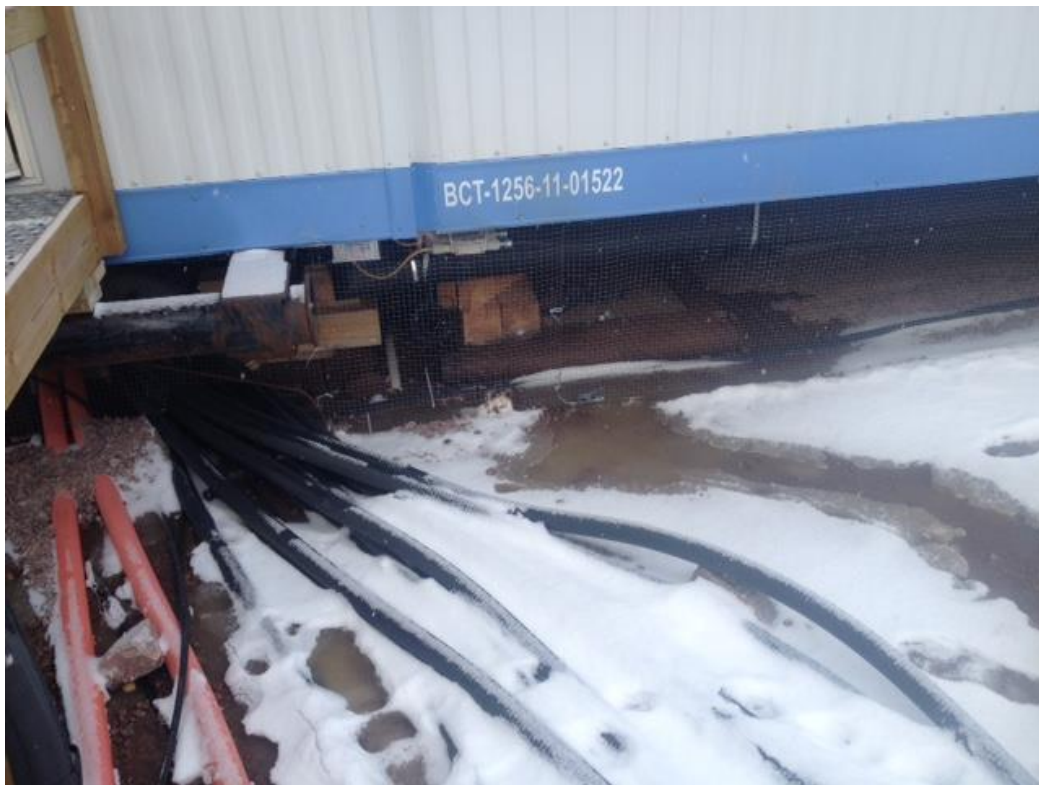
Photo 2 – Sewage Spill

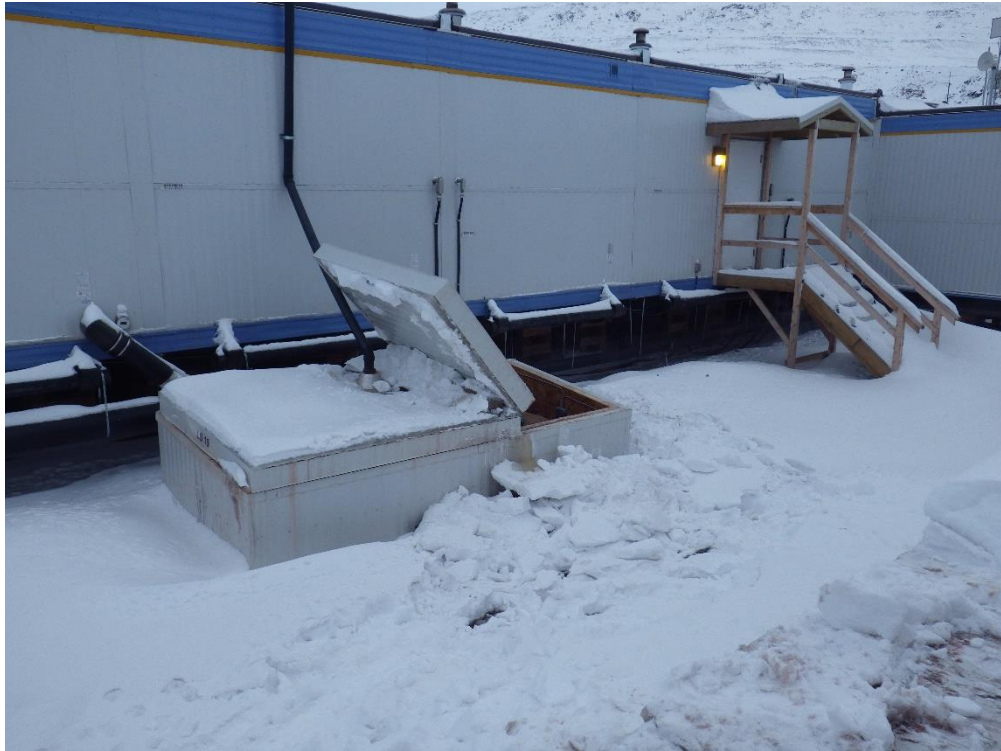
On October 16, 2015 at approximately 08:30, a release of untreated sewage was observed at the lift station located between the office and kitchen complexes of the Mine Site Complex. Upon investigation, the lift station float switch malfunctioned and the pumps were not activated causing approximately 500 Litres of untreated sewage to overflow onto the adjacent ground surface and surrounding camp pad. An area of approximately 10m² was impacted. The location of the spill was greater than 200 meters from the nearest watercourse.

Photo 1 – Lift Station Spill

Housing Maintenance and the Environment Department were immediately notified. The vacuum truck was used to empty the lift station and remove any pooling sewage. The pumps were shut off and the float switch was repaired.

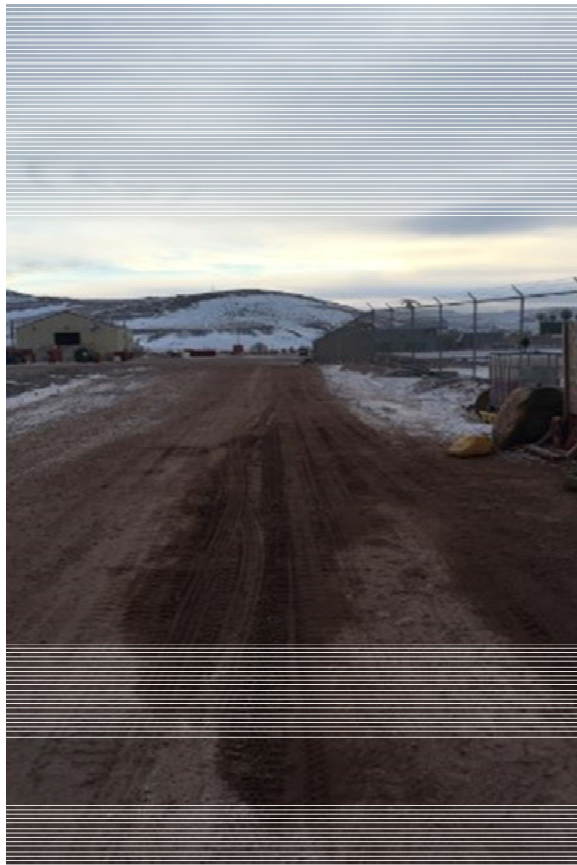
Due to frozen ground conditions, the diesel fuel released remained on top of the ground surface, penetrating to a maximum depth of 1 cm. The contaminated surface soil was removed and disposed of at the Milne Port Landfarm Facility.

Figure 1 - Impact of Spill Area (facing south)

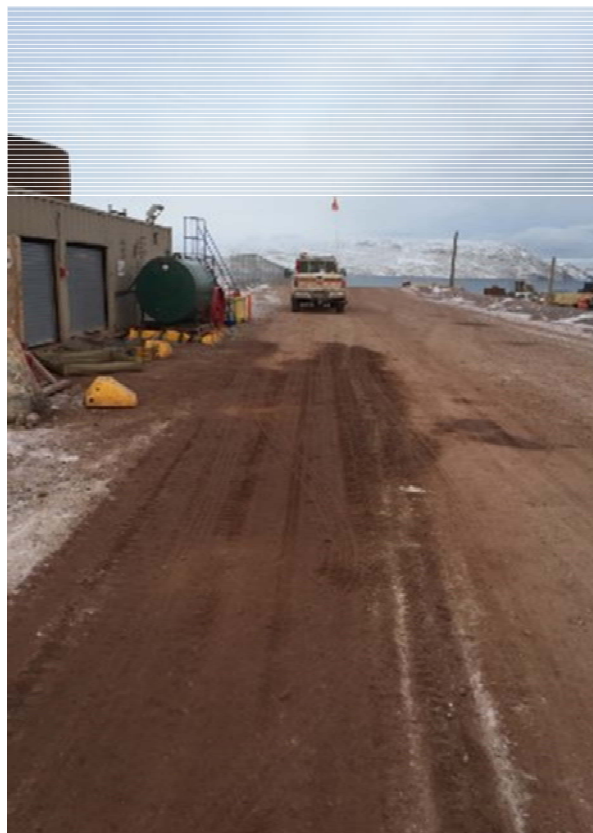
Figure 2 - Impact of Spill Area (facing north)

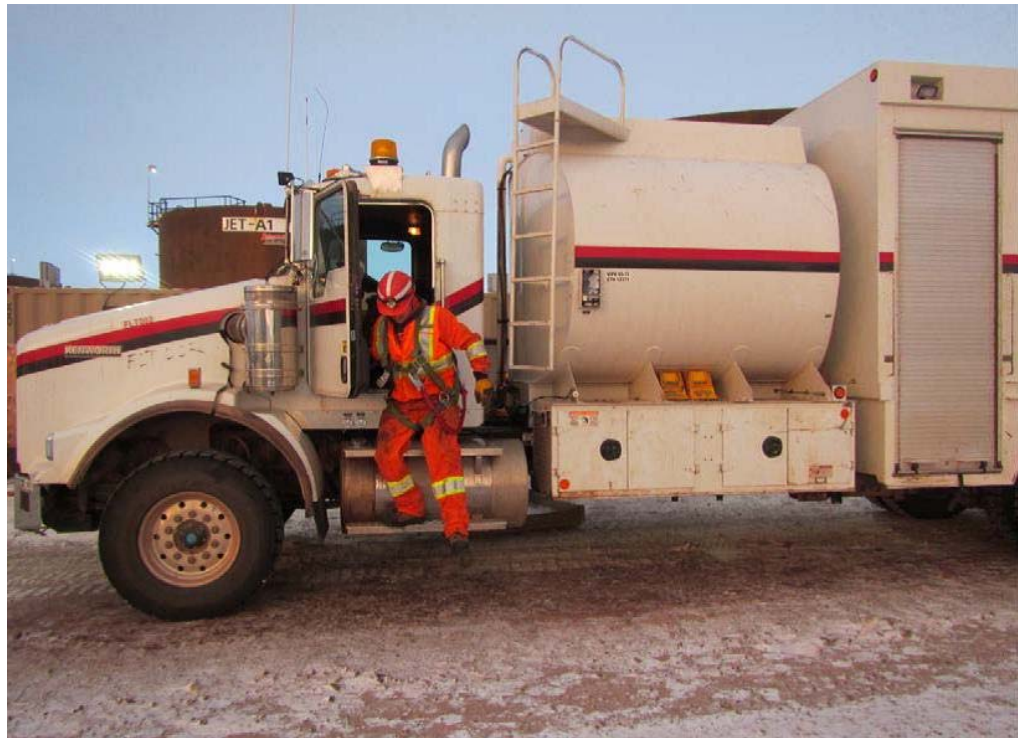
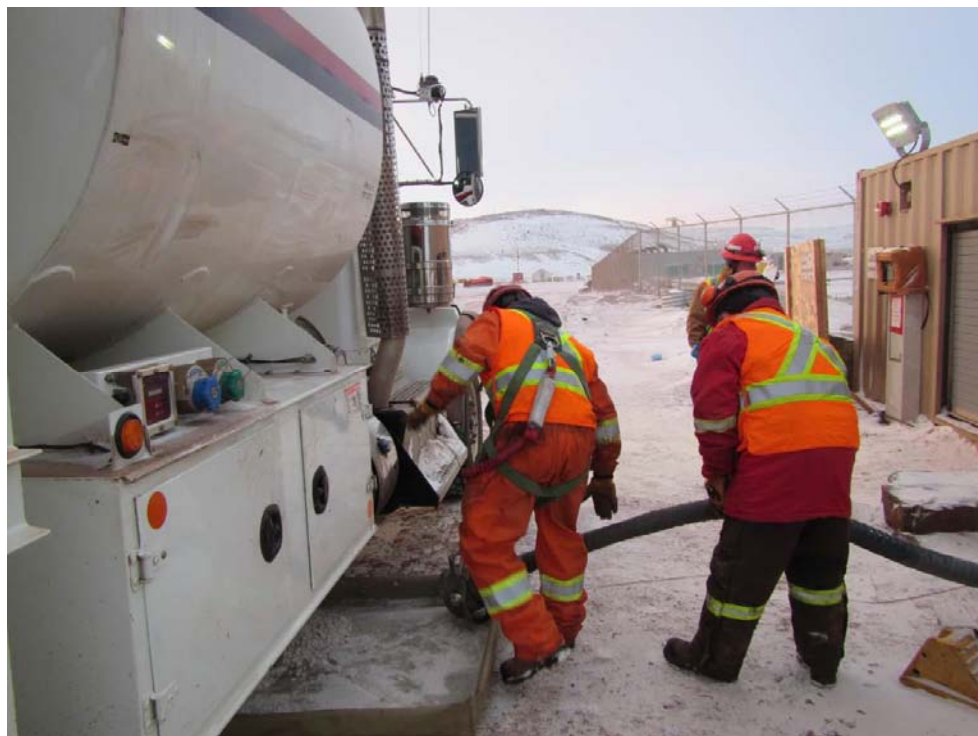
The likely causes of the spill included inconsistencies in the SOP for the task and difficulties in the use of the Scully Control System.

Figure 3 – Review of Re-fueling Procedure following Clean Up

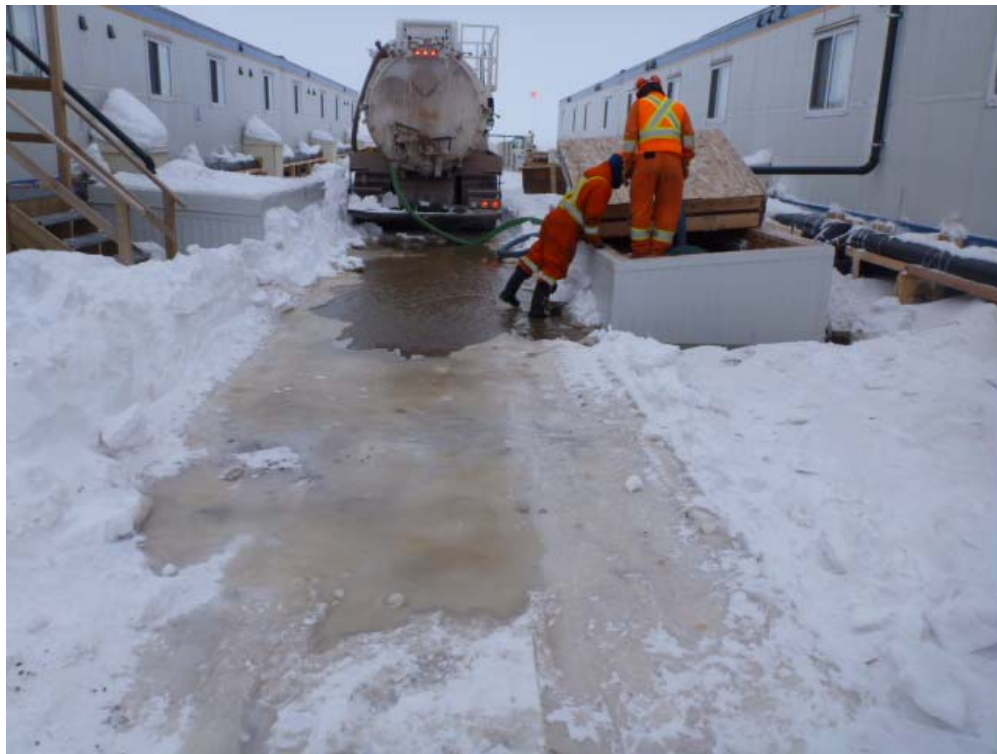
Photo 1 – Lift Station Spill

Ongoing routine inspection of the sewage lines and lift stations are required to inspect for leaks, malfunctions and potential locations of failure. Heat trace settings should be monitored to ensure they are sufficient.

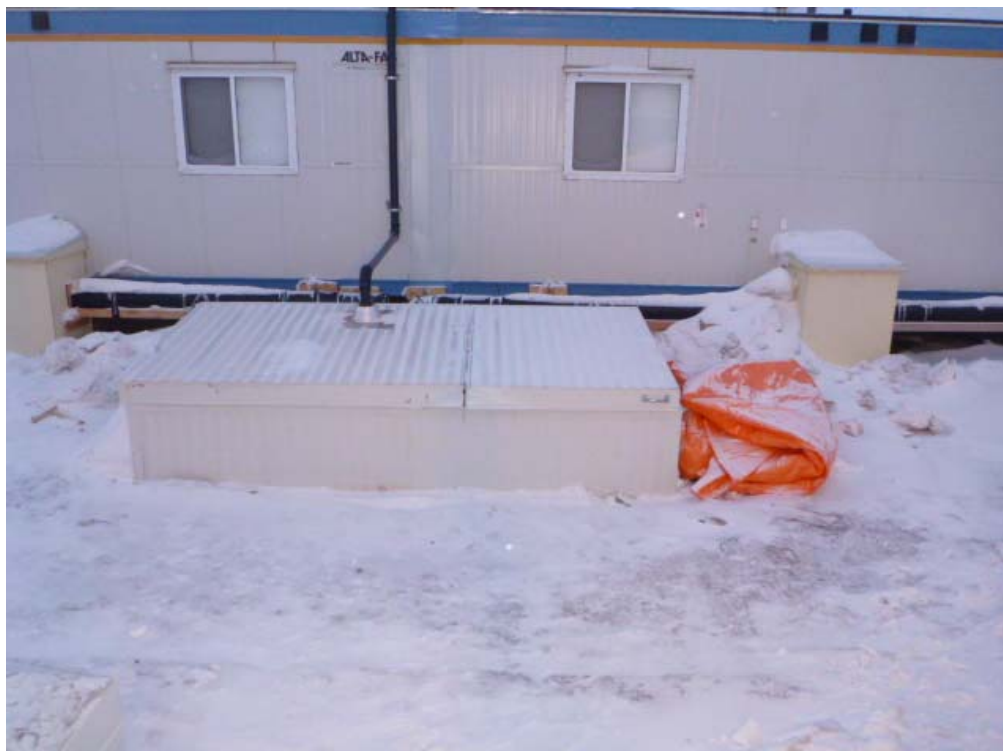
Photo 2 – Lift Station Spill Post Clean Up

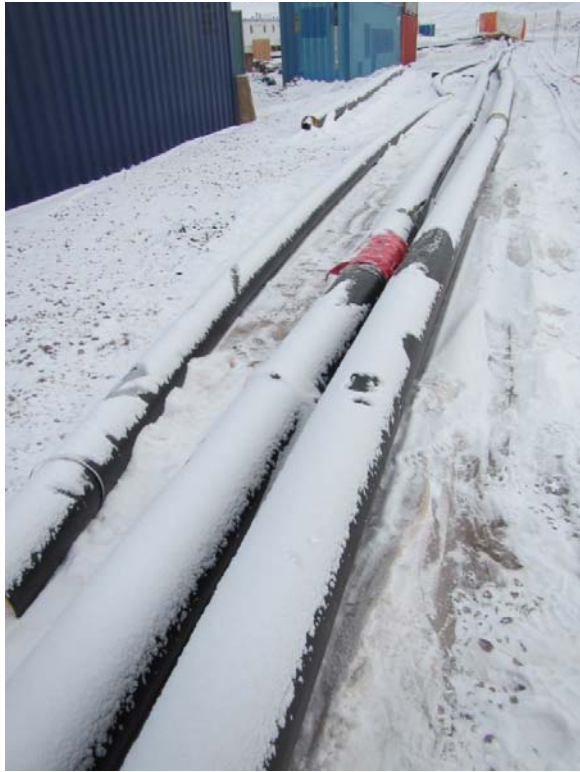
Photo 1 – Sewage Spill

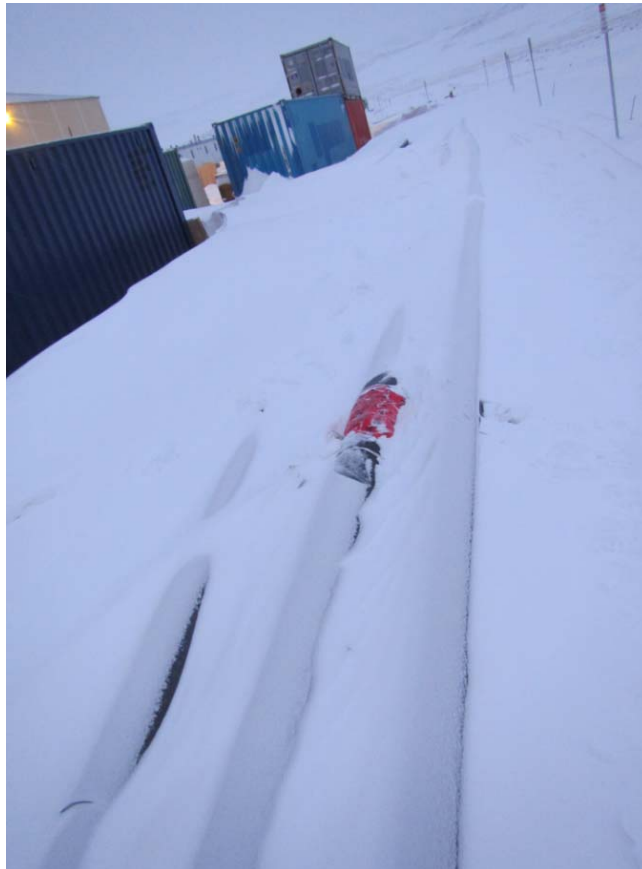
Photo 2 – Sewage Spill

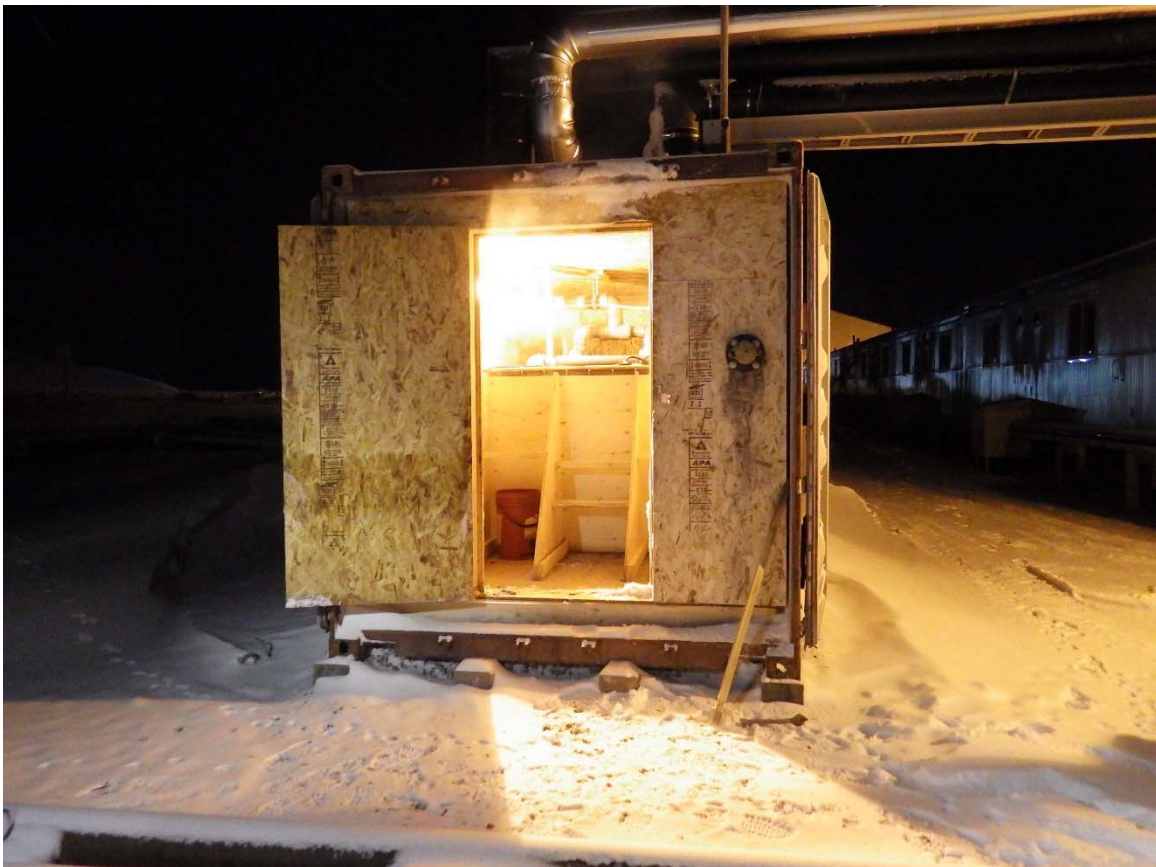
Photo 2 – Port Site Main Lift Station

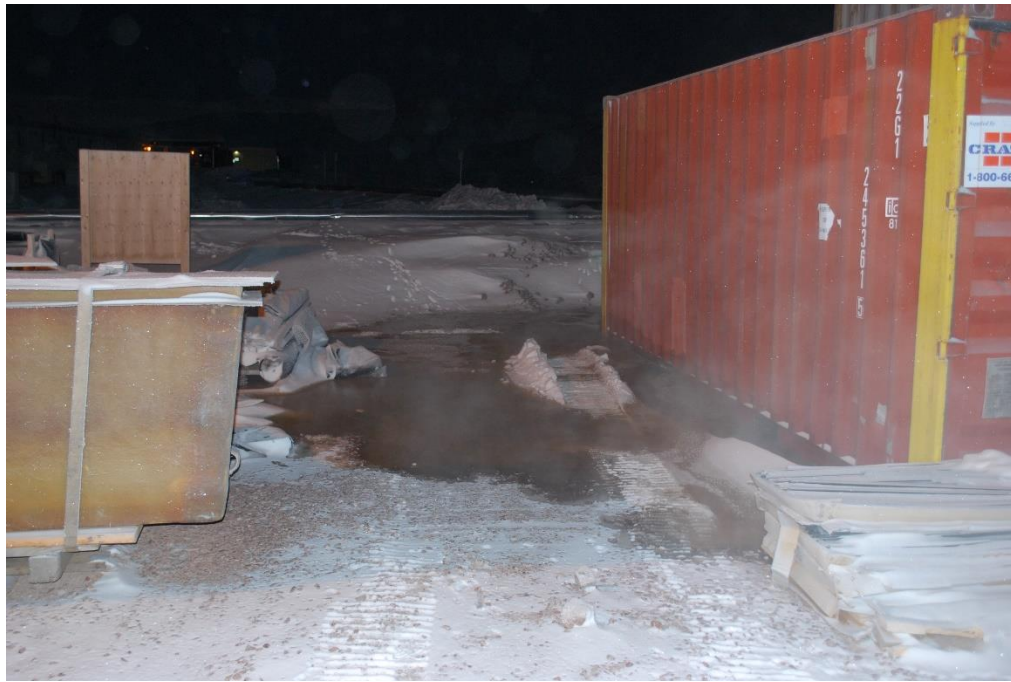
Photo 1 – Sewage Spill

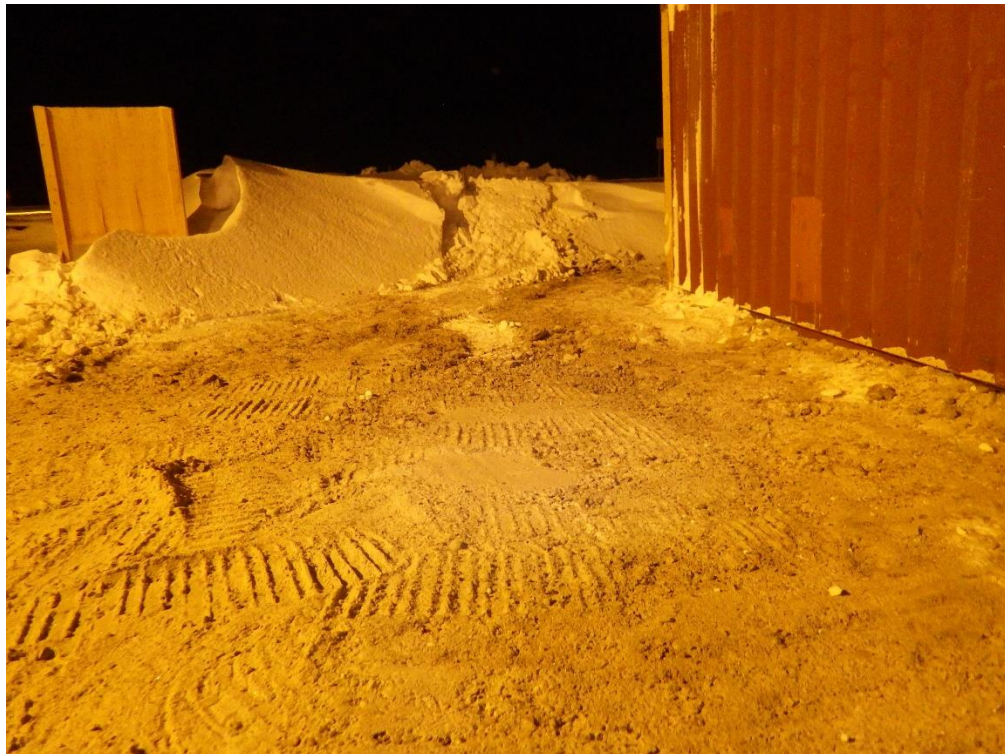
Photo 2 – Spill Location after Cleanup

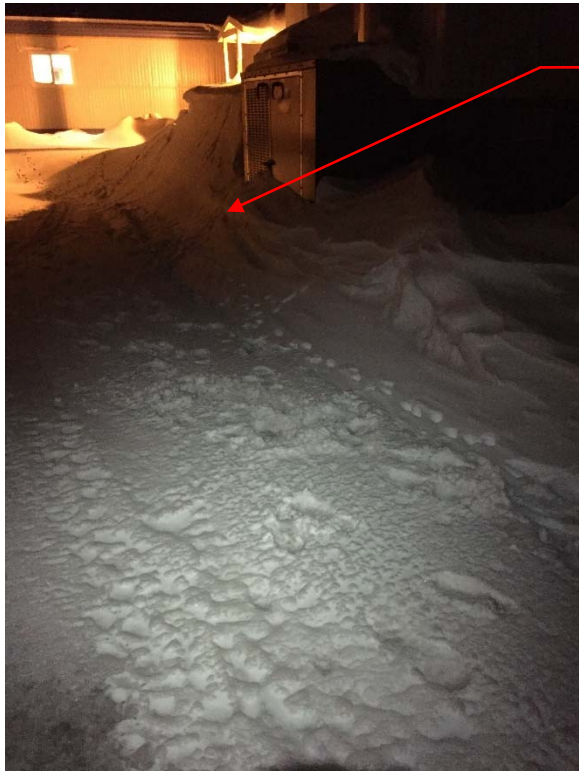
Photo 1 - Diesel Spill

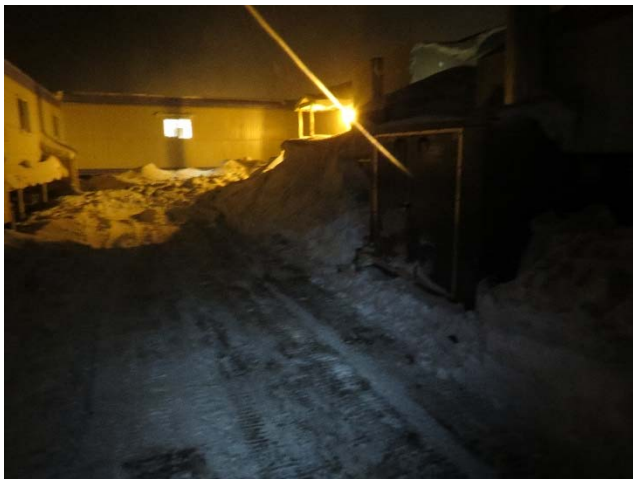
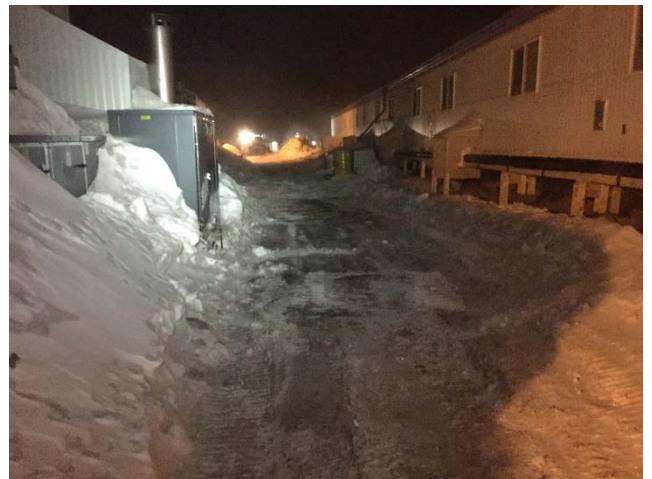
Photo 3 - Spill Clean up

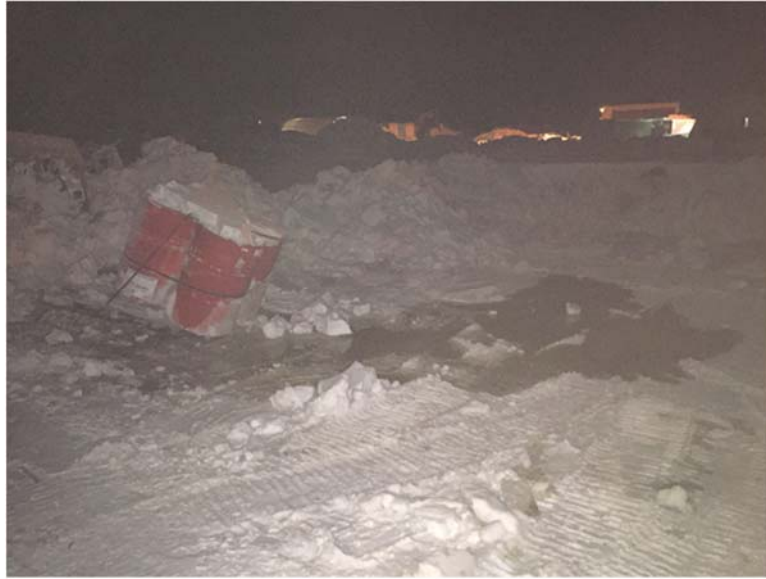
Photo 1 – Hydraulic Oil Spill

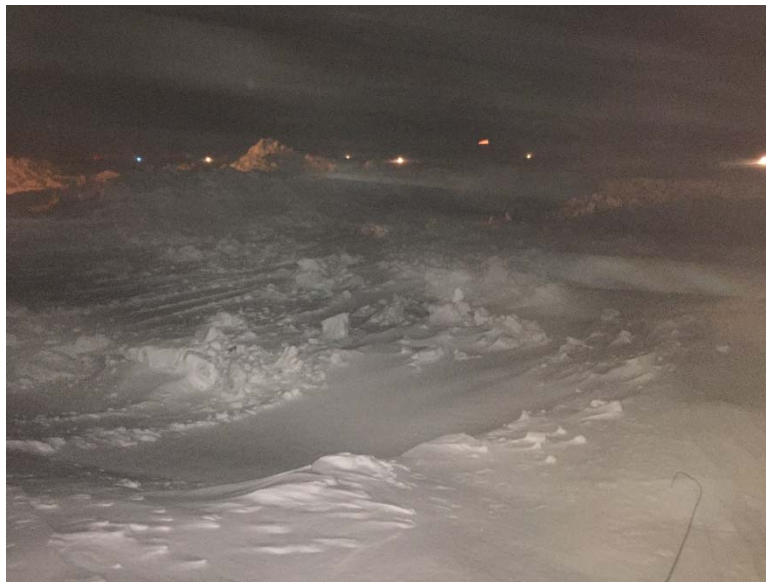
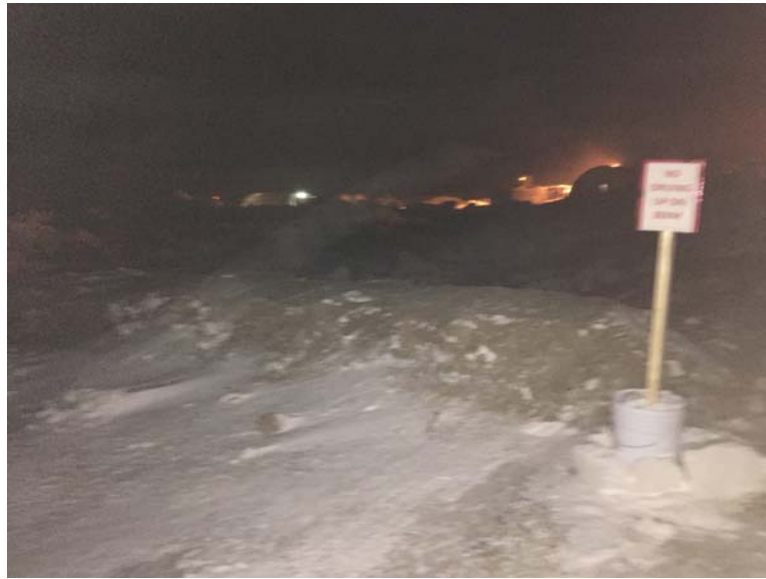
Photo 2 - Spill Clean Up
