2011 Annual Geotechnical Inspection Various Earth Structures Ulu, Nunavut

November 24, 2011

Ref. No. 11-293

**2011 Annual Geotechnical Inspection
Various Earth Structures
Ulu Gold Project, Nunavut**

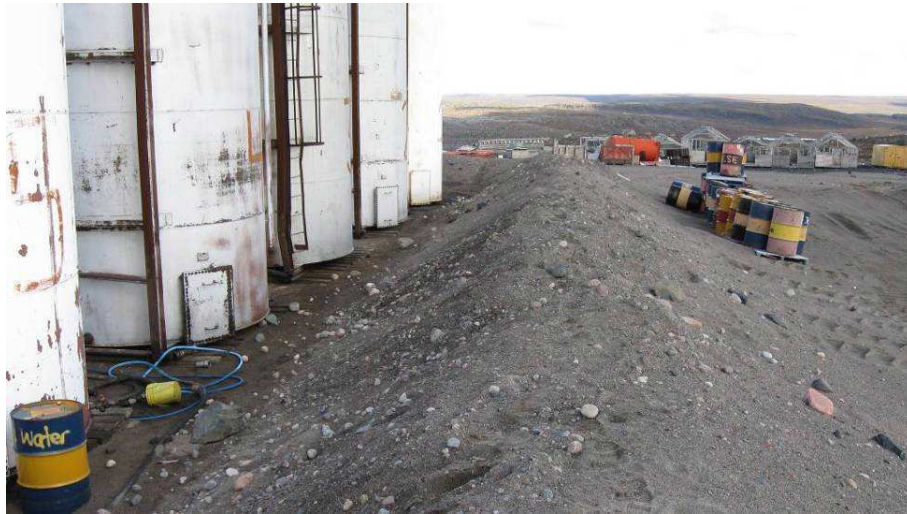
| BERM CONDITION: | Berm is constructed from esker sand and gravel and appears in good condition. Numerous animal burrows observed on the outside slope of the berm. Several areas of exposed liner along interior of berm. Exposed liner appears to be in good shape (no visible holes). |

Exterior Berm – 2010

| RECOMMENDATIONS: | Cover areas of exposed liner. |

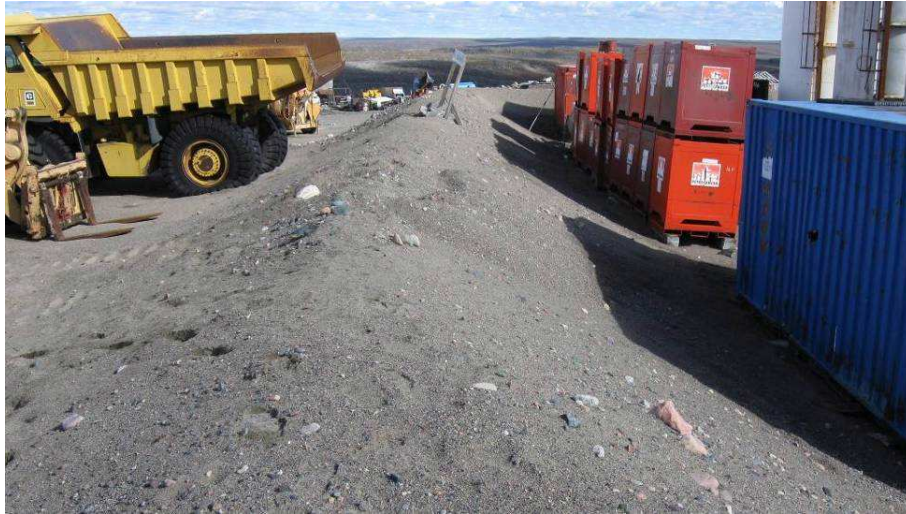
Exterior Berm – 2010

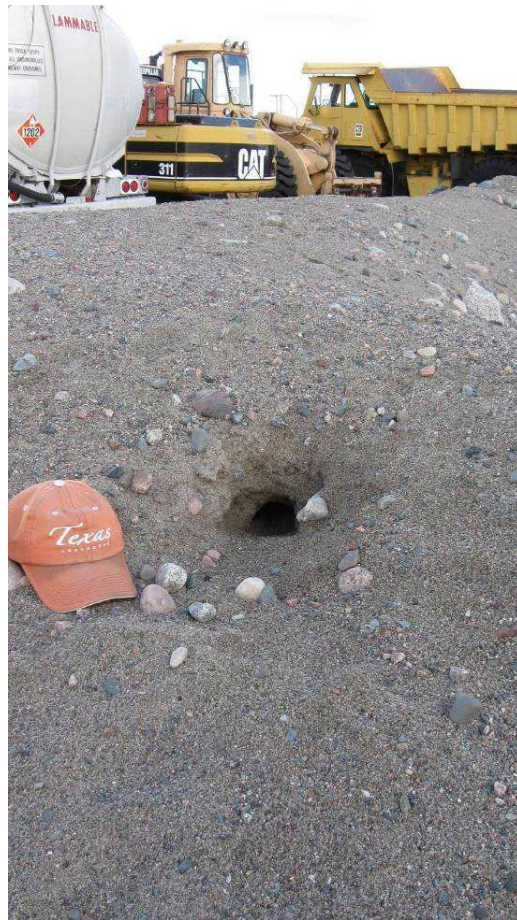
Animal Burrow – 2010

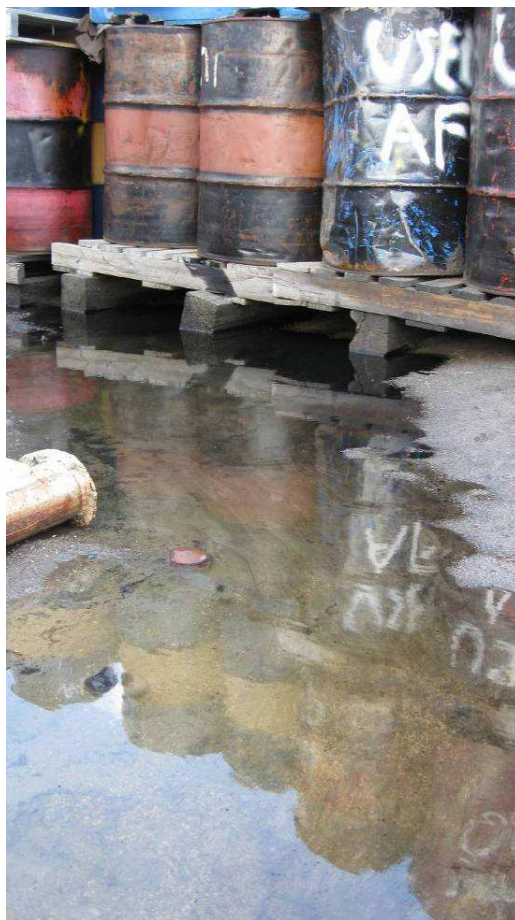
| SEEPAGE: | No evidence of seepage observed at the exterior berm toe. Small amounts of water with oil sheen are being retained within the storage area. Slightly more water being retained this year as compared to last year. |

Small amount of water with oily sheen – 2010

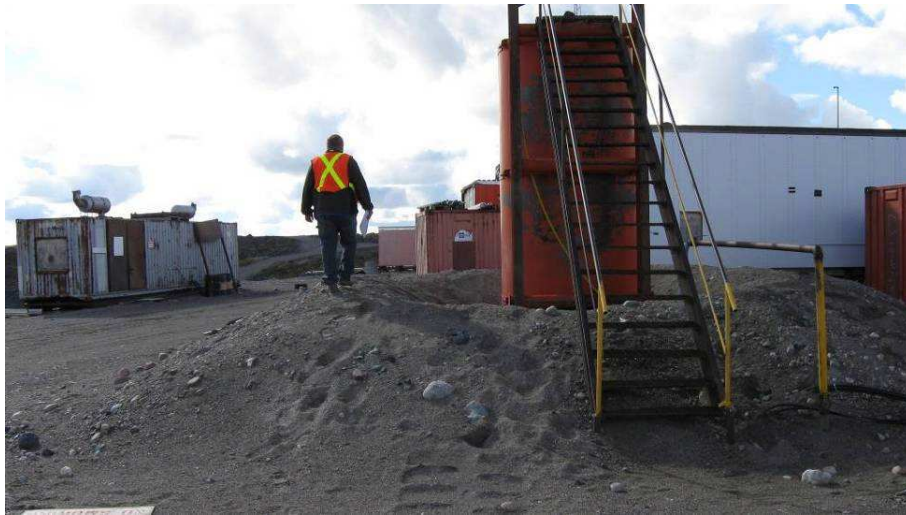
Day Tank Berm – 2010

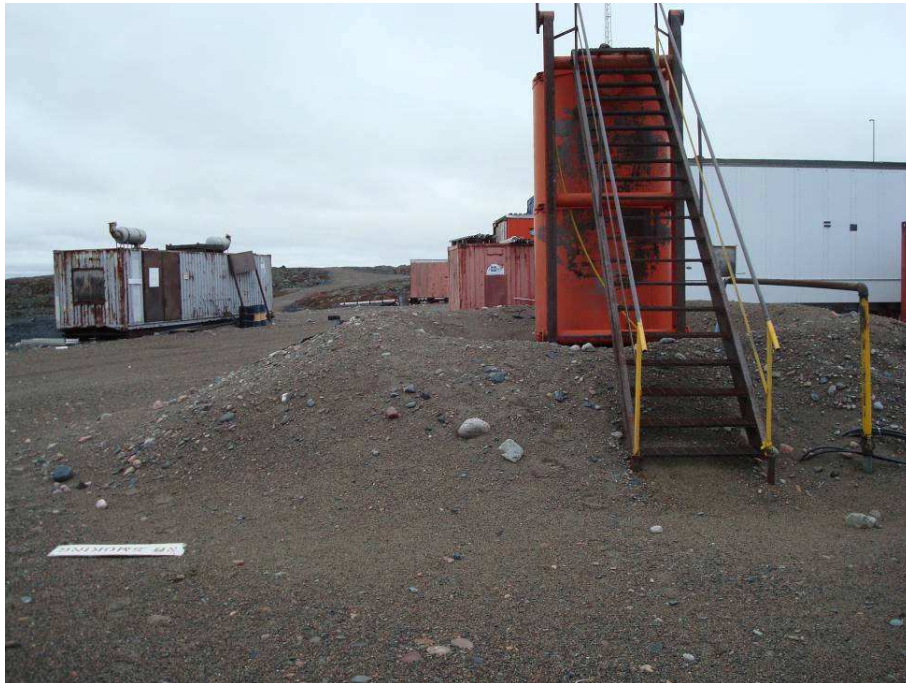
| BERM CONDITION: | Berm is constructed from esker sand and gravel and appears in overall good condition. Liner is exposed at one location along the interior of the berm. Where the liner is exposed, it is also separated at a seam. |

Day Tank Berm – 2011

| MAINTENANCE/MONTORING RECOMMENDATIONS: | Repair and cover exposed section of separated liner. |

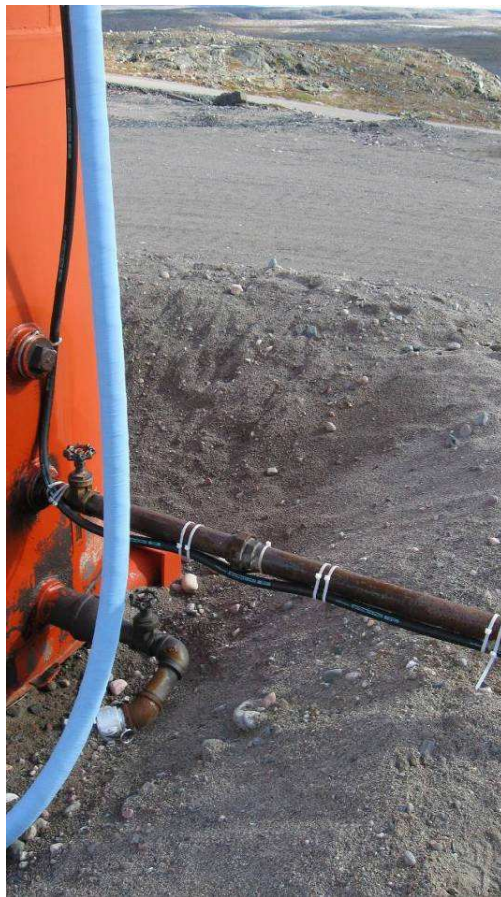
Inside of Berm West Side – 2010

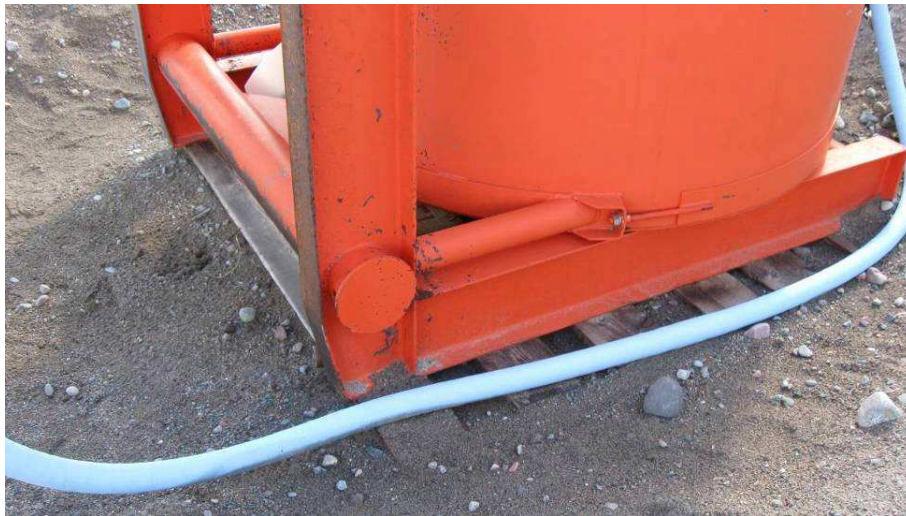
| SEEPAGE: | No evidence of seepage observed at the berm toe. Approximately 50 mm of water has accumulated in bottom of containment area. |

Inside of Berm Dry – 2010

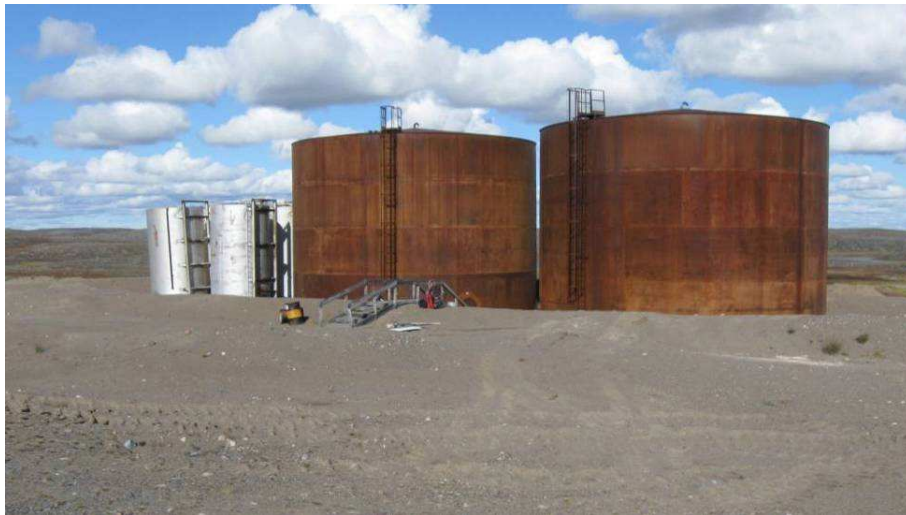
Camp 3 Tank Farm – 2010

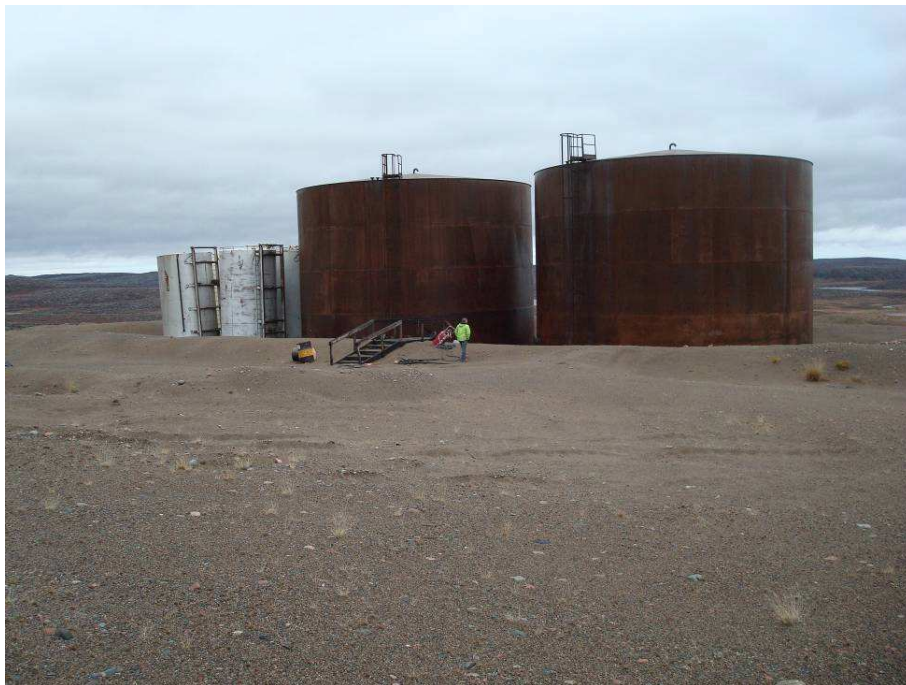
| BERM CONDITION: | Berm is constructed from esker sand and gravel and appears in good condition. Some new areas of liner are exposed, but no holes were observed at the interior locations. Several animal burrows were noted along the exterior of the berm. Some of the smaller tanks have broken timber foundation supports causing the tanks to lean. This should be repaired. |

Camp 3 Tank Farm – 2011

| MAINTENANCE/MONITORING RECOMMENDATIONS: | Areas of exposed liner should be covered with granular fill. |

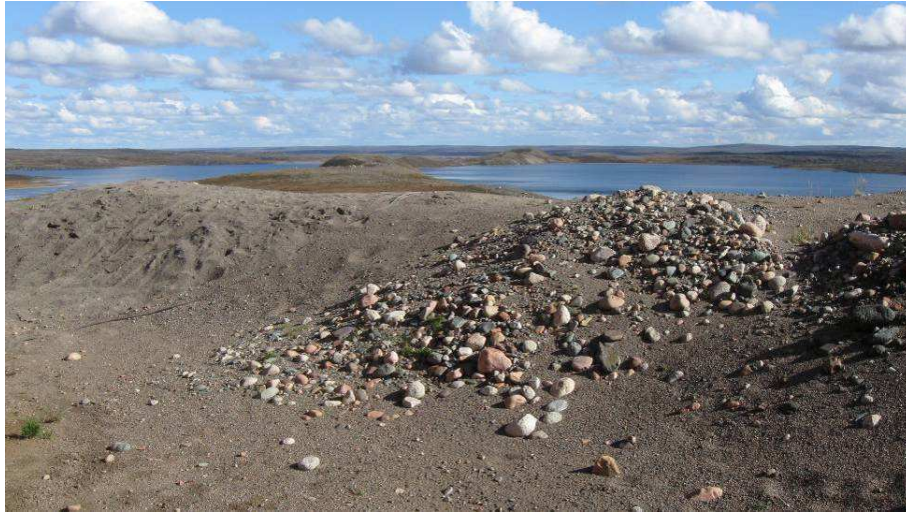
Area of Exposed Liner Covered in 2010 – 2010

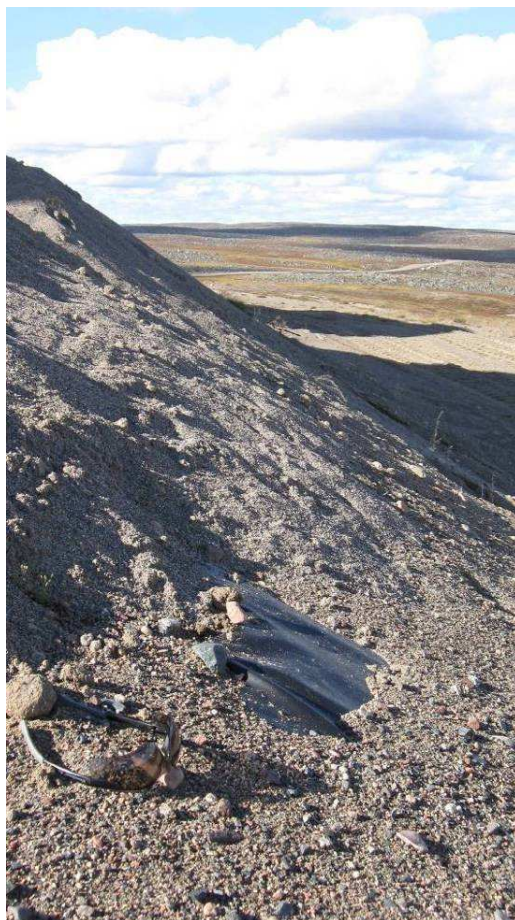
One Area of Exposed Liner on Downstream Slope – 2010

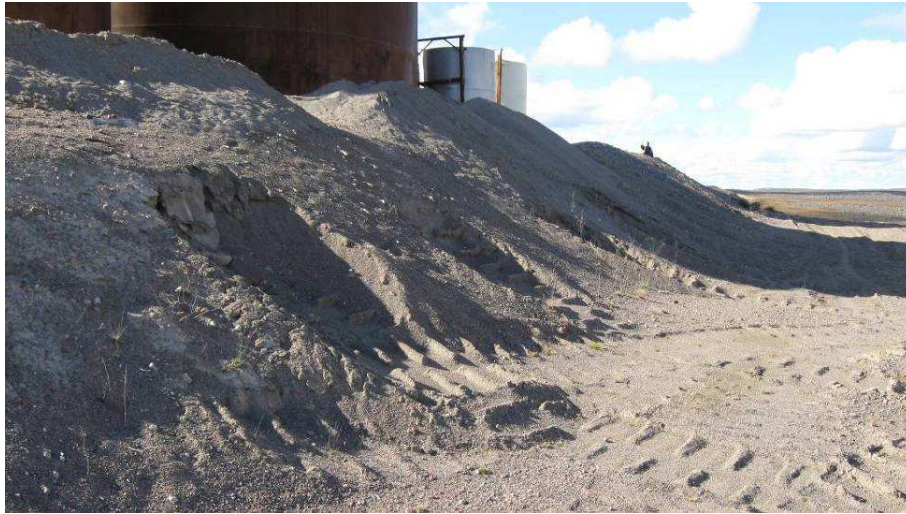
Area of Cut Into Downstream Slope – 2010

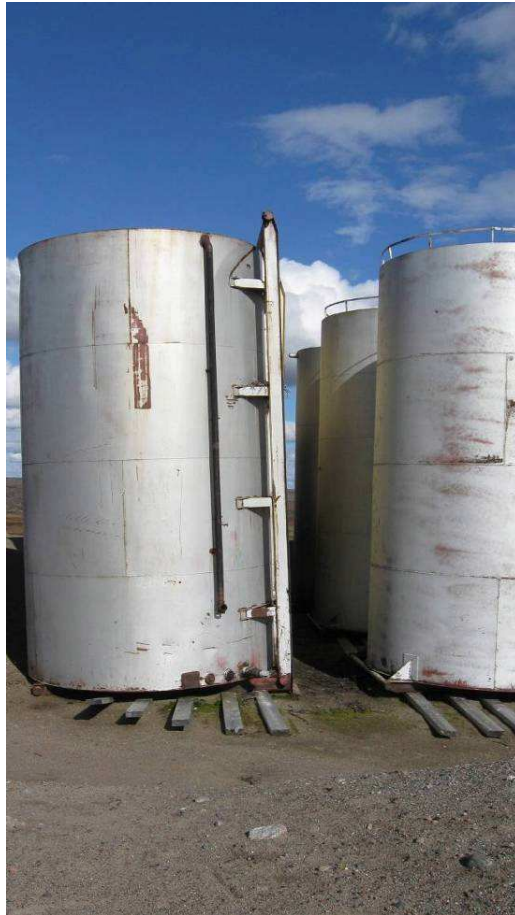
Several of the smaller tanks are leaning due to broken timber foundations supports. This should be assessed and repaired if deemed necessary.

Leaning Tank – 2010

| CONCLUSIONS: | The berm appears in generally satisfactory condition. See above maintenance items. The leaning tanks should be assessed/repared |

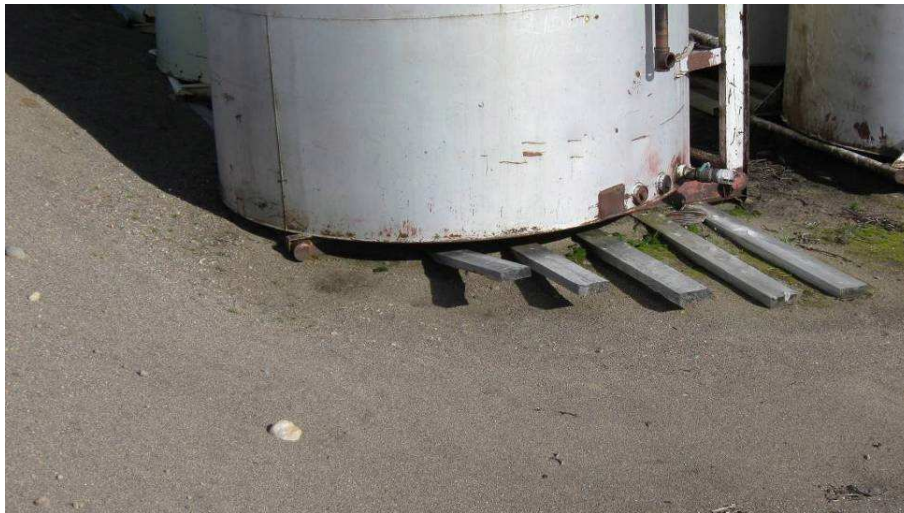
Broken Timber Support – 2010

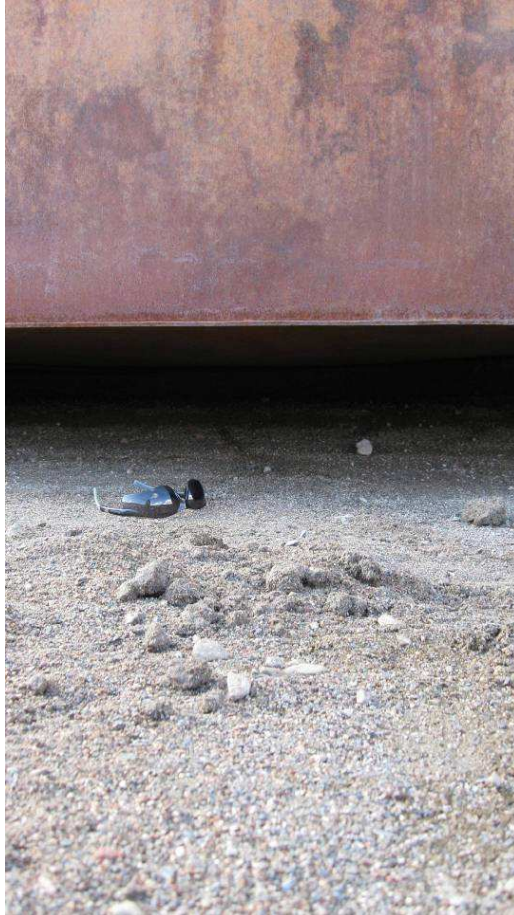
Gap below tank – 2010

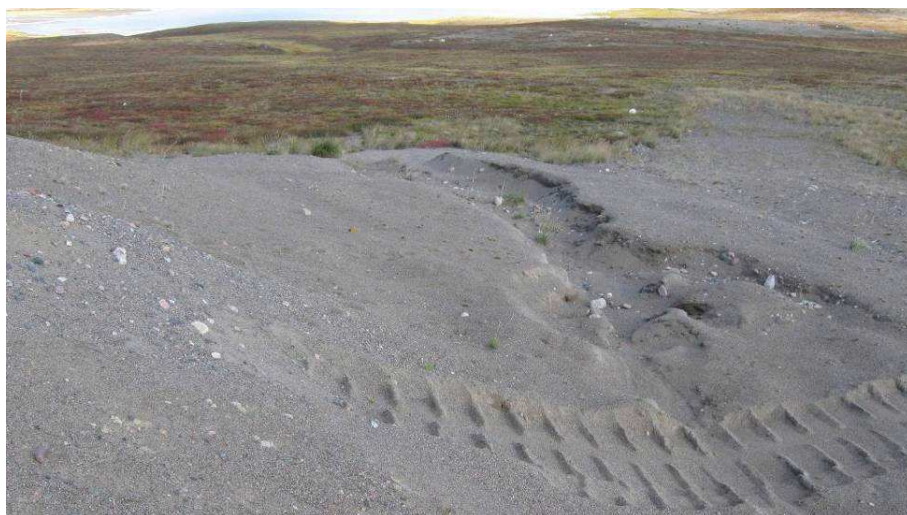
Erosion Gully Near Toe of Berm S/E Corner – 2010

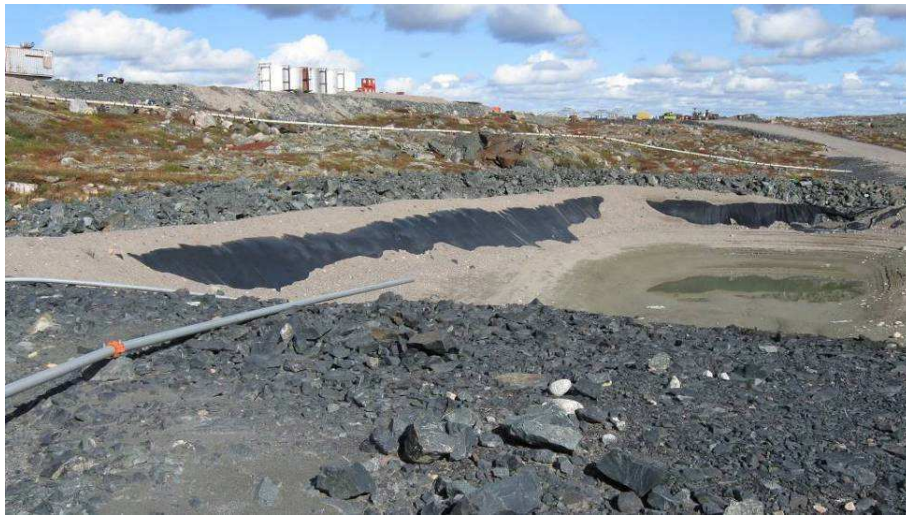
The mine sump pit remains in the same condition over the last 2 years with exposed liner with small holes and loose ends. This should be repaired before the sump is ever put back into operation.

| BERM CONDITION: | <p>Berm is constructed from rockfill (waste rock) and esker sand and gravel. The banks are over-steepened.</p> <p>Geomembrane liner within berm is exposed at numerous locations along the north, east and west sides. The liner at north end of the pond is loose. Small tears are developing in the liner.</p> |

Mine Sump Pit – Exposed Liner – 2010

| MAINTENANCE/MONTORING RECOMMENDATIONS: | Before the sump is put back into service the liner and side slopes should be repaired/restored. |

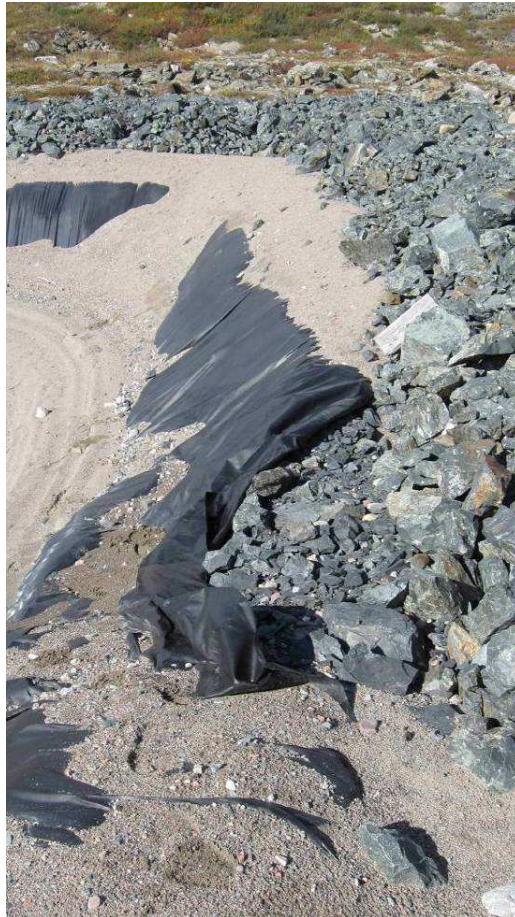
Exposed and Loose End of Liner – 2010

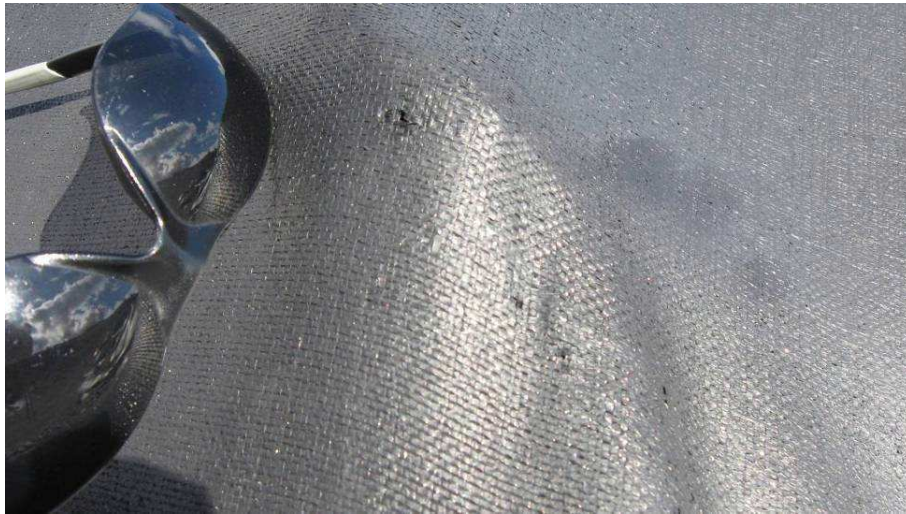
Typical Small Tear in Liner – 2010

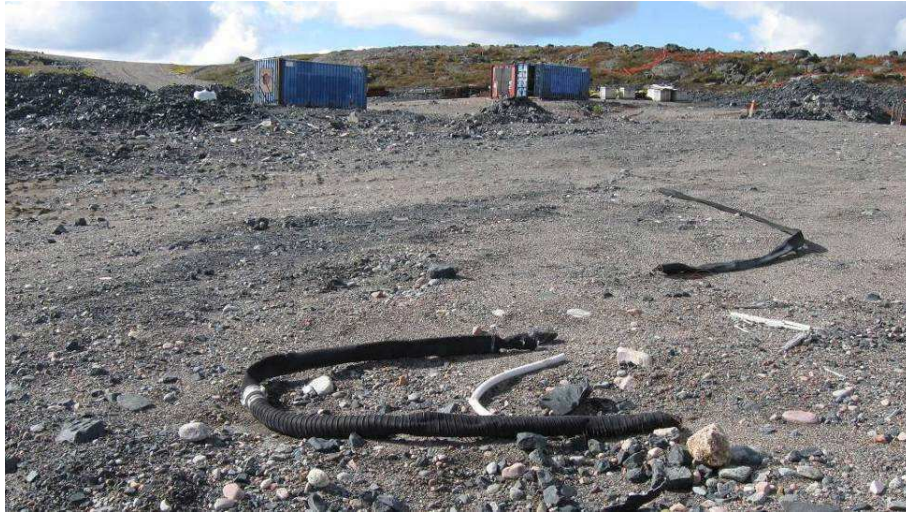
Portal Laydown Pad – 2010

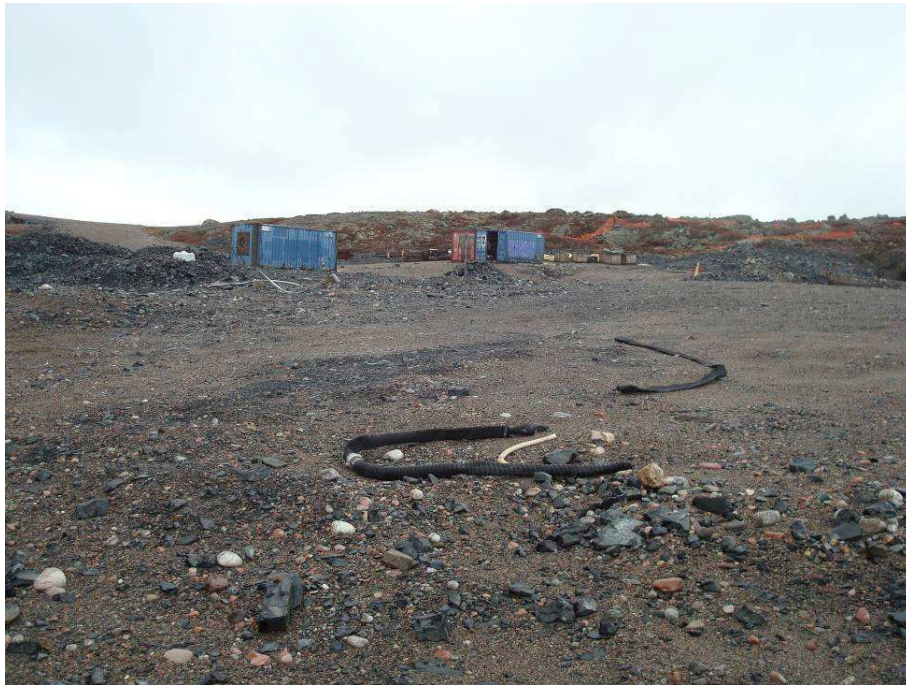
| PAD CONDITION: | Pad is constructed from rockfill (waste rock). Toe of the pad sits at the angle of repose for rockfill. Scarps and cracks have developed on downhill toe due to sloughing and erosion of loose fill. |

Portal Laydown Pad – 2011

| CONCLUSIONS: | The pad appears to shows signs of instability and erosion on the downstream side. Re-grading and shaping will be required before the pad is put into use. A sample of seepage identified at the toe of the pad was collected. Pending the results of analytical testing, additional measures to address the seepage may be required. Runoff from the pad is collected within East Lake that passes through a wetland before entering Ulu Lake. The existing down slope silt curtain is in need of repair and has been covered by the toe of the pad at some locations. The silt curtain should be restored. |

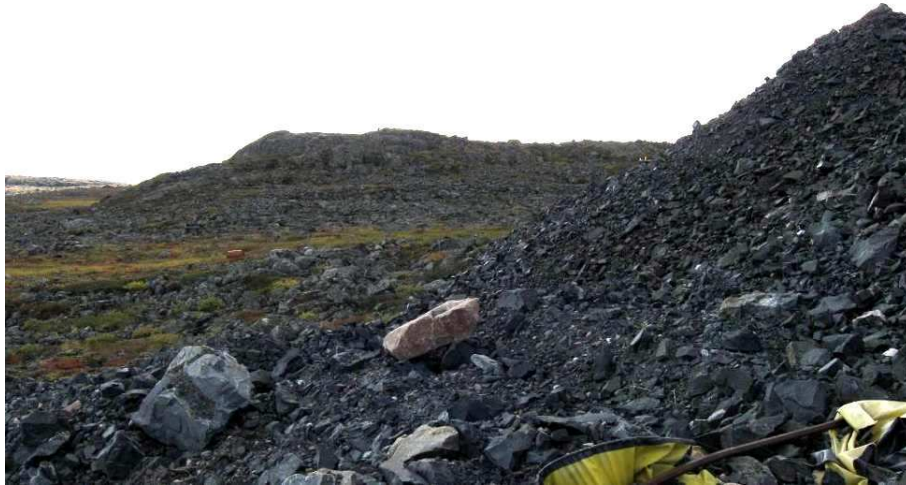
Downhill Face of Pad – 2010

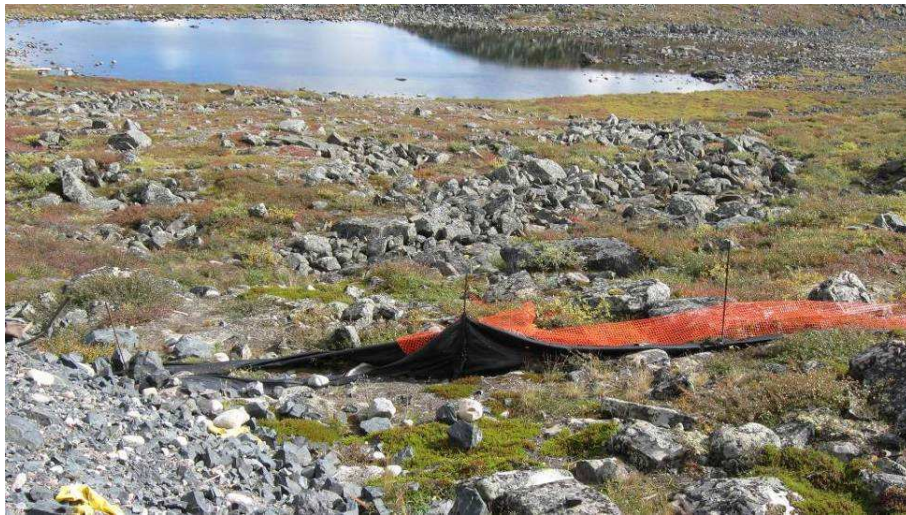
Silt Fence – 2010

| MAINTENANCE/MONTORING RECOMMENDATIONS: | Existing downstream stream silt fencing is in need of repair. |

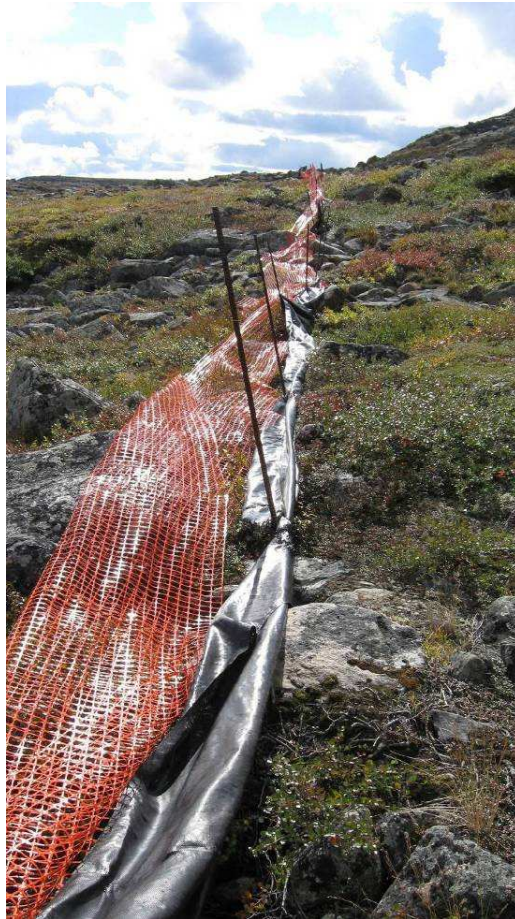
Silt Fence – 2010

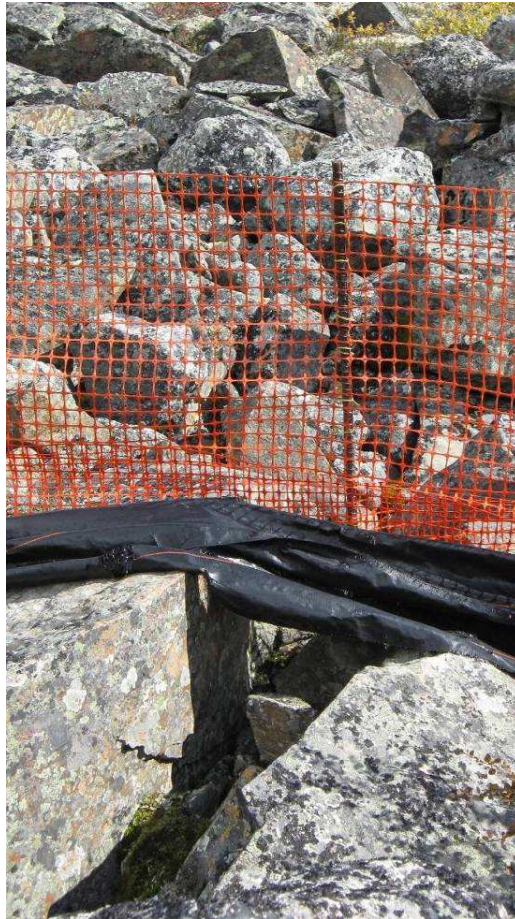
Silt Fence – 2010

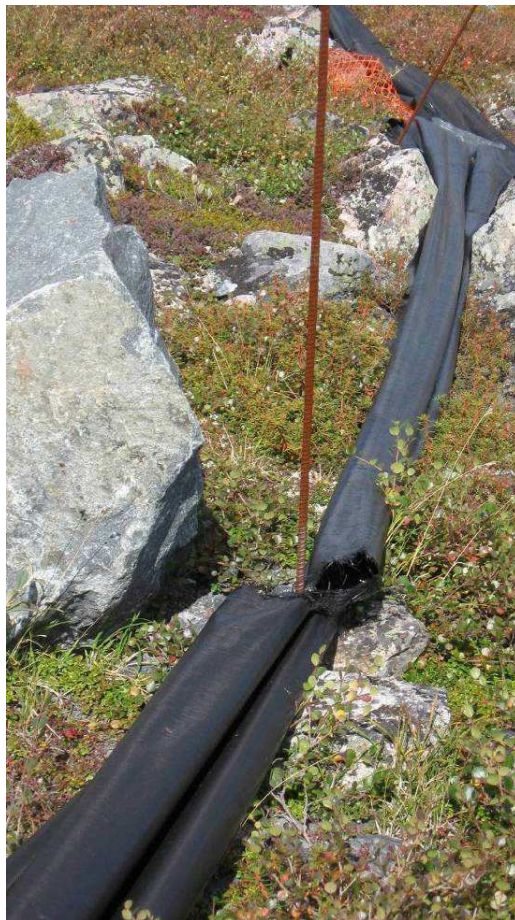
Silt Fence – 2010

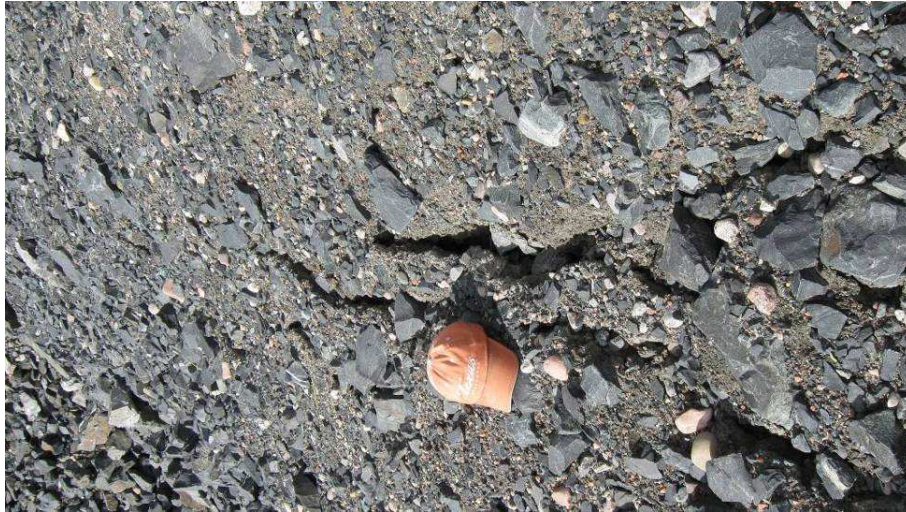
Slump Cracking Downhill Side – 2010

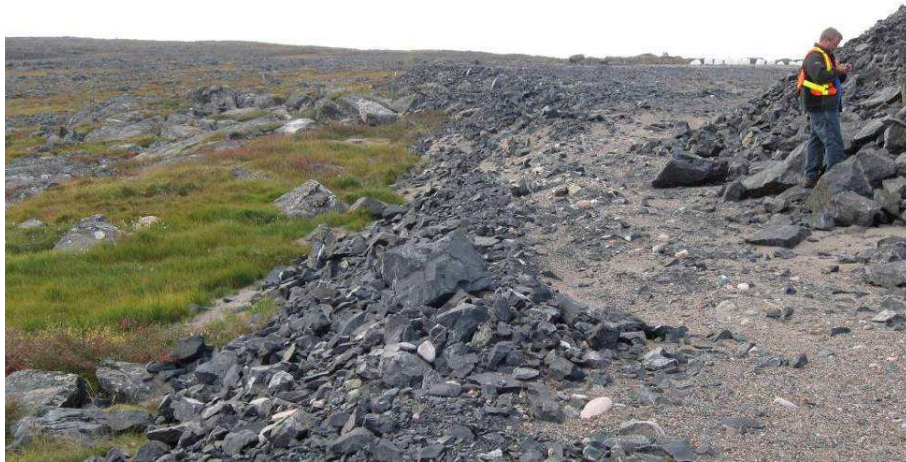
Storage Pad Outside Edge – 2010

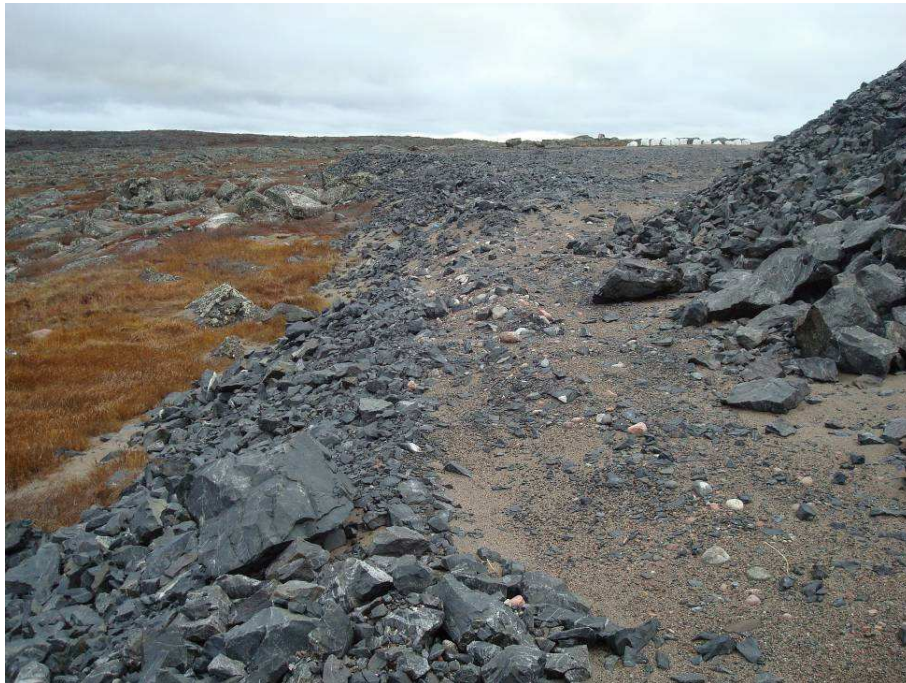
| PAD CONDITION: | Pad is constructed from rockfill (waste rock) and esker sand and gravel. Two ore stockpiles located on the east corner of the pad. The side slopes of the pad site are at the angle of repose for rockfill. |

Storage Pad Outside Edge – 2011

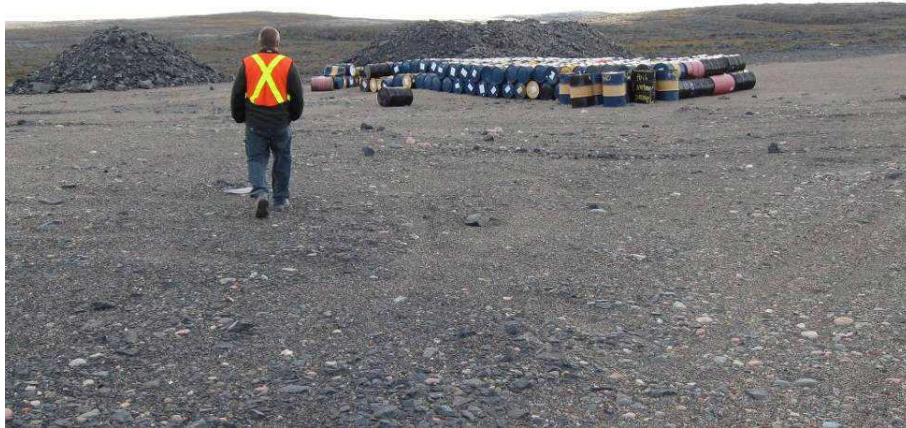
Storage Pad Area – 2010

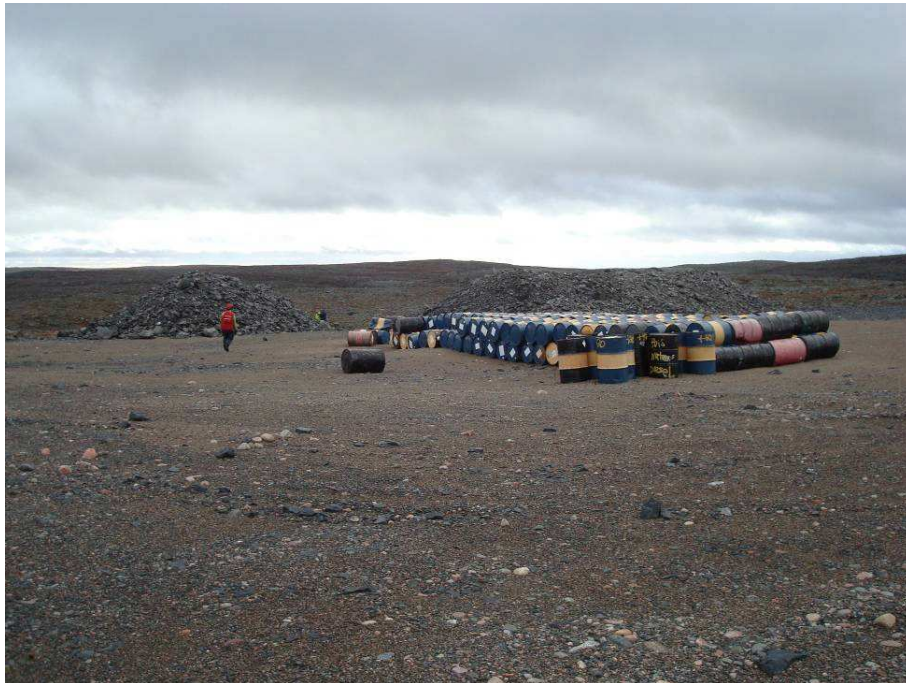
| CONCLUSIONS: | The pad appears stable with no signs of erosion or instability. A sample of seepage identified outside the toe of the pad was collected. Pending the results of analytical testing, additional measures to address the seepage may be required. |

Storage Pad Area – 2011
