Interim Closure and Reclamation Plan
Ulu Gold Project
(including Hood River, Roma and other licensed projects)

Kitikmeot Region, Nunavut

NOVEMBER 2025

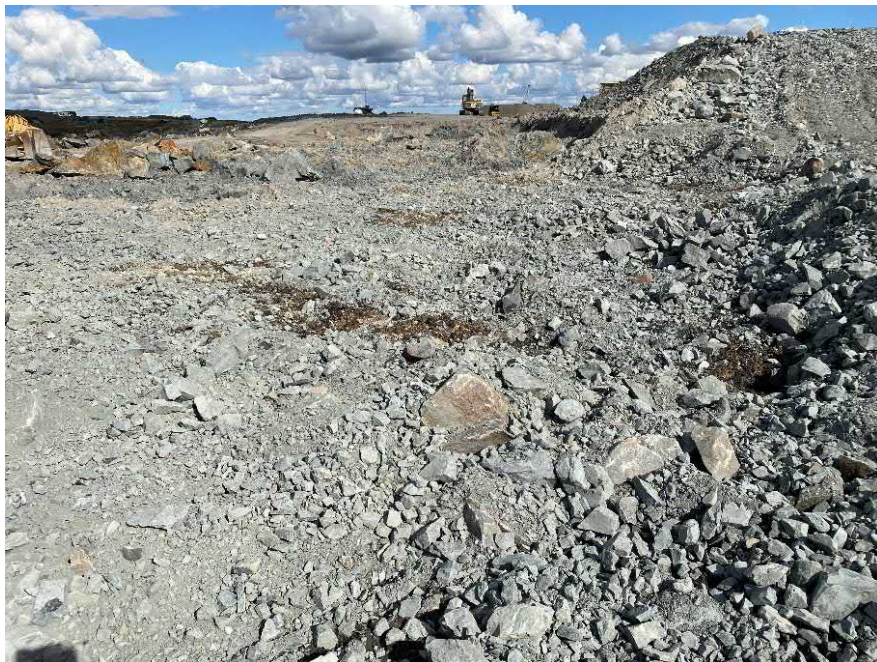
- SRK inspected the reclamation efforts at the northern edge of the ore pad during a site visit (August 17–20, 2025). At the time of the site visit the majority of the waste rock had been removed down to the tundra surface (Figure 3 and Figure 4). The amount of waste rock remaining varied depending on the difficulty to remove material given the uneven tundra surface below the waste rock. Figure 5 to Figure 9 shows the range of waste rock material

Figure 3: Waste rock remaining on northern portion of ore pad as of August 18, 2025 (facing east from center).

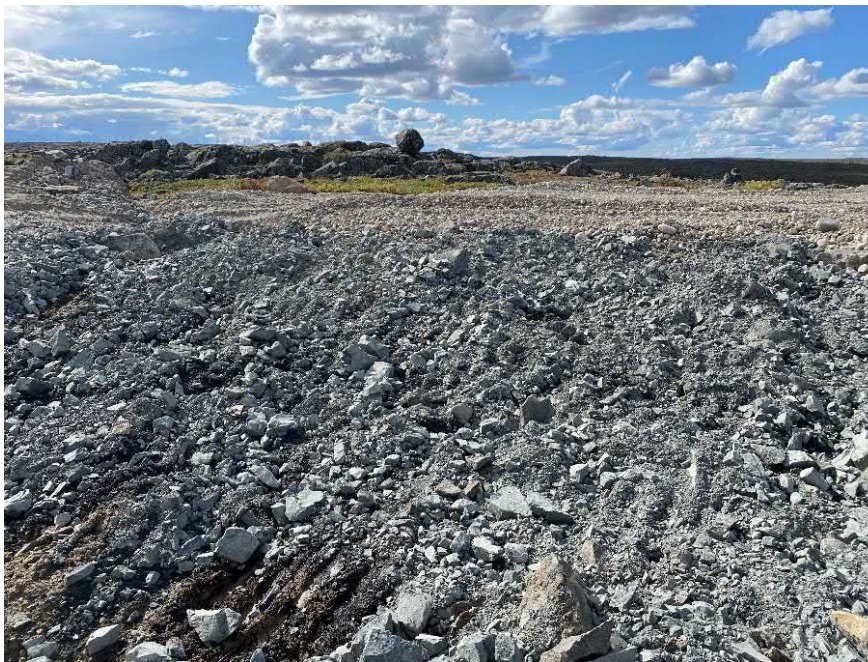
Figure 4: Waste rock remaining on northern portion of ore pad as of August 18, 2025 (facing west from center).

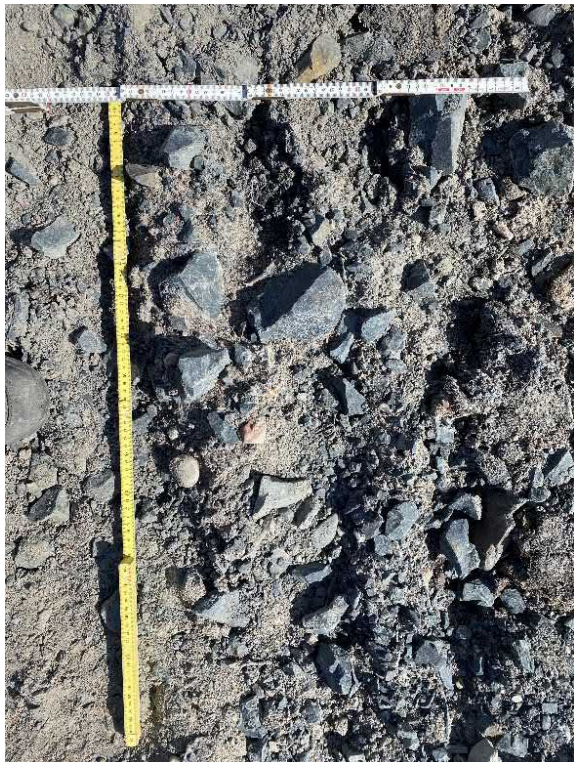
Figure 5: Example one of waste rock remaining on north ore pad area.

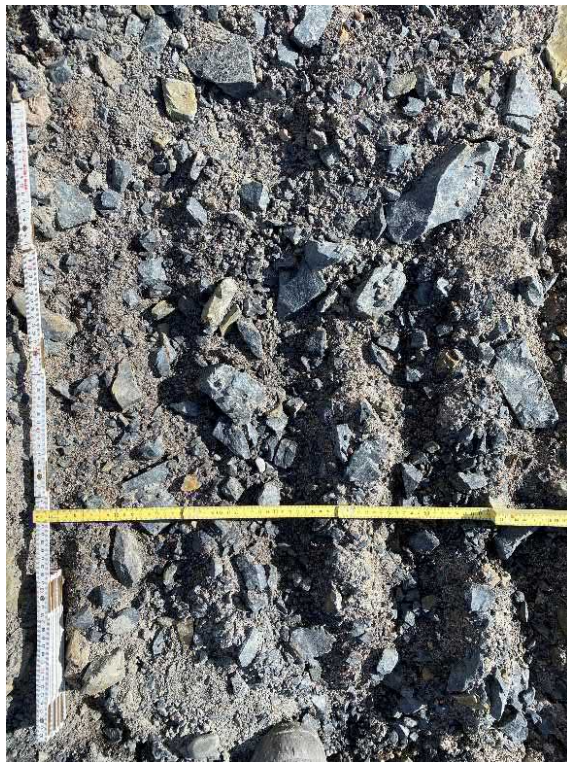
Figure 6: Example two of waste rock remaining on north ore pad area.

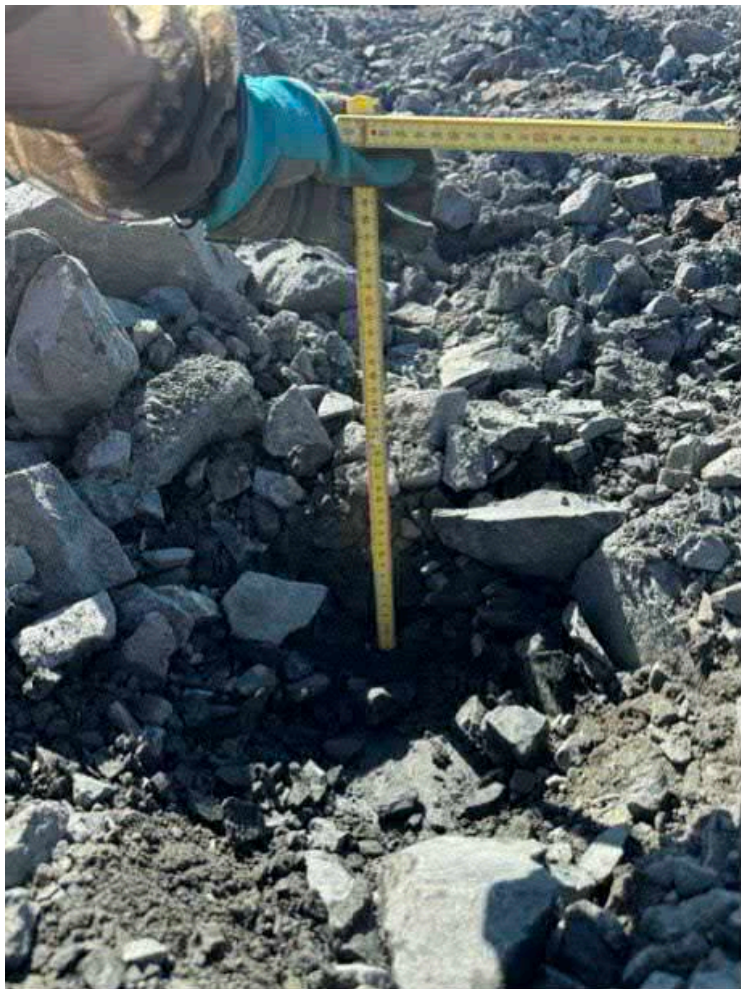
Figure 8: Example four of waste rock remaining on north ore pad area (~15 cm depth).

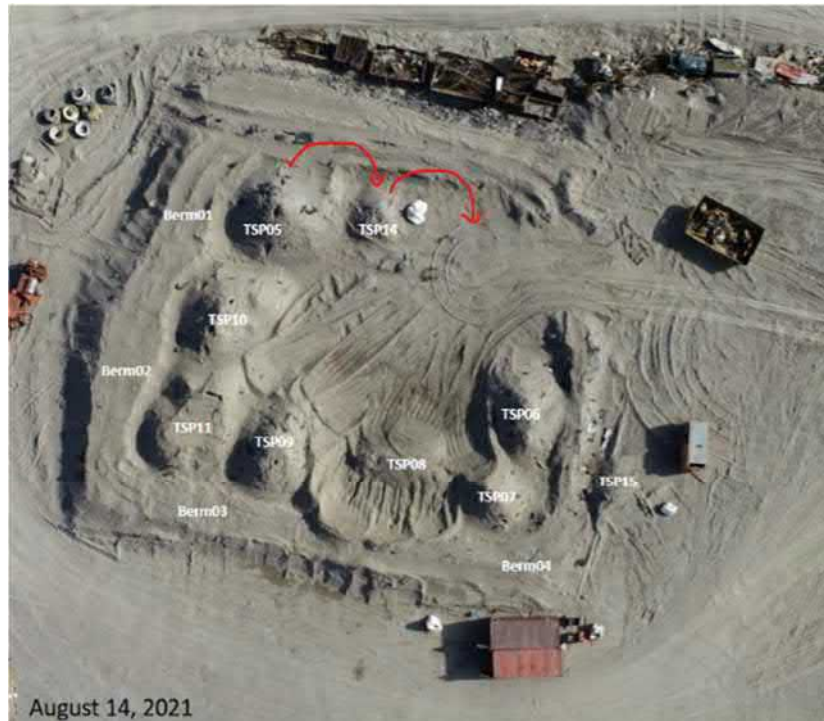
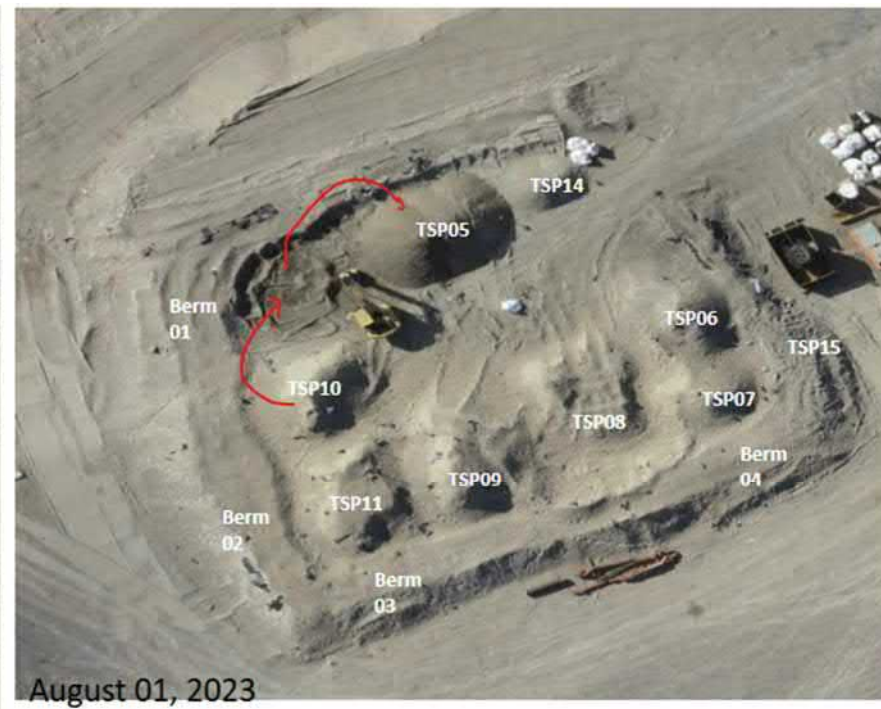
No sampling program undertaken during the season however stockpiles were fully aerated using an excavator (Figure 1).

Figure 1: Aerating of stockpiles in the soil holding area August 2023.

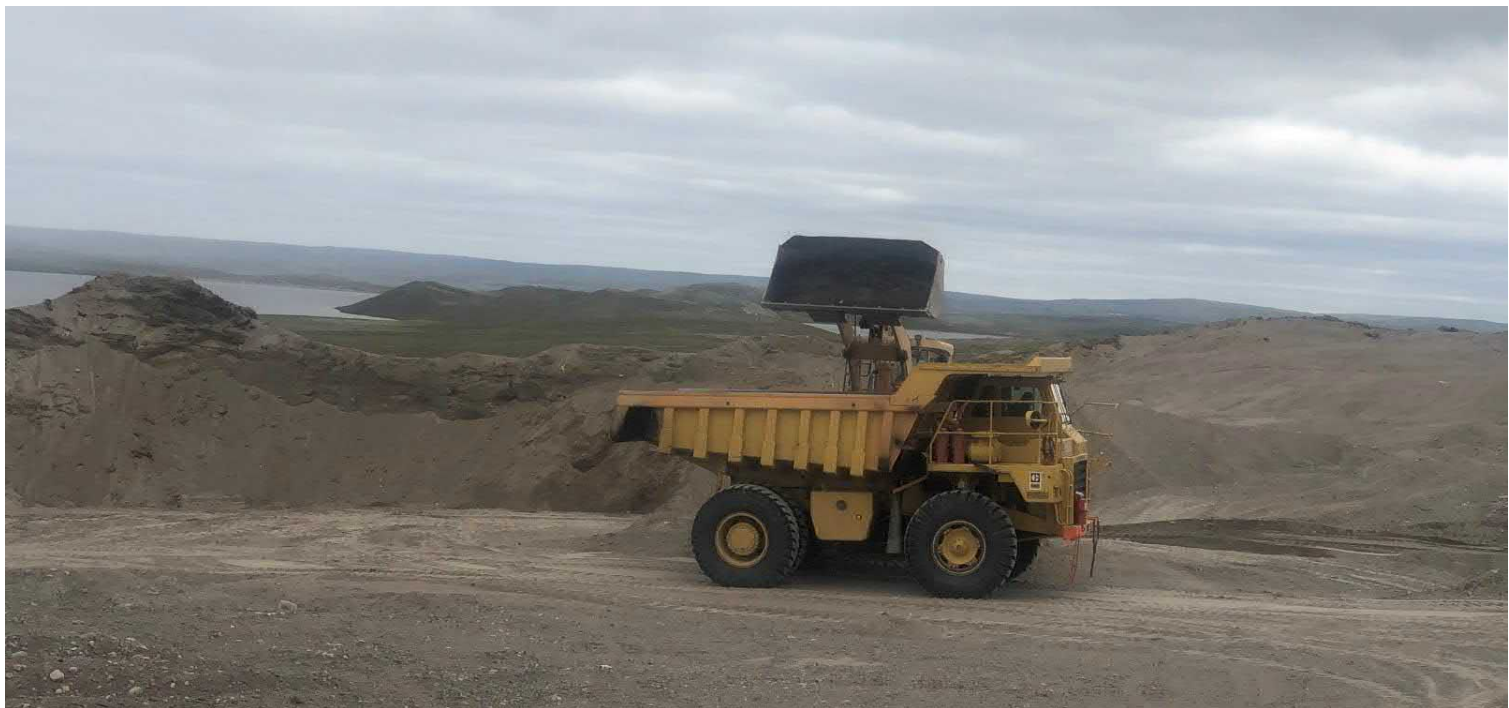
Transporting esker sand on July 18, 2021

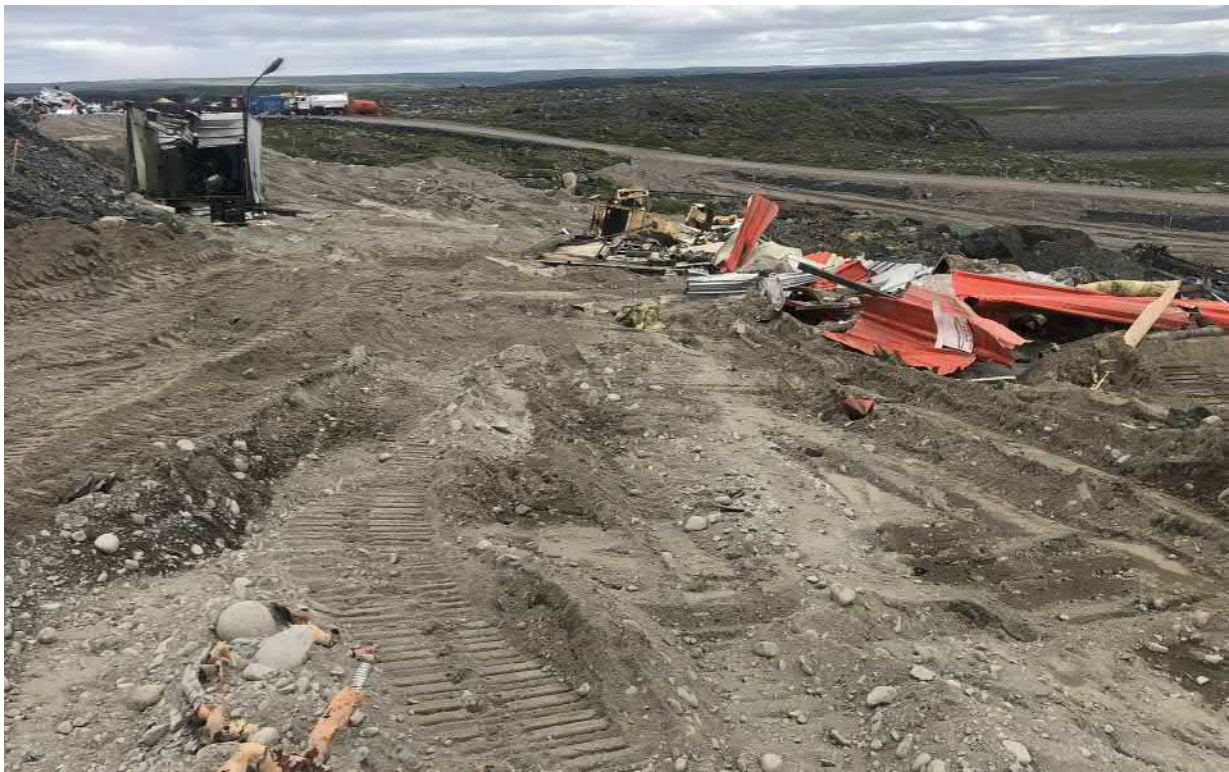
Debris placement and esker cover on July 16, 2021

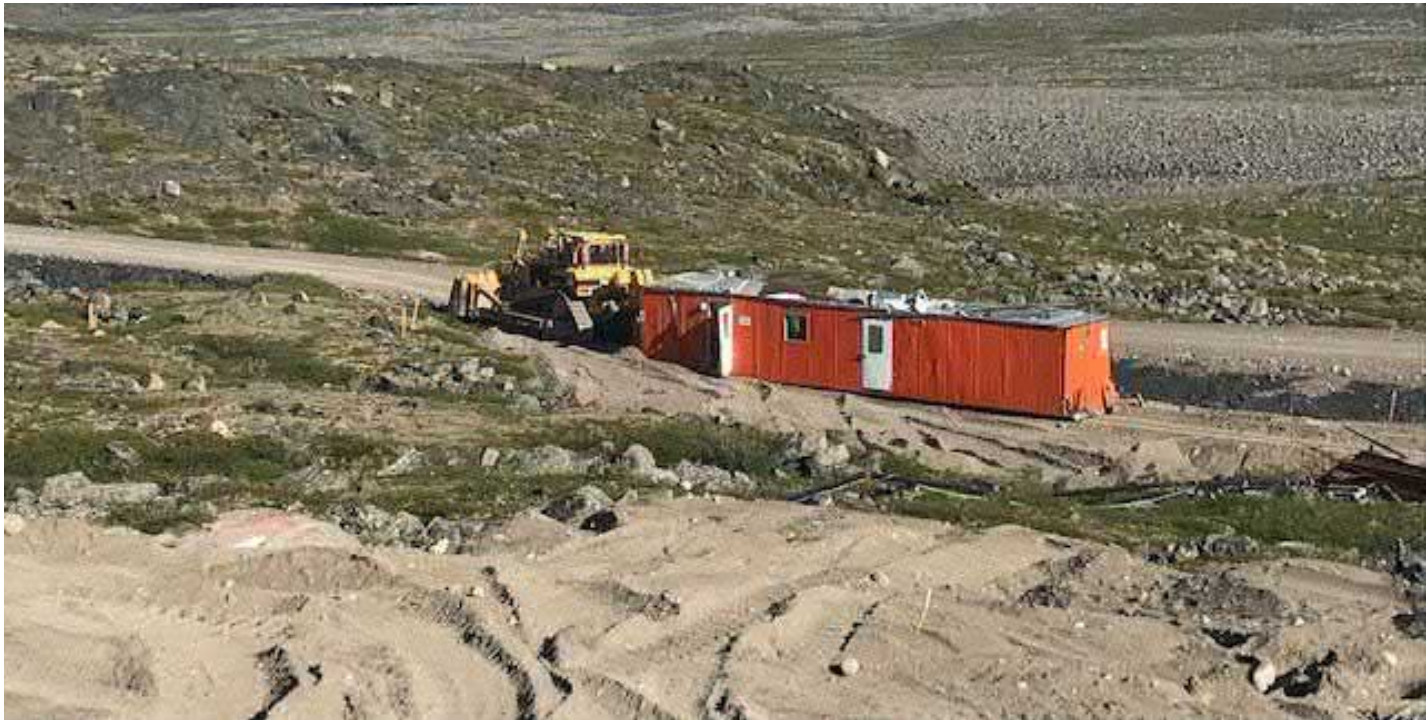
Disassembly of Bunkhouses on July 19, 2021

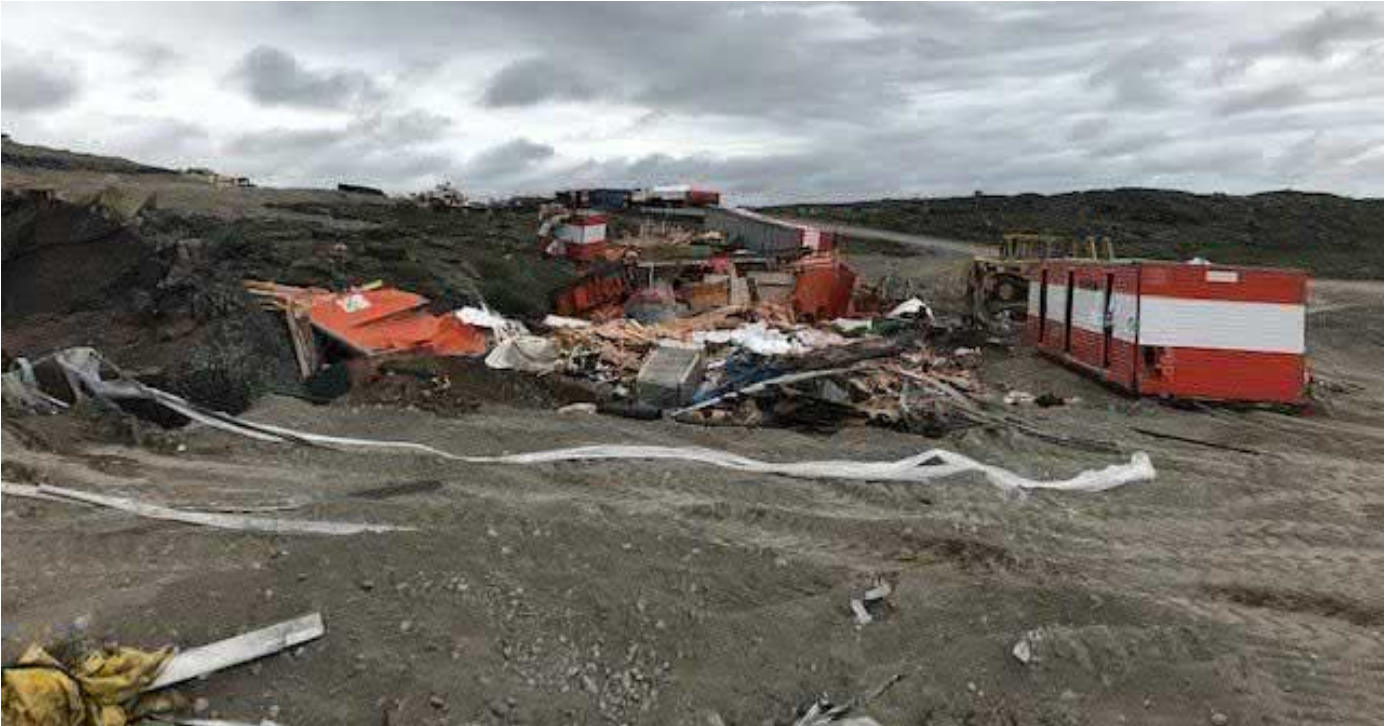
Continued bunkhouse placement and disassembly on July 19, 2021

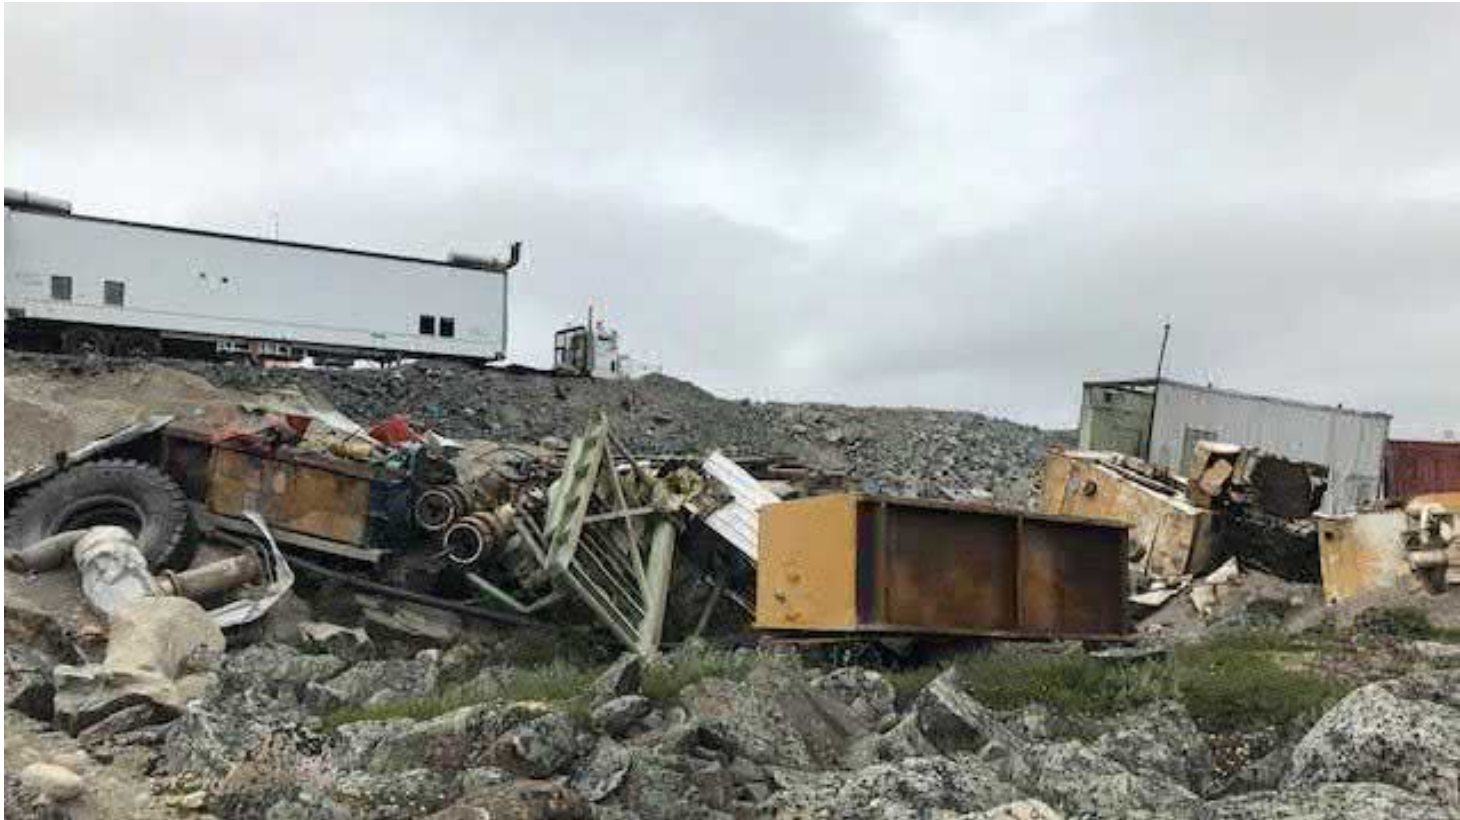
The south side of the site facing north on July 19, 2021

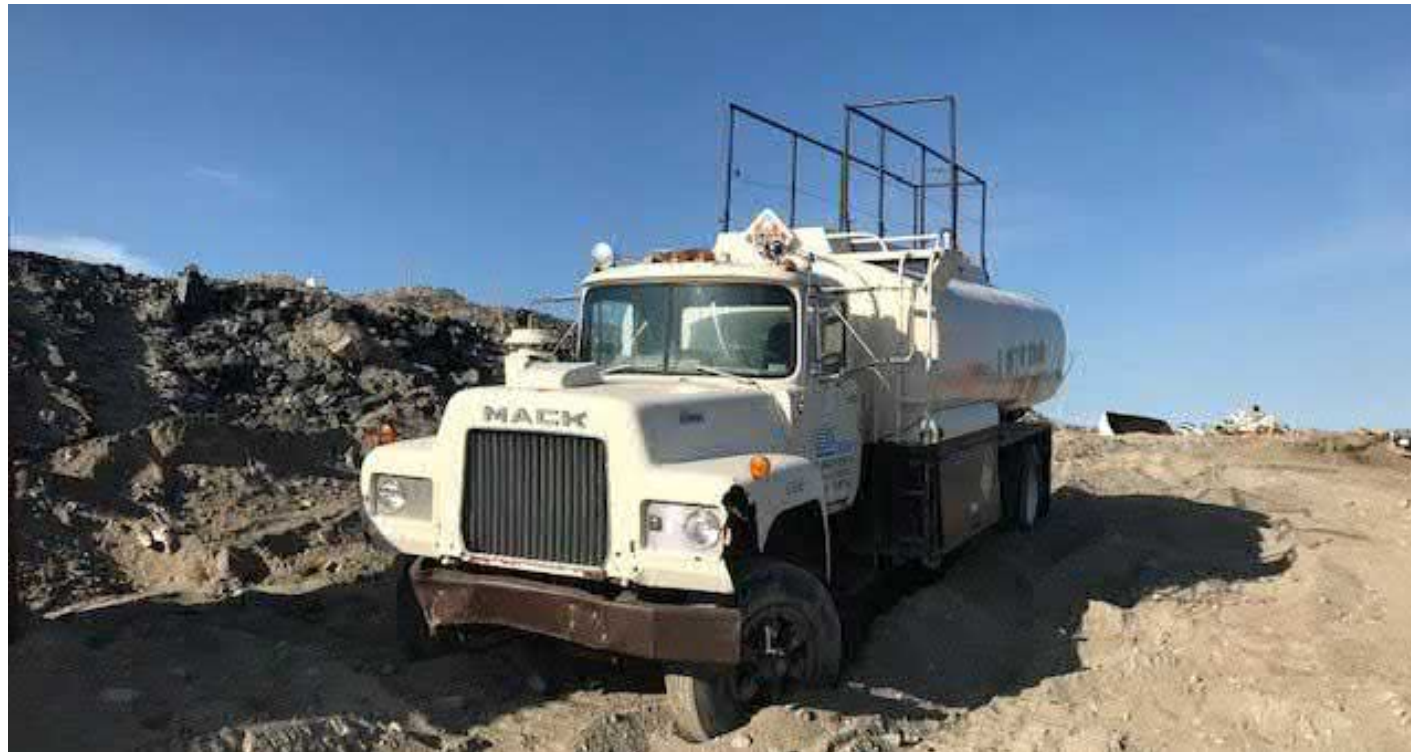
Fuel truck placement in the landfill on July 20, 2021

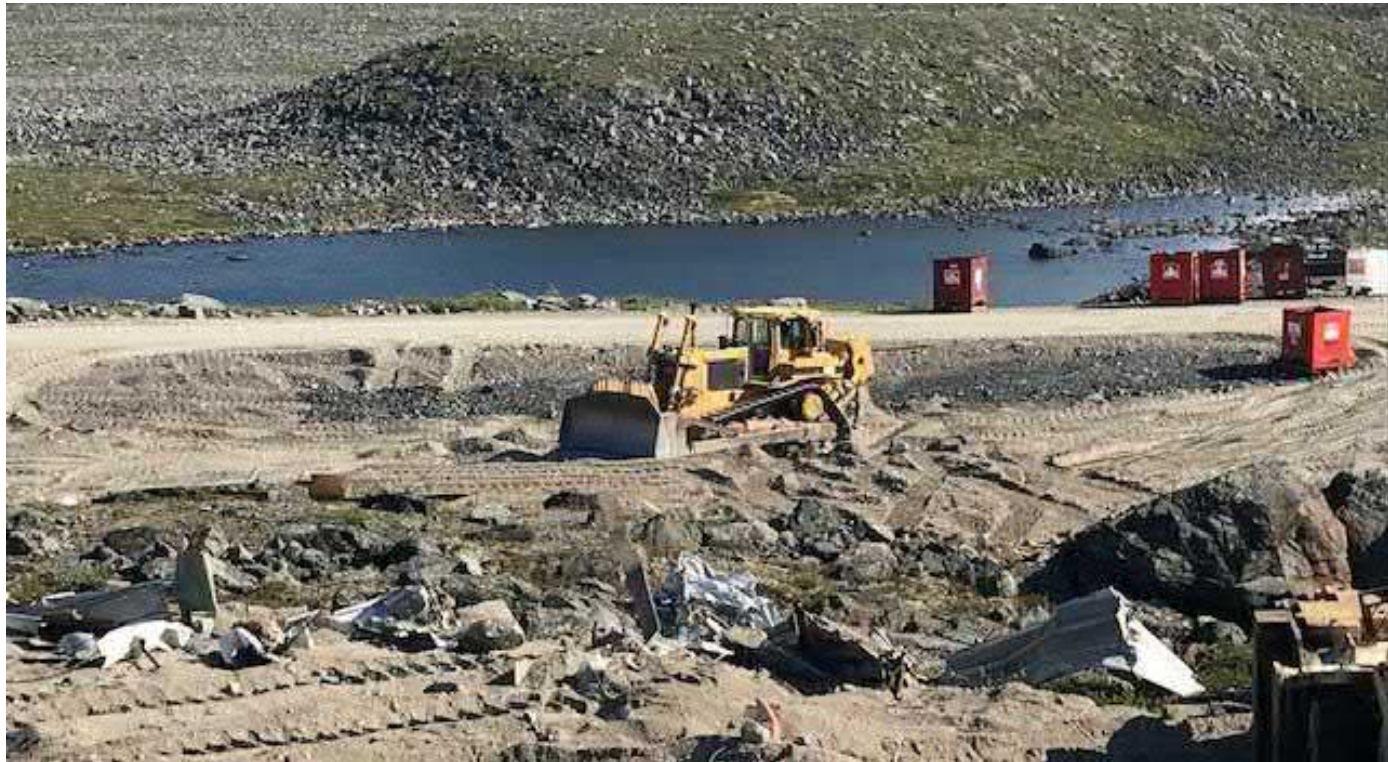
Esker sand placed over bunkhouses on July 21, 2021

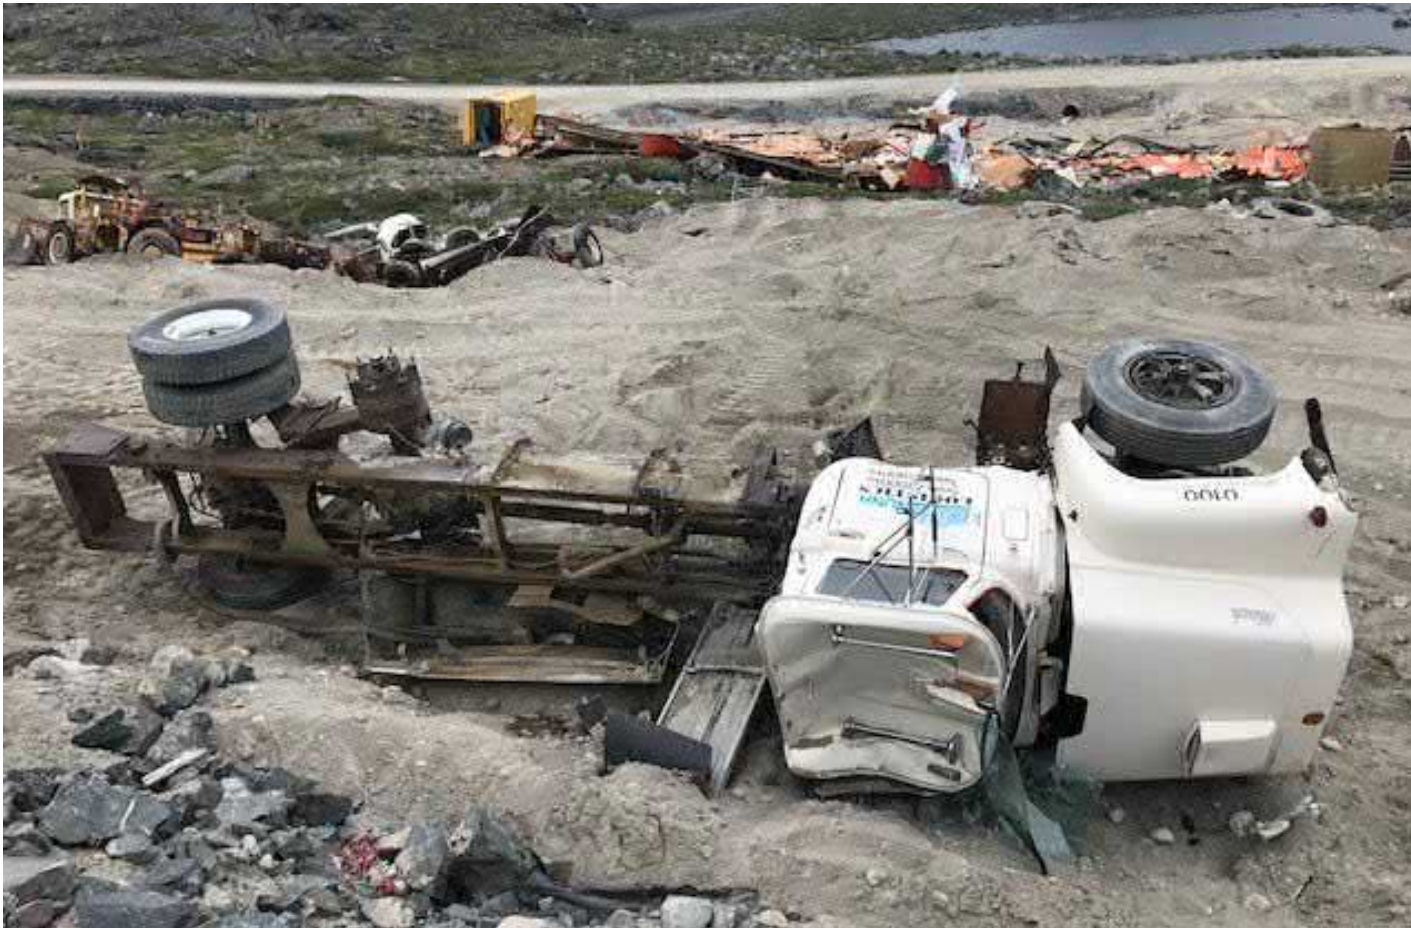
Fuel truck dismantling progress as of July 22, 2021

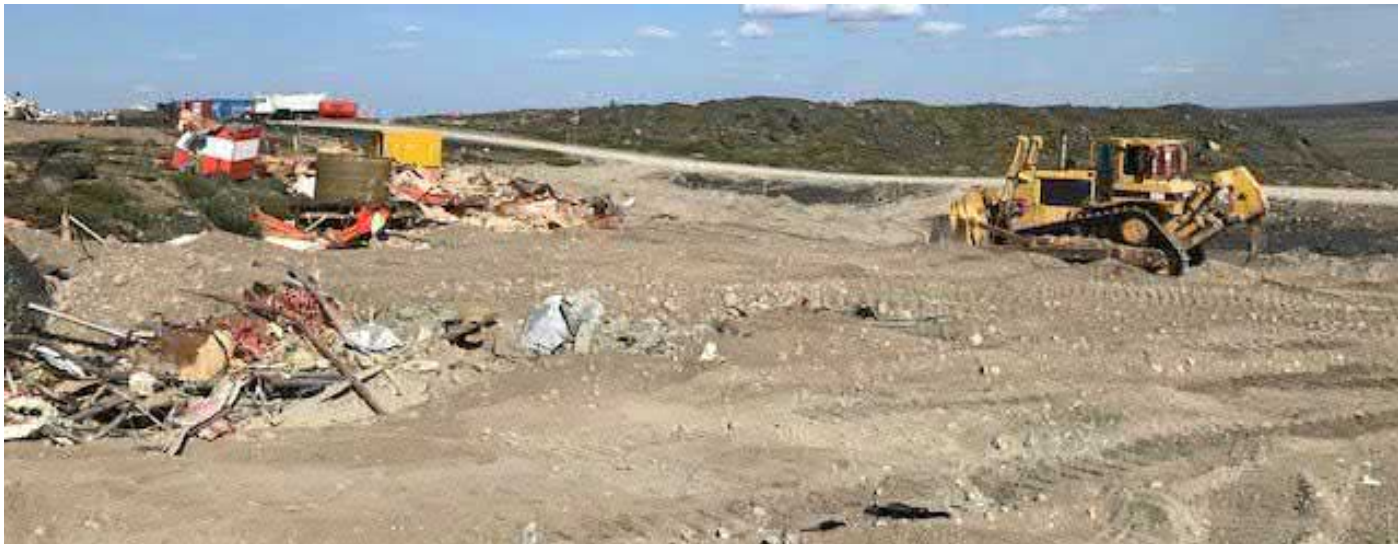
Esker sand placed over bunkhouses on July 21, 2021

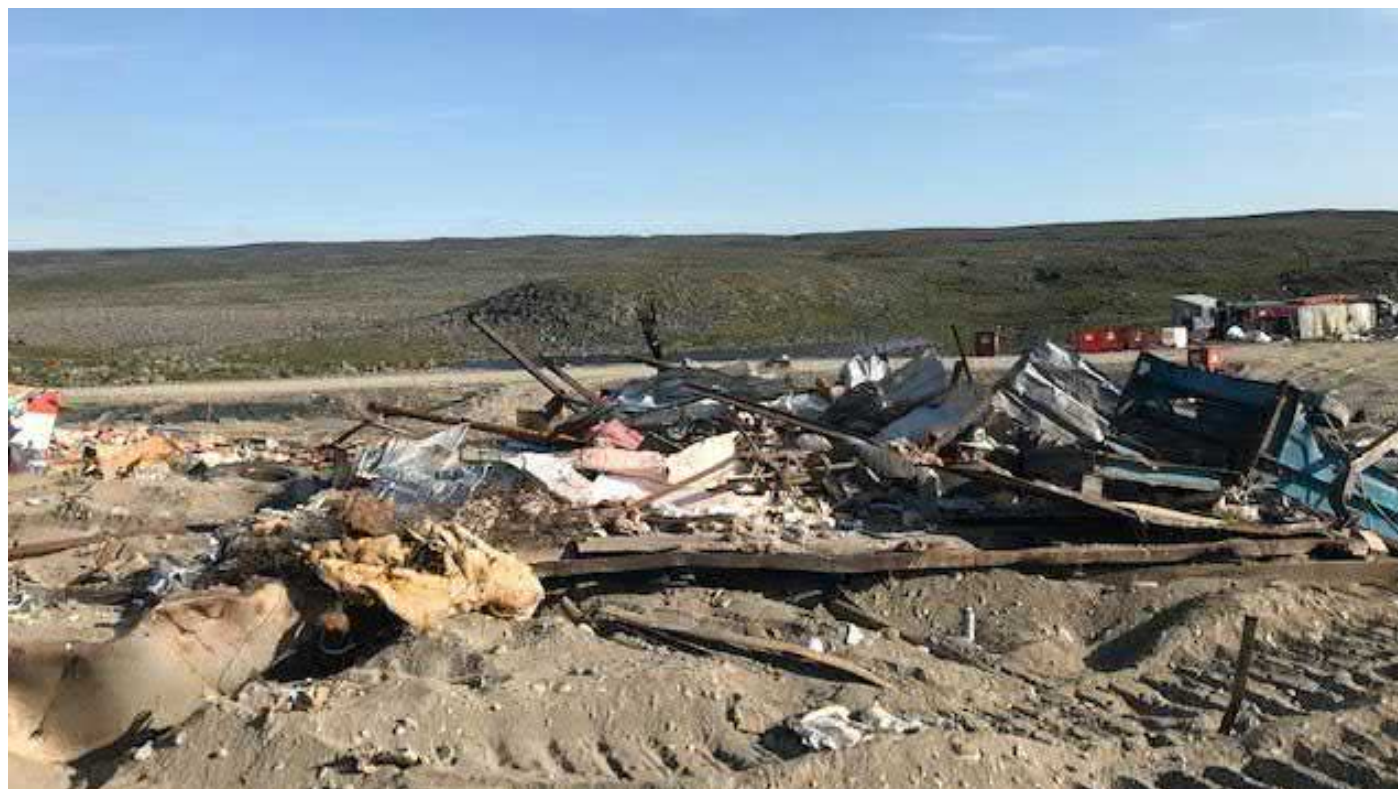
Steel waste placed in the landfill. July 20, 2021

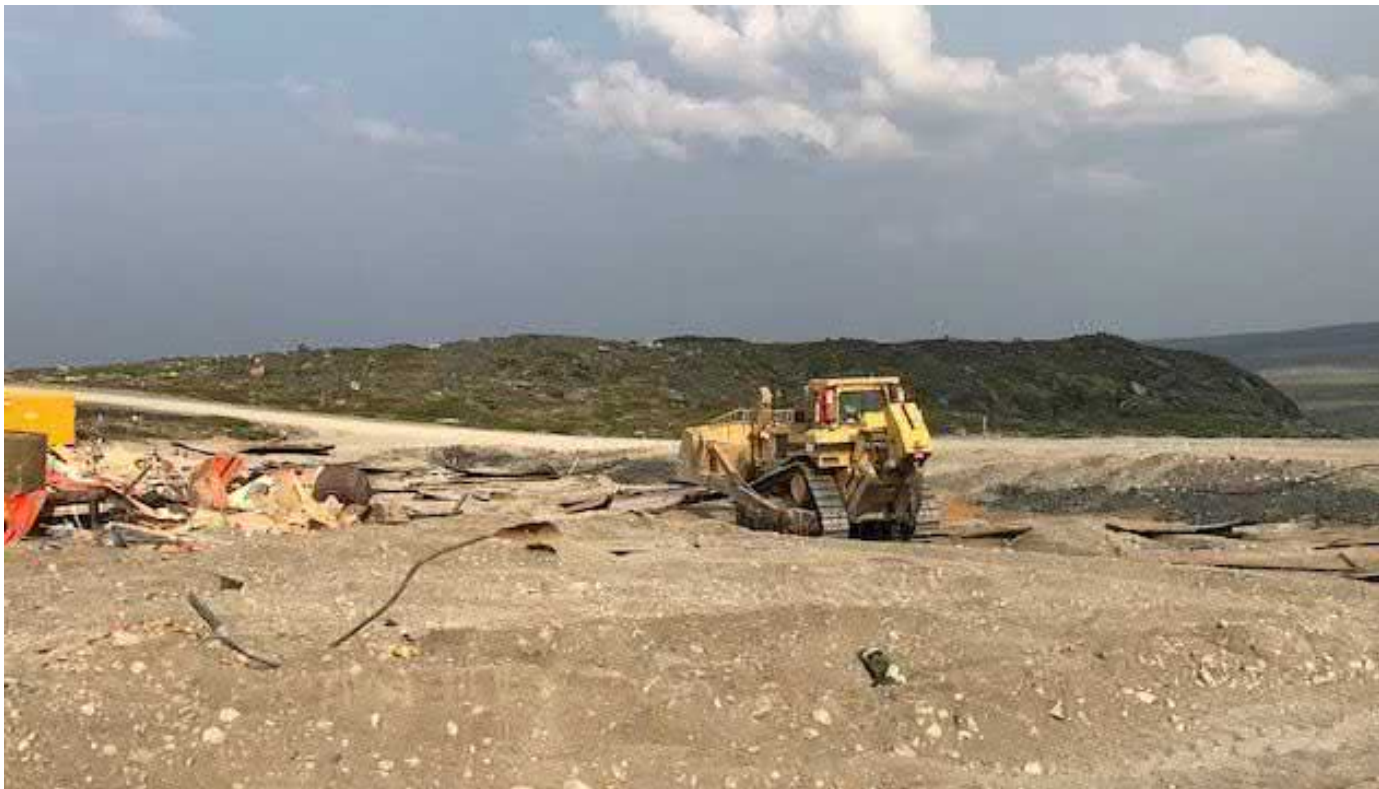
Bulldozer placing steel in the landfill. July 22, 2021

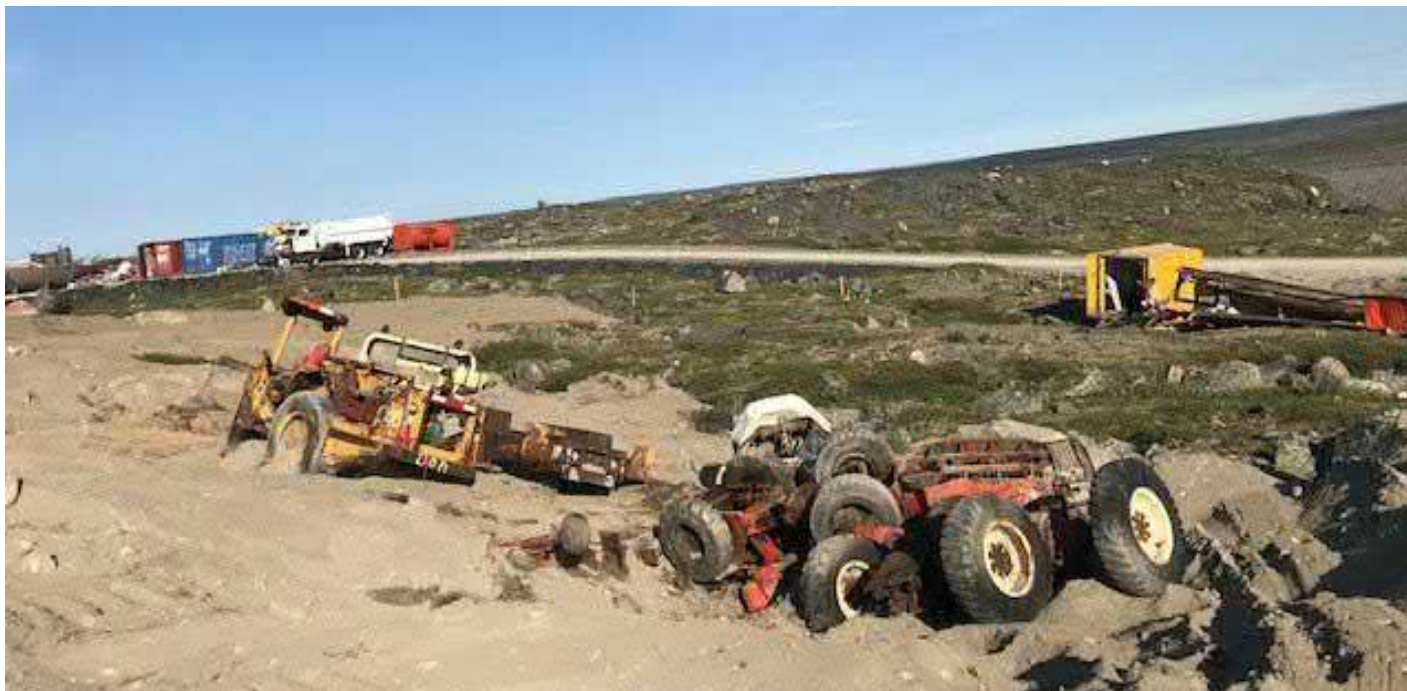
Underground mine equipment placed in the landfill. July 20, 2021

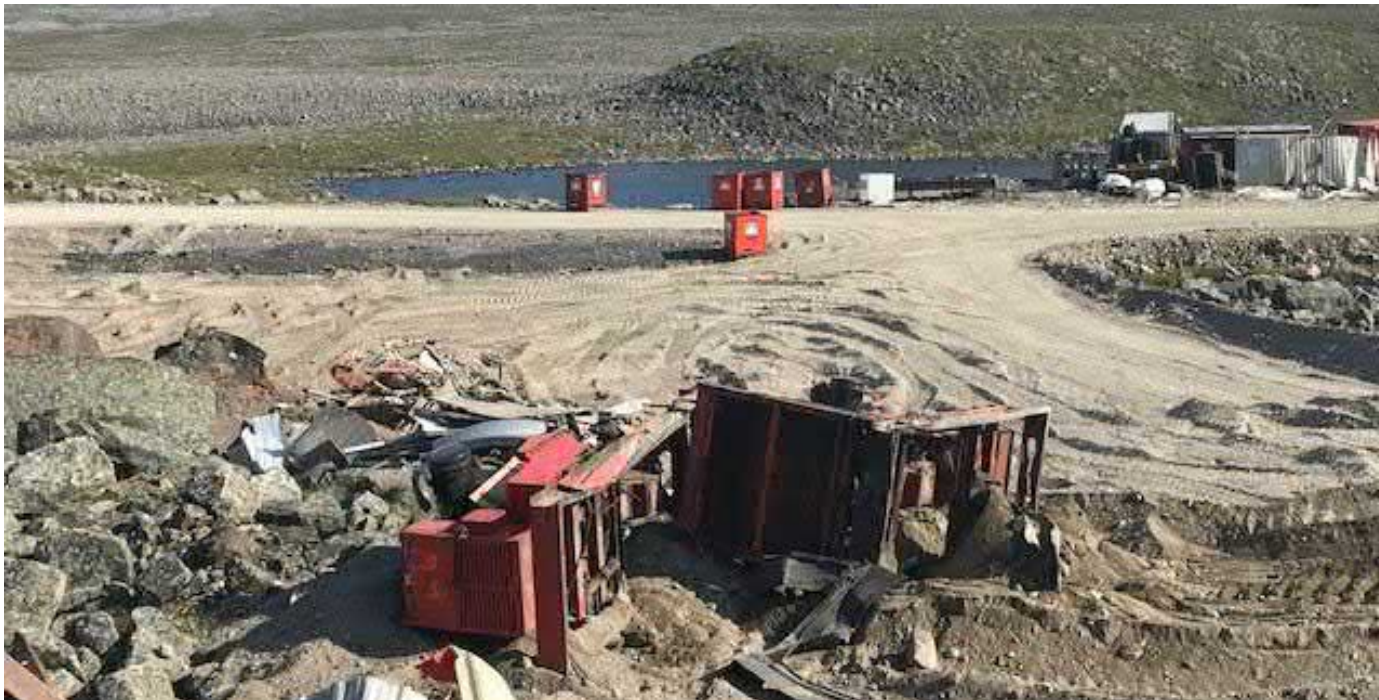
A generator placed in the landfill. July 21, 2021

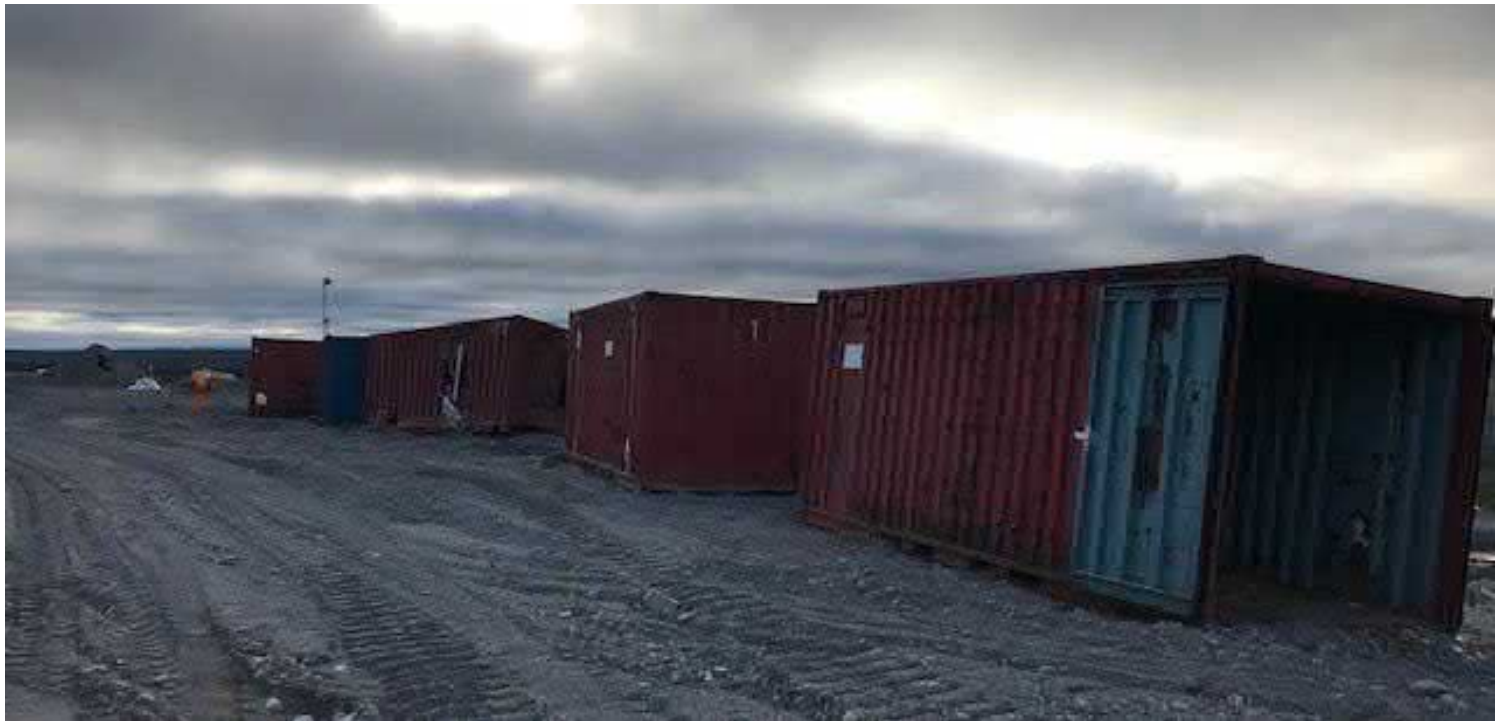
The south side of the site facing north – staging shipping containers on July 23, 2021

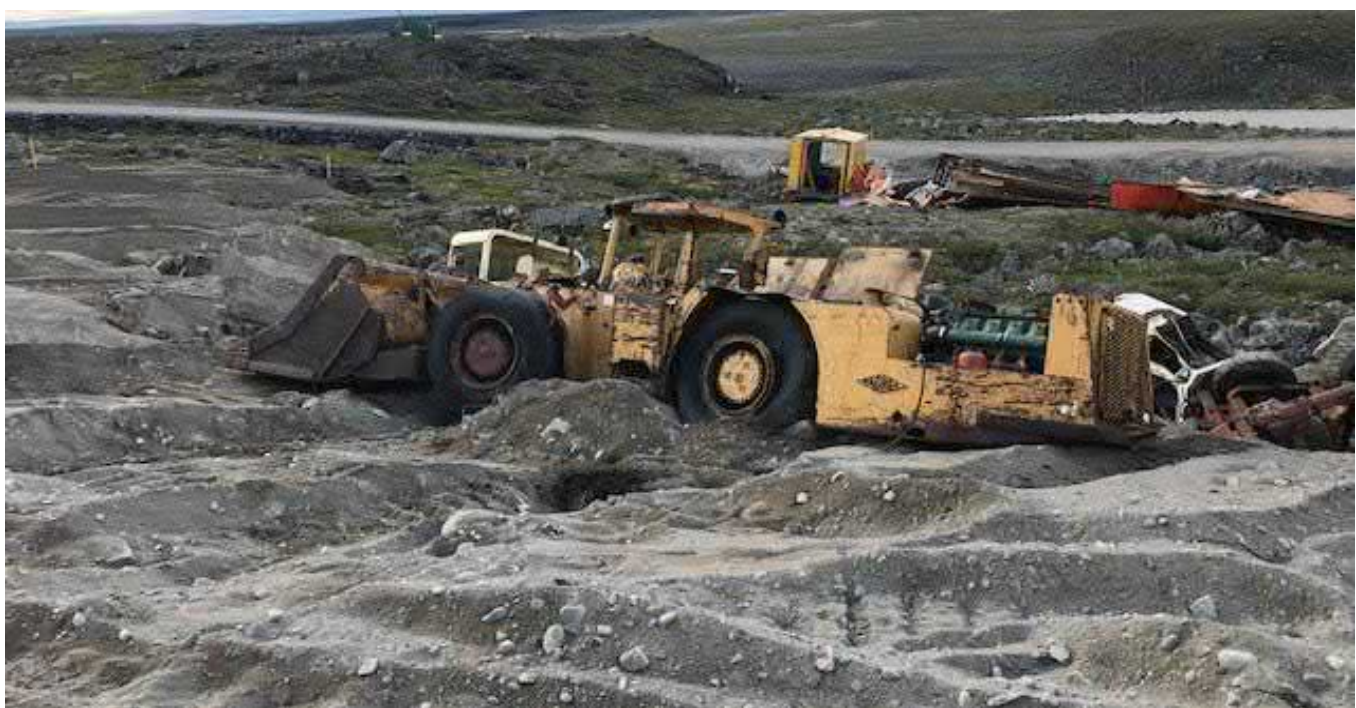
Underground equipment placement. July 23, 2021

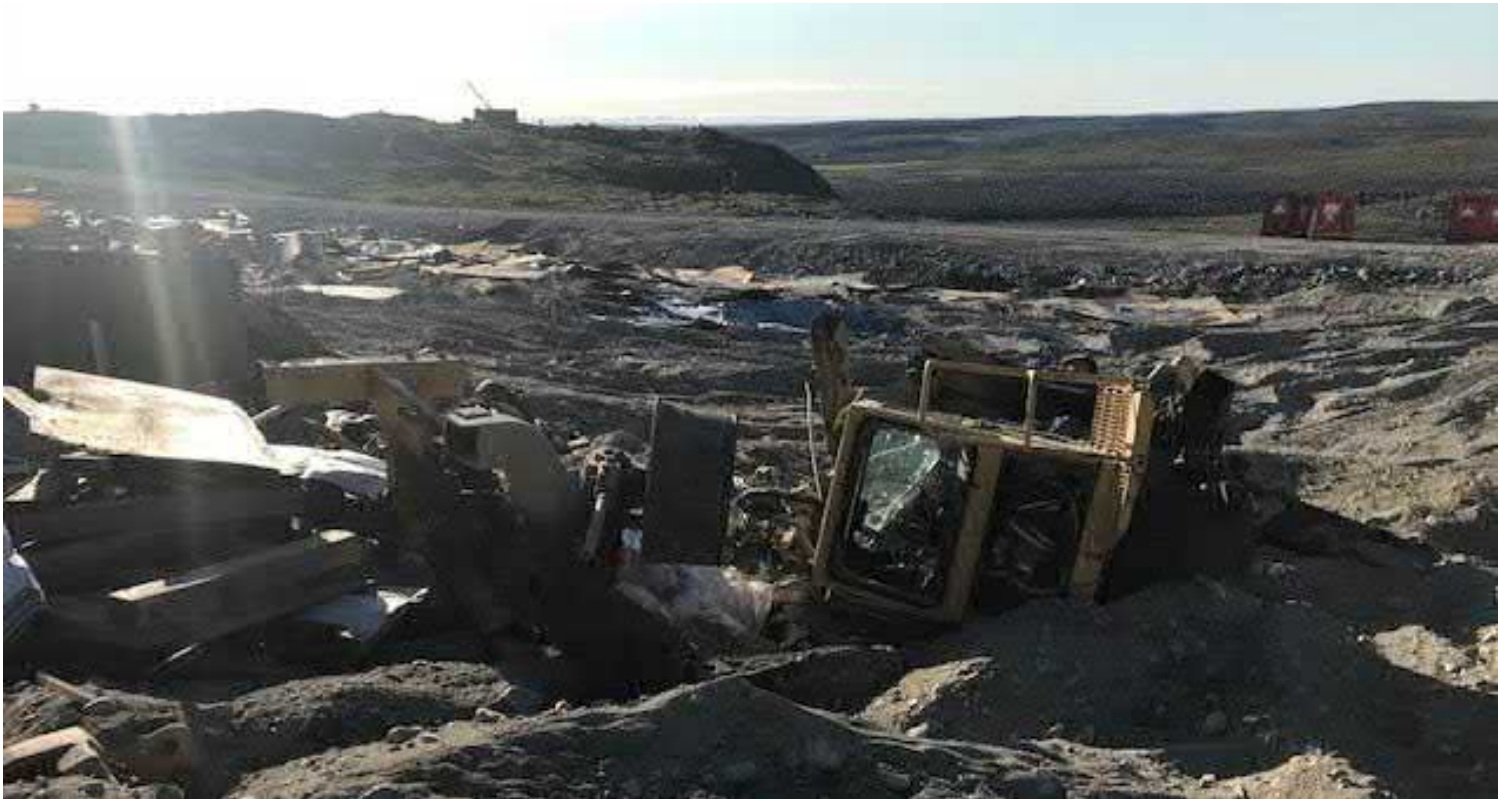
Surface haul truck placed. July 24, 2021

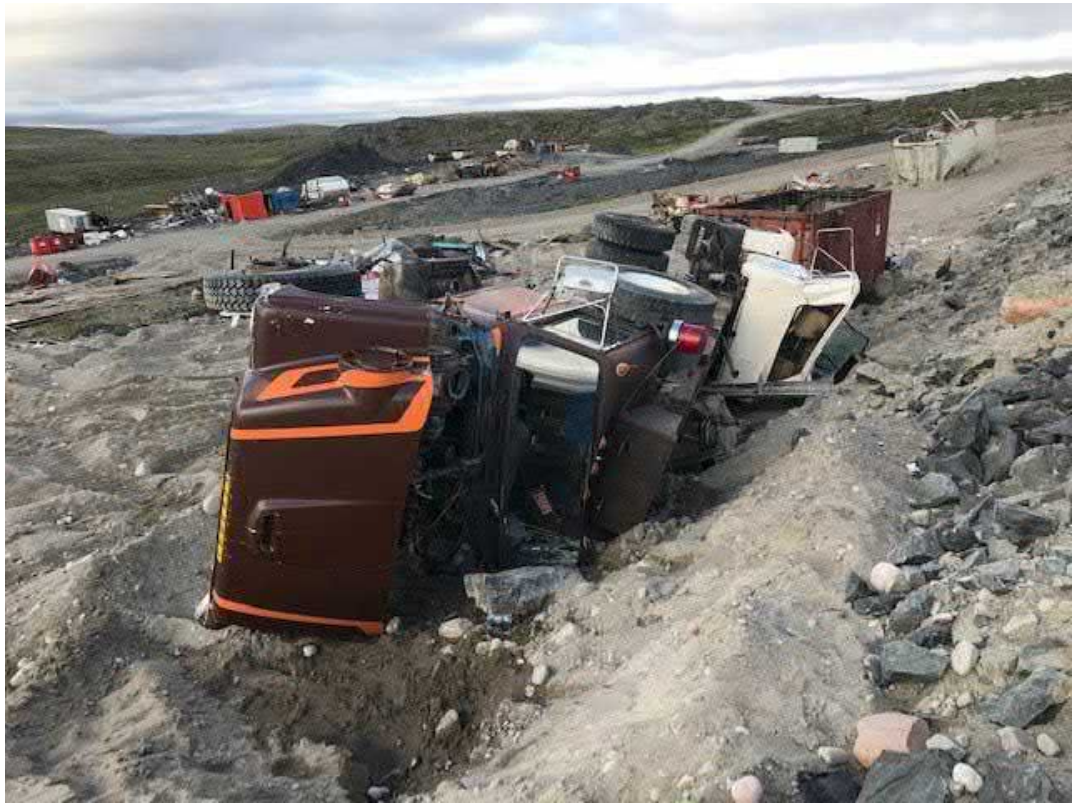
The north side of the site facing southwest on July 23, 2021

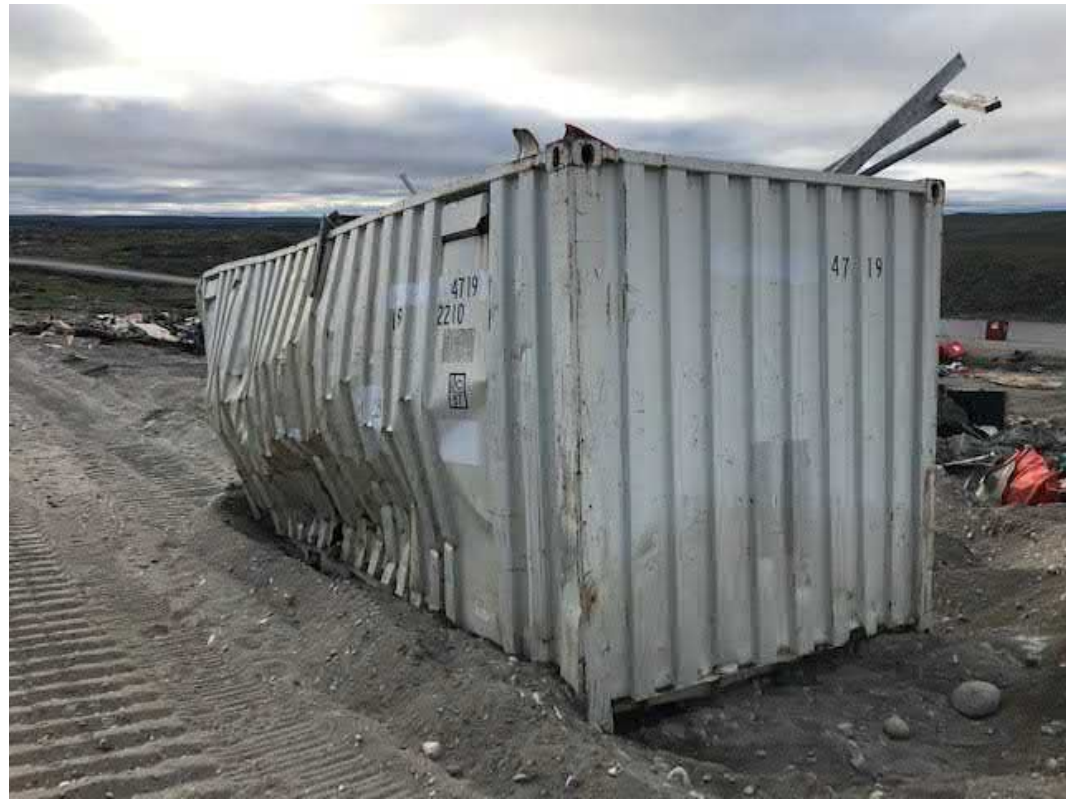
Seacan filled with waste on July 23, 2021
