Interim Closure and Reclamation Plan
Ulu Gold Project
(including Hood River, Roma and other licensed projects)

Kitikmeot Region, Nunavut

NOVEMBER 2025

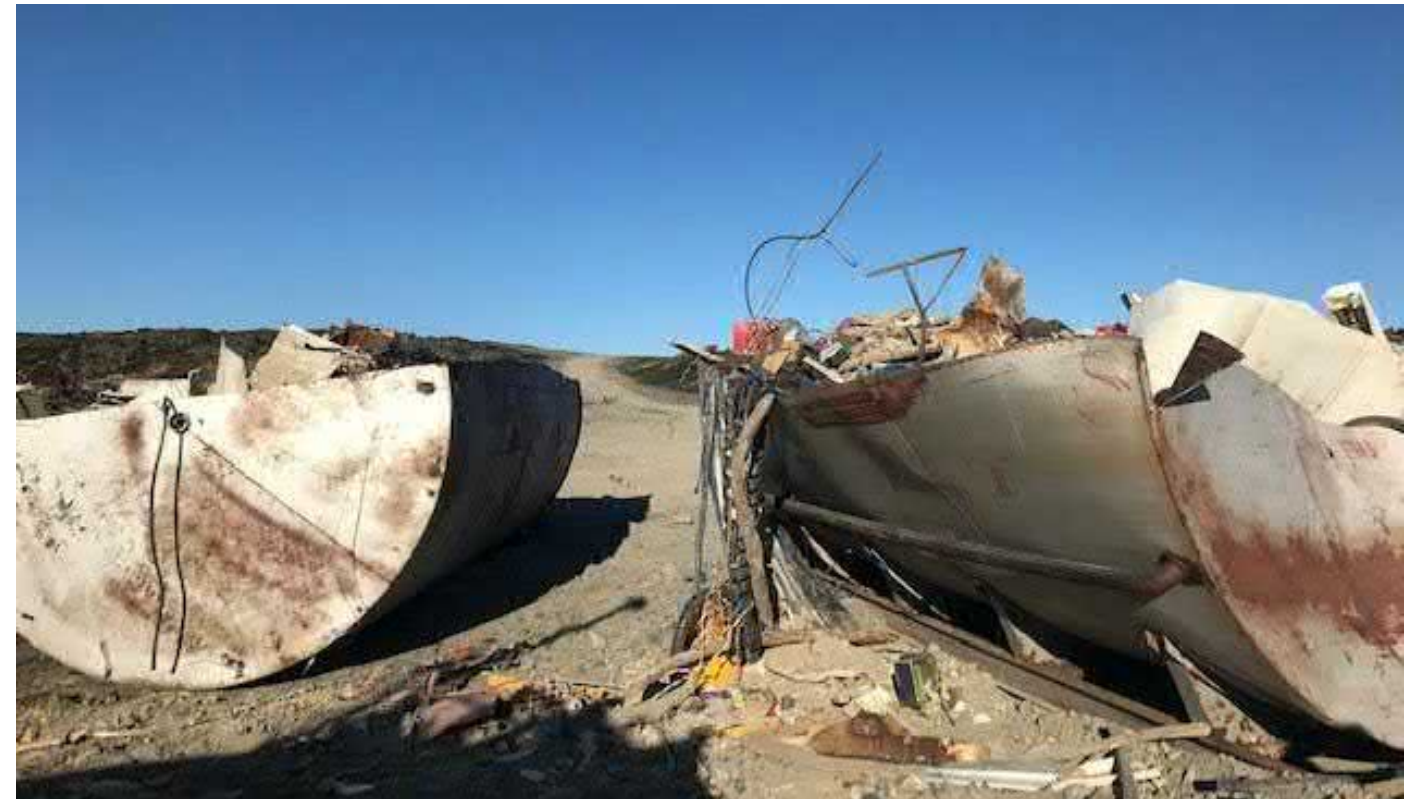
Tanks filled with waste. July 24, 2021

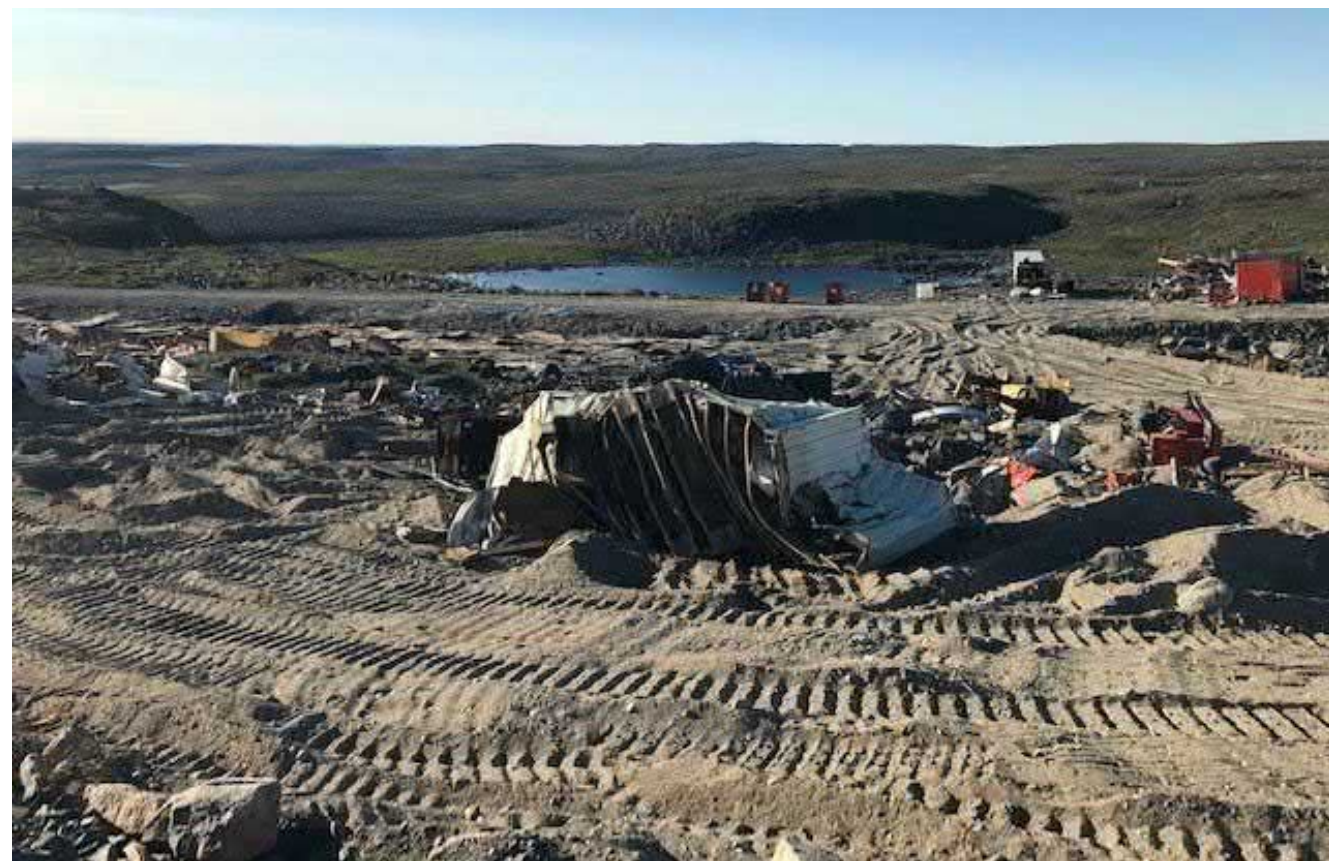
Seacan filled and compacted in landfill on July 24, 2021

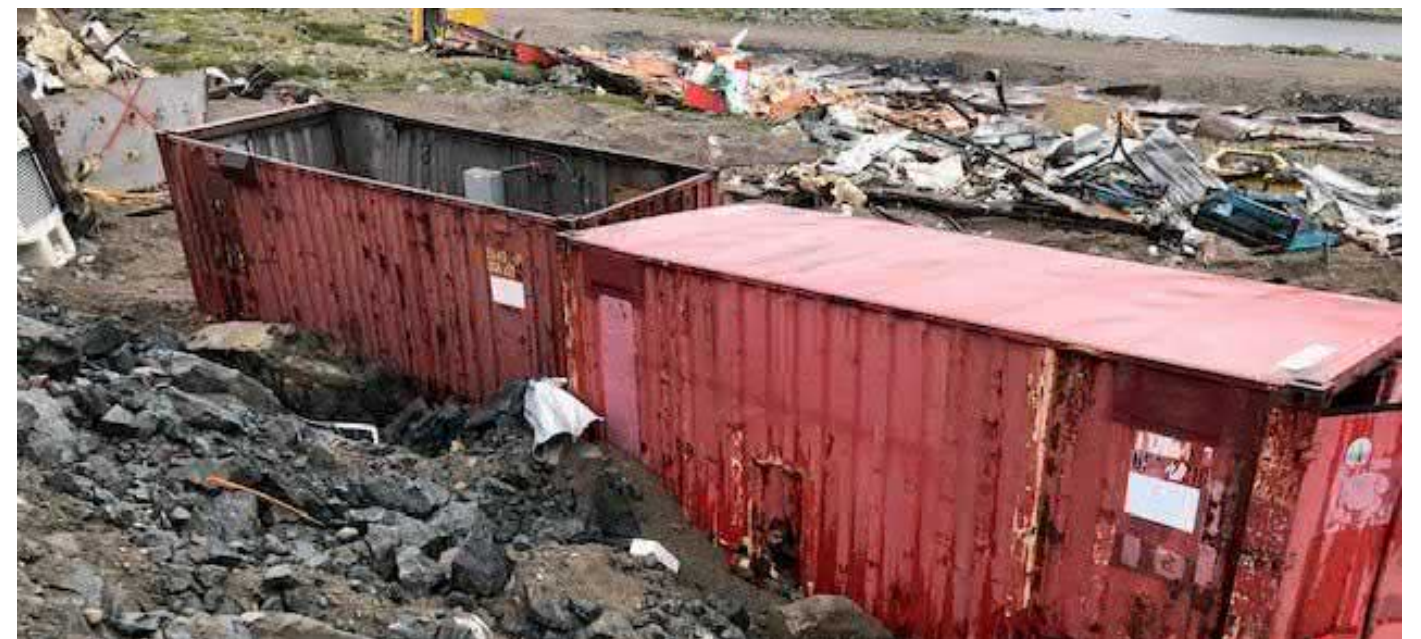
Shipping containers placed. July 25, 2021

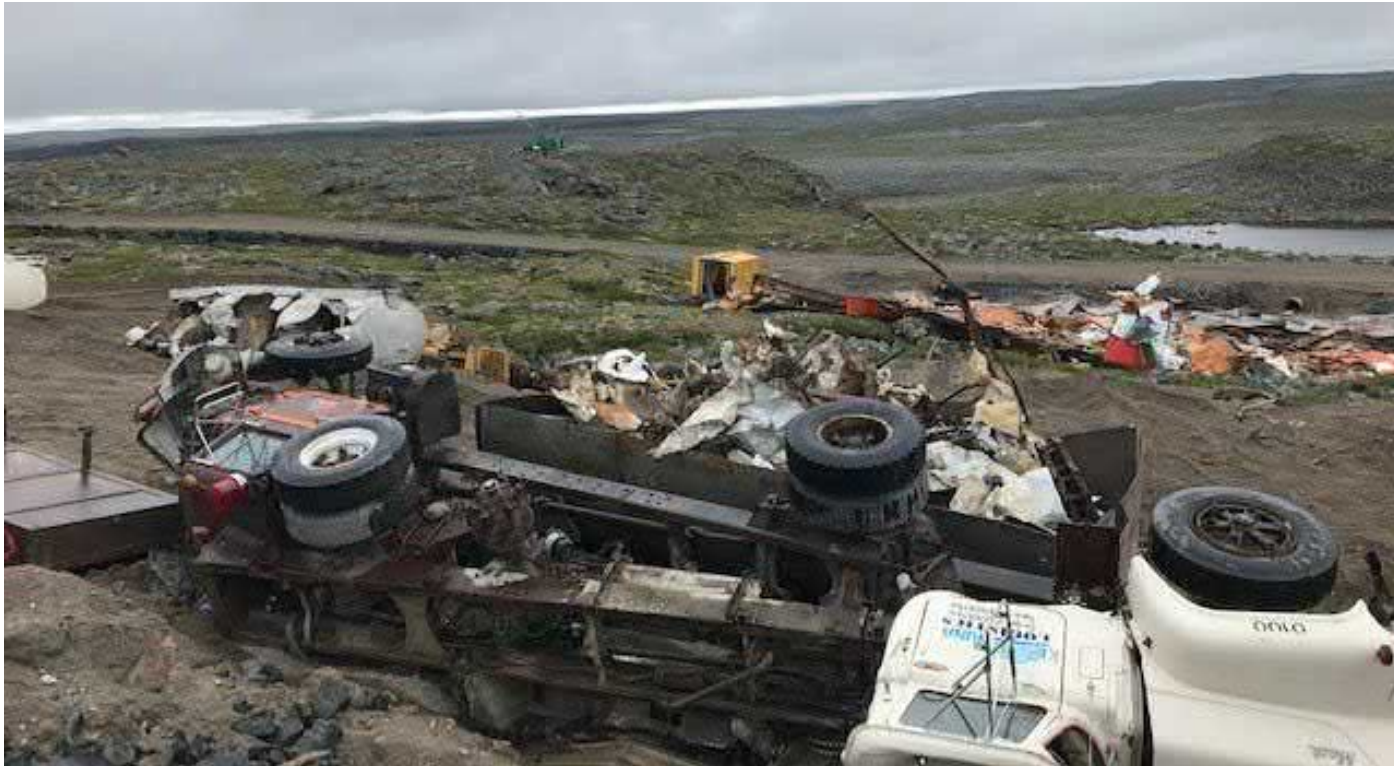
Tanks filled with waste were placed next to trucks. July 25, 2021

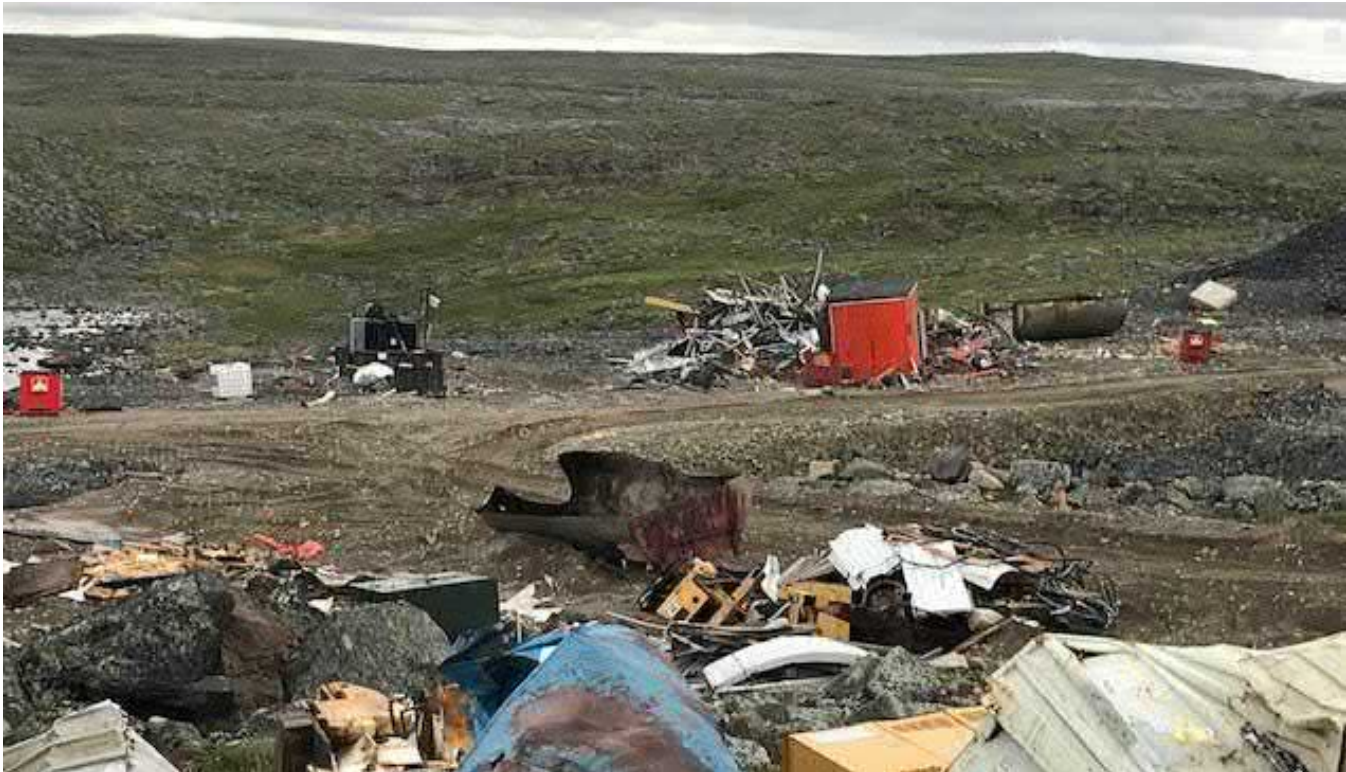
Tanks filled with waste were placed next to trucks. July 25, 2021

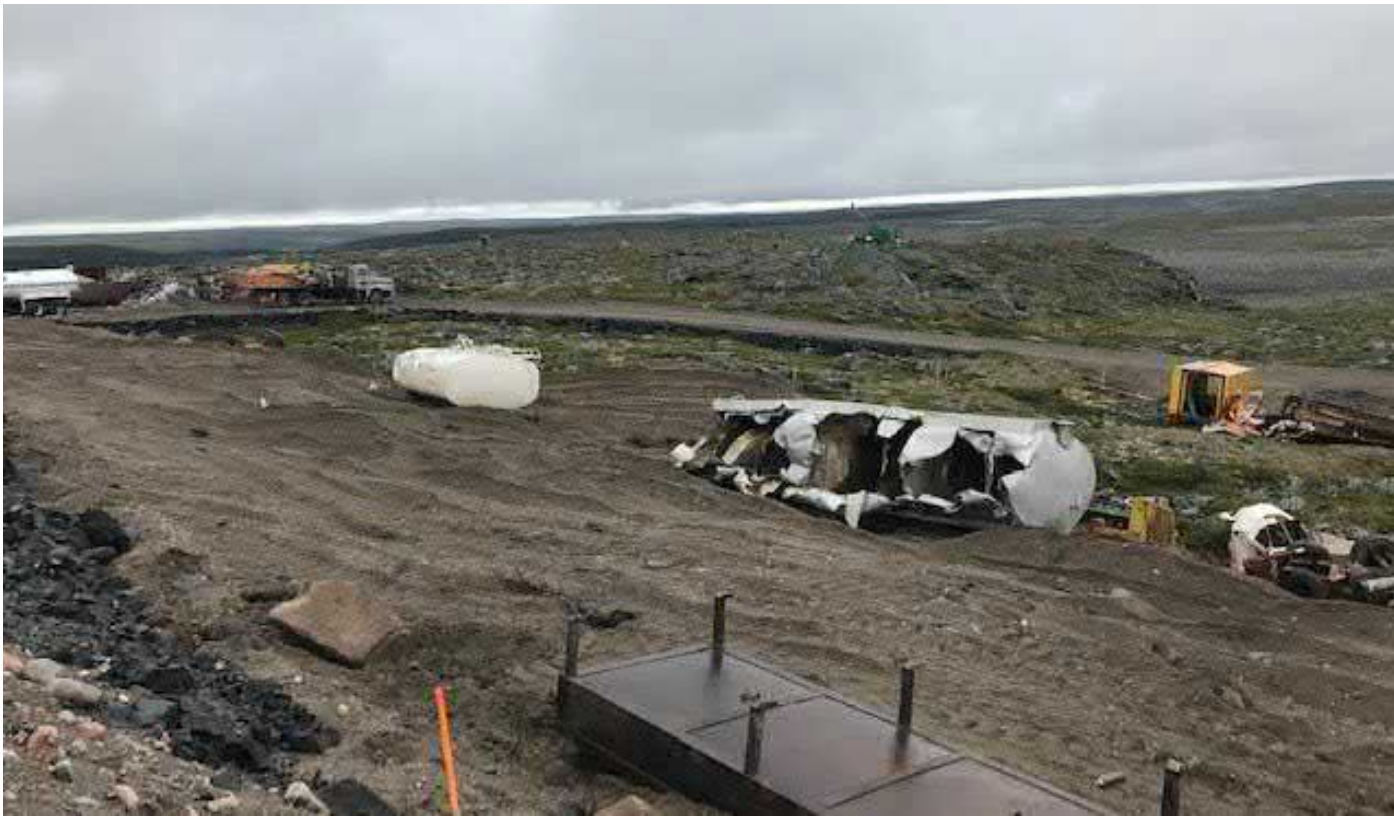
Clean tanks were staged in the landfill for cutting. July 25, 2021

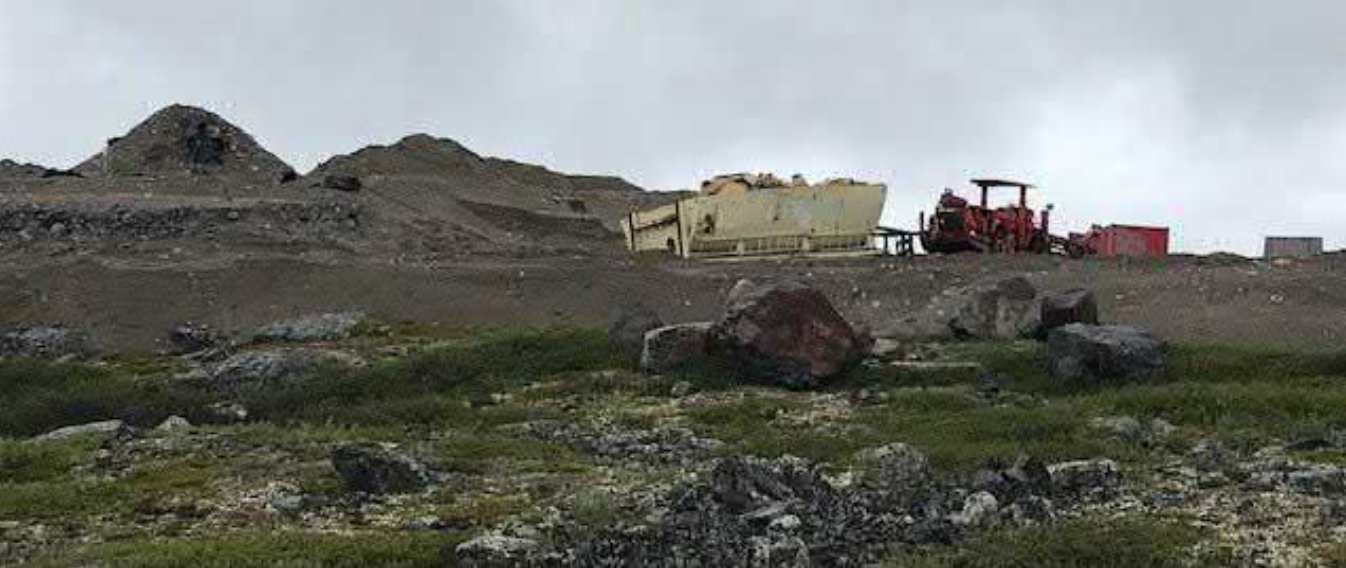
Tanks filled with waste were staged. July 25, 2021

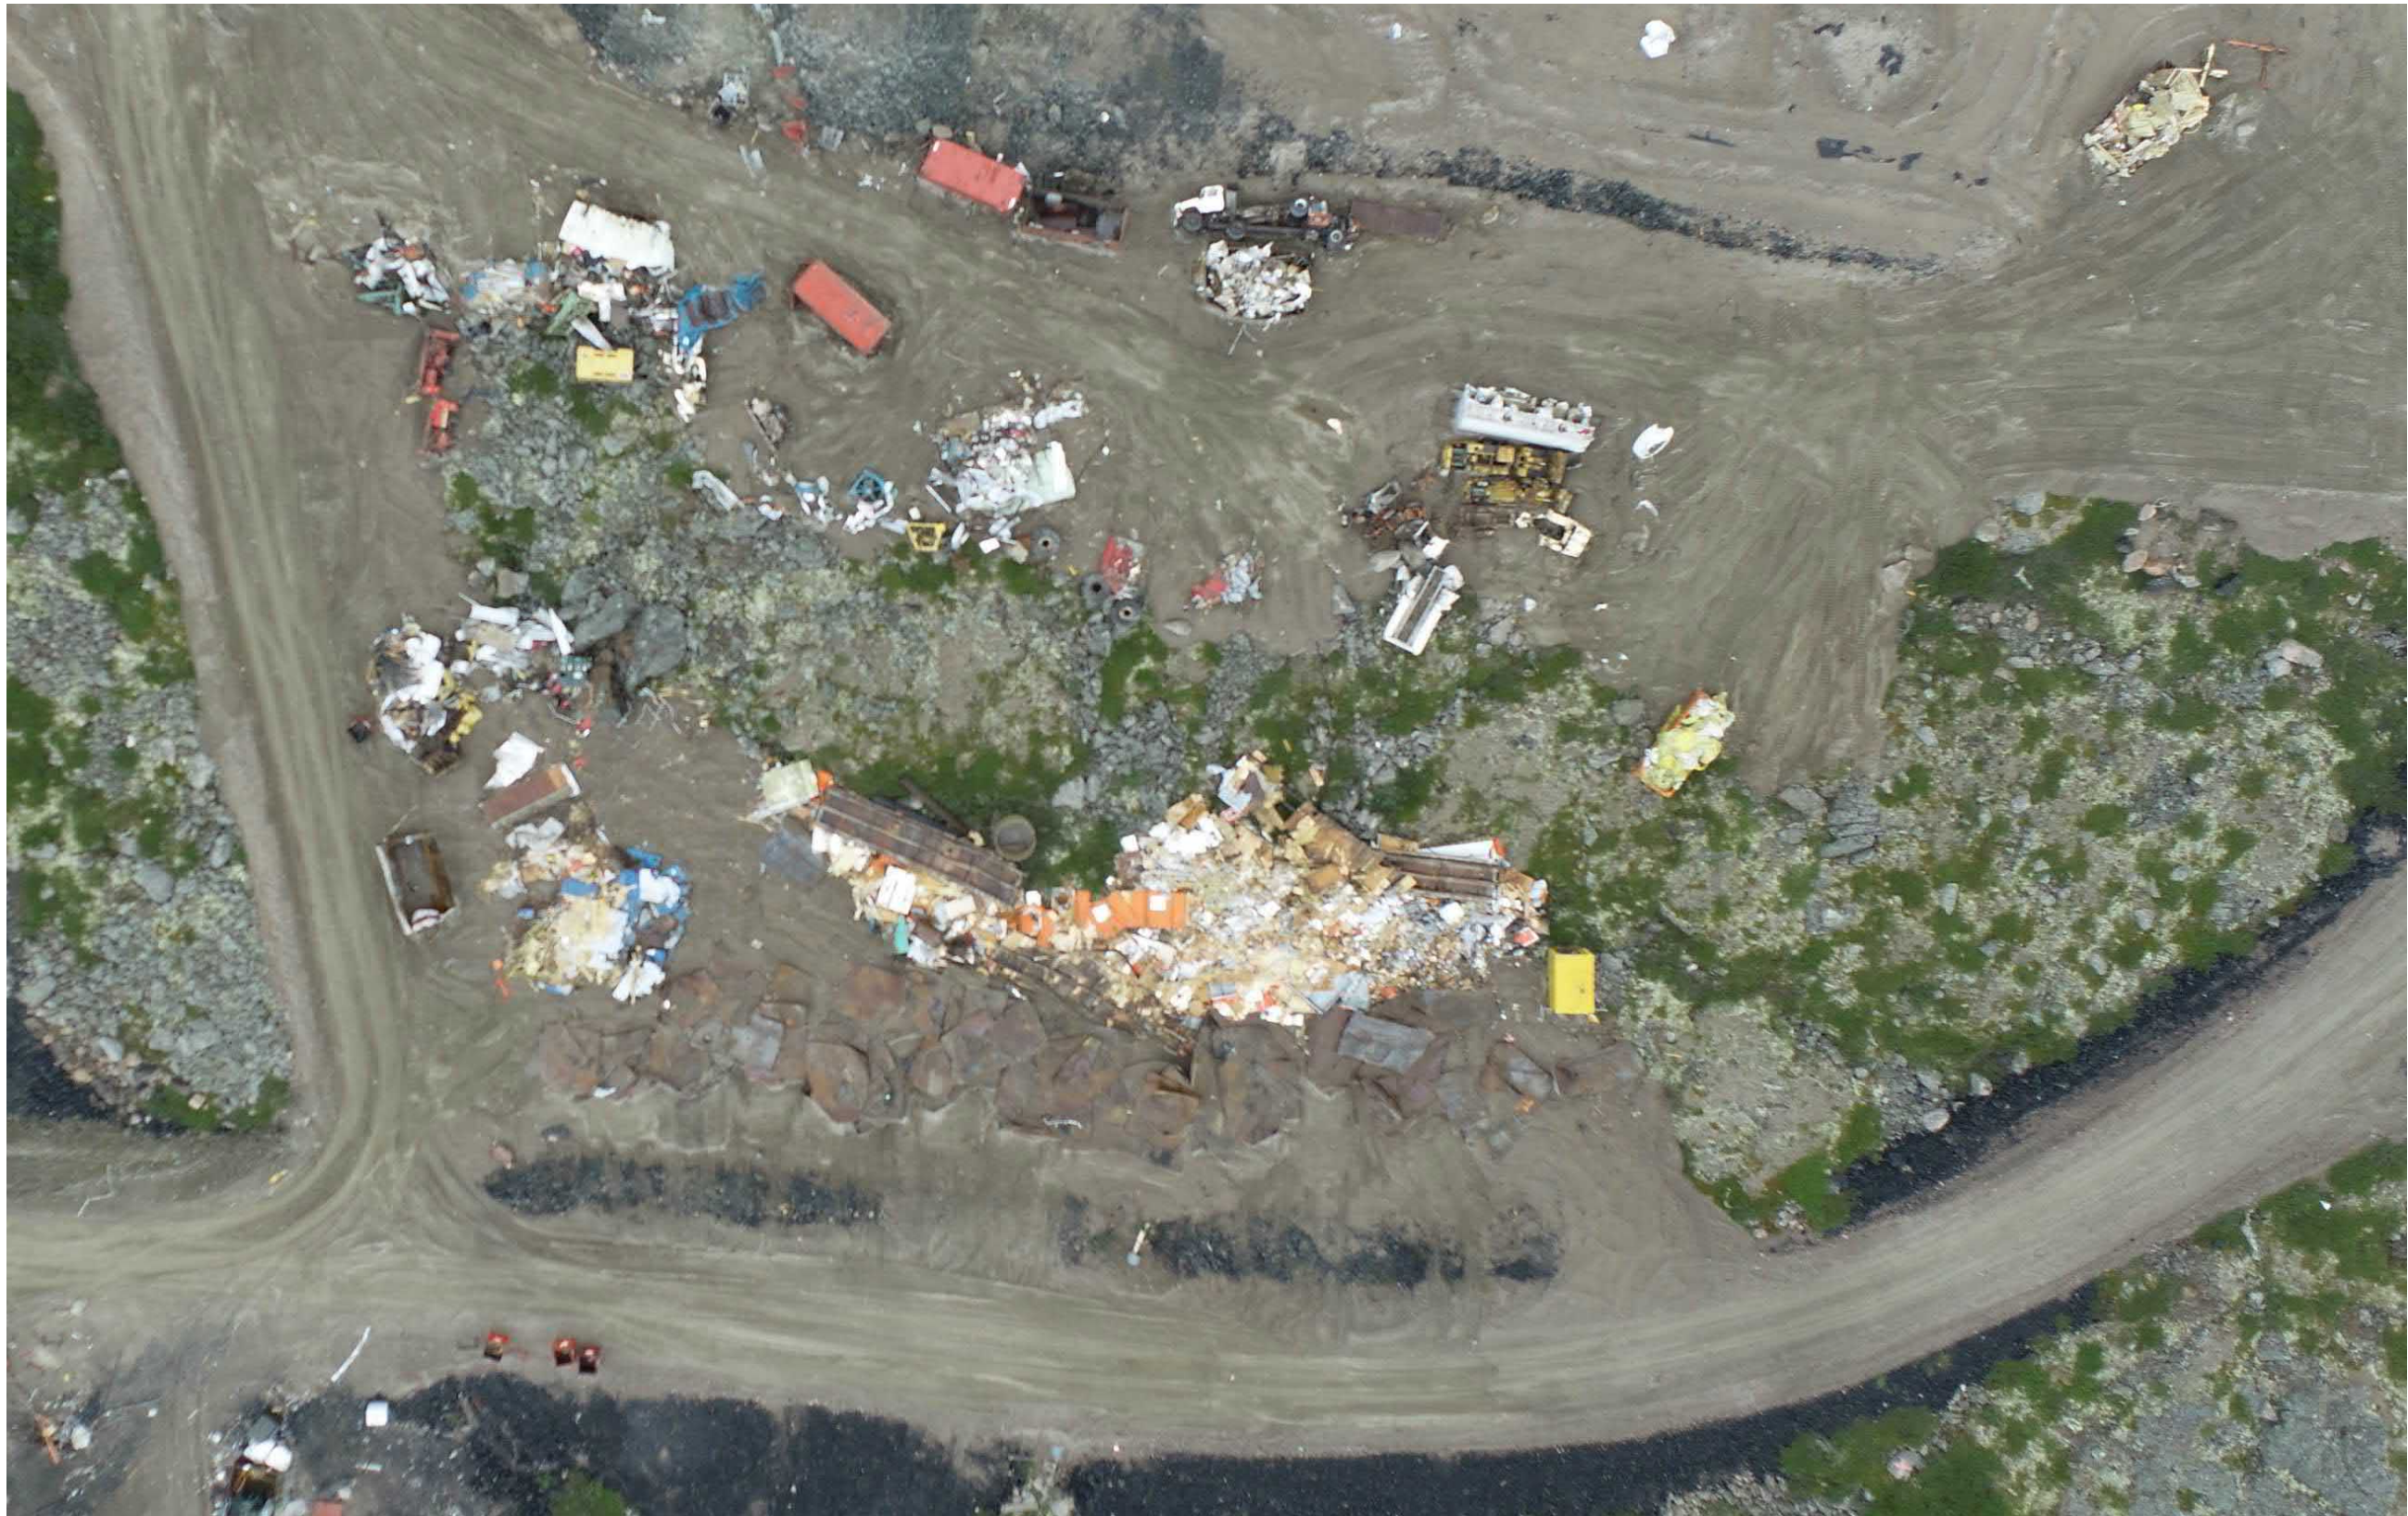
Progress overview on July 27, 2021

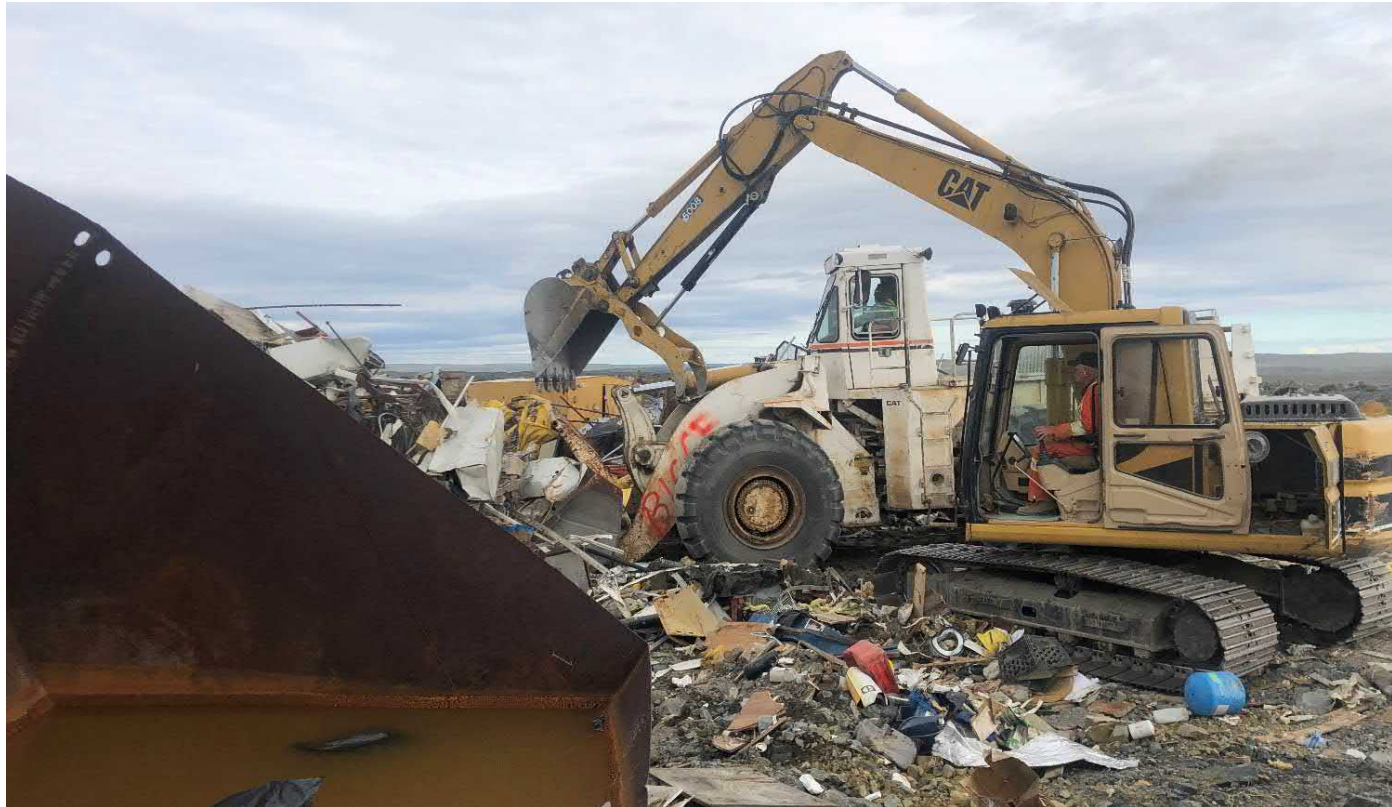
Waste placement and compaction on August 2, 2021

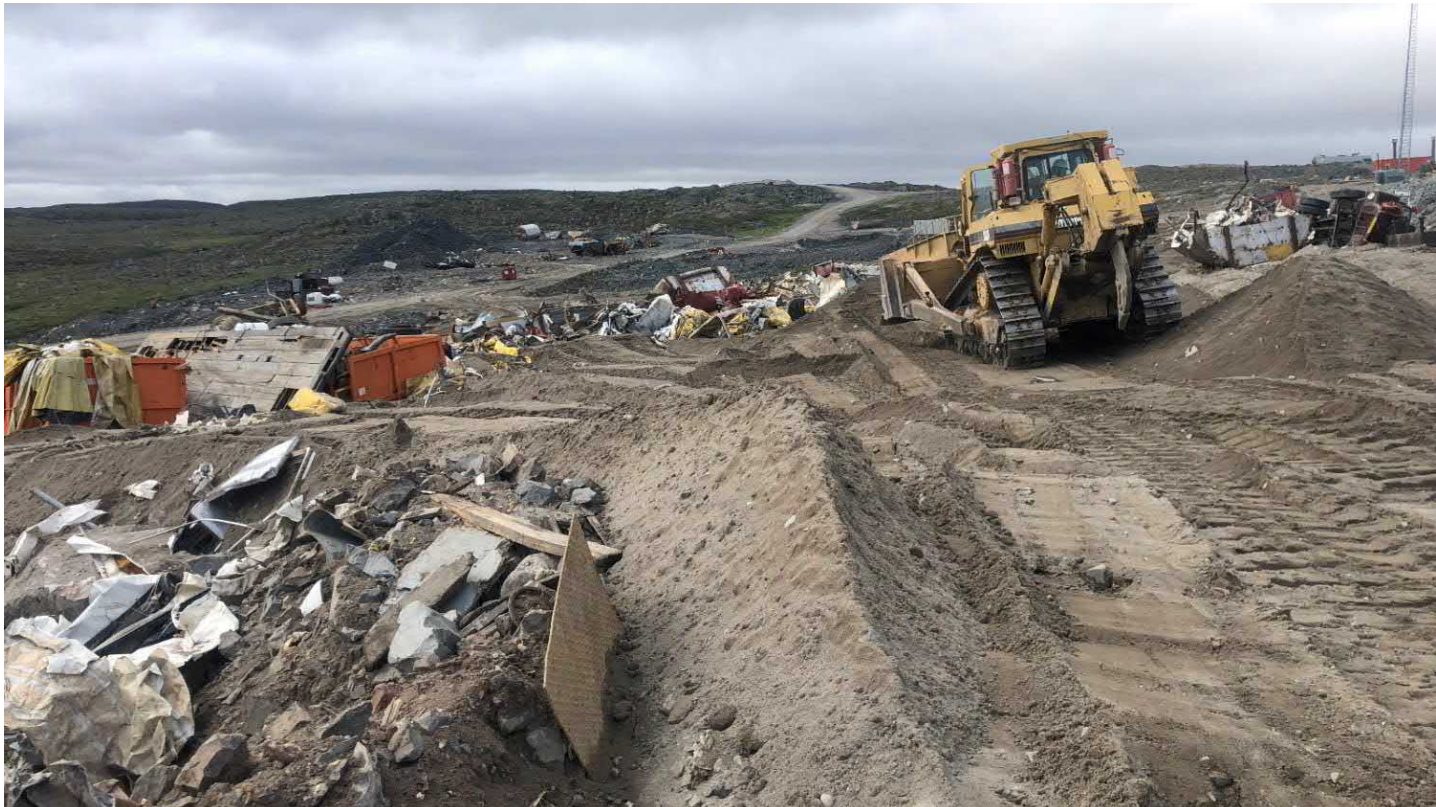
The east side of the site facing west, esker placement within voids and wind cover on August 3, 2021

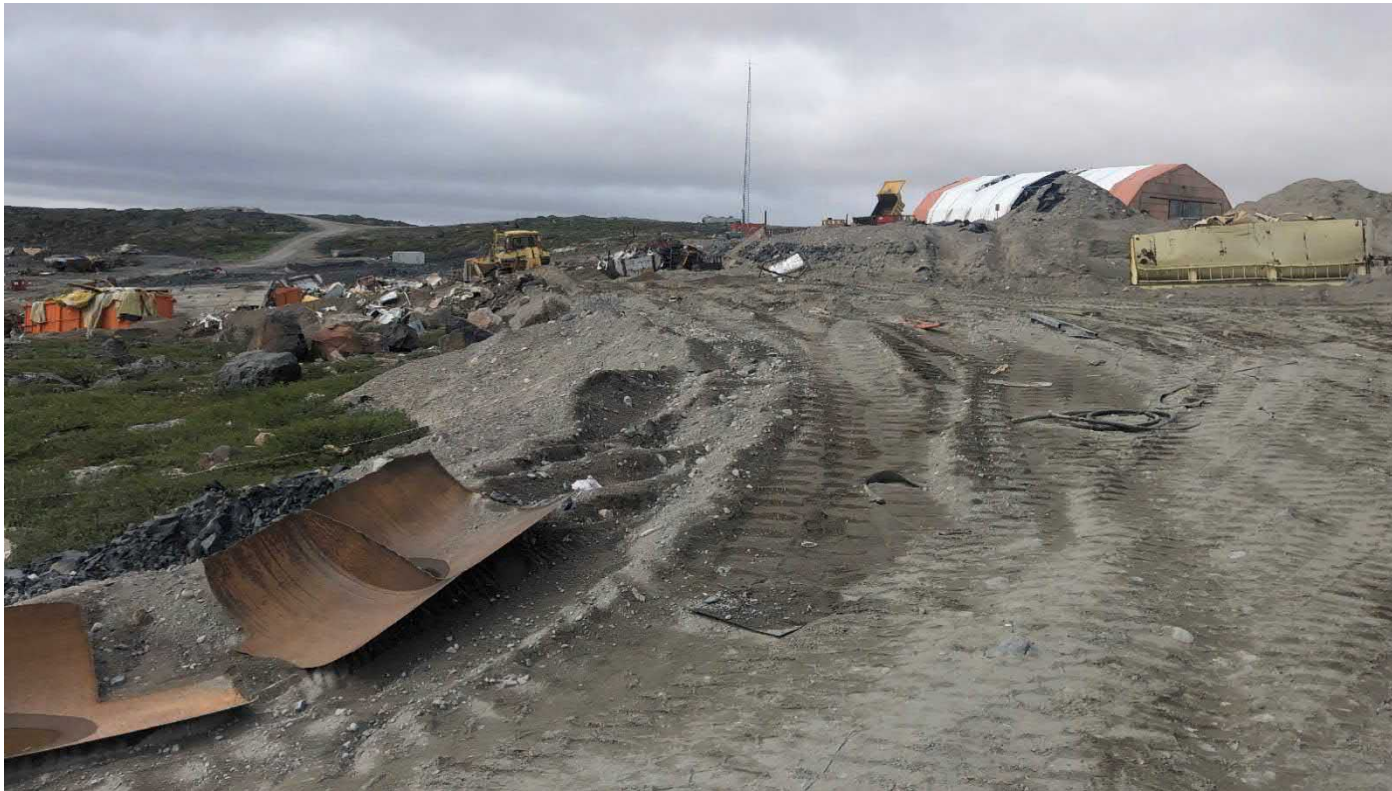
The east side of the site facing west on August 3, 2021

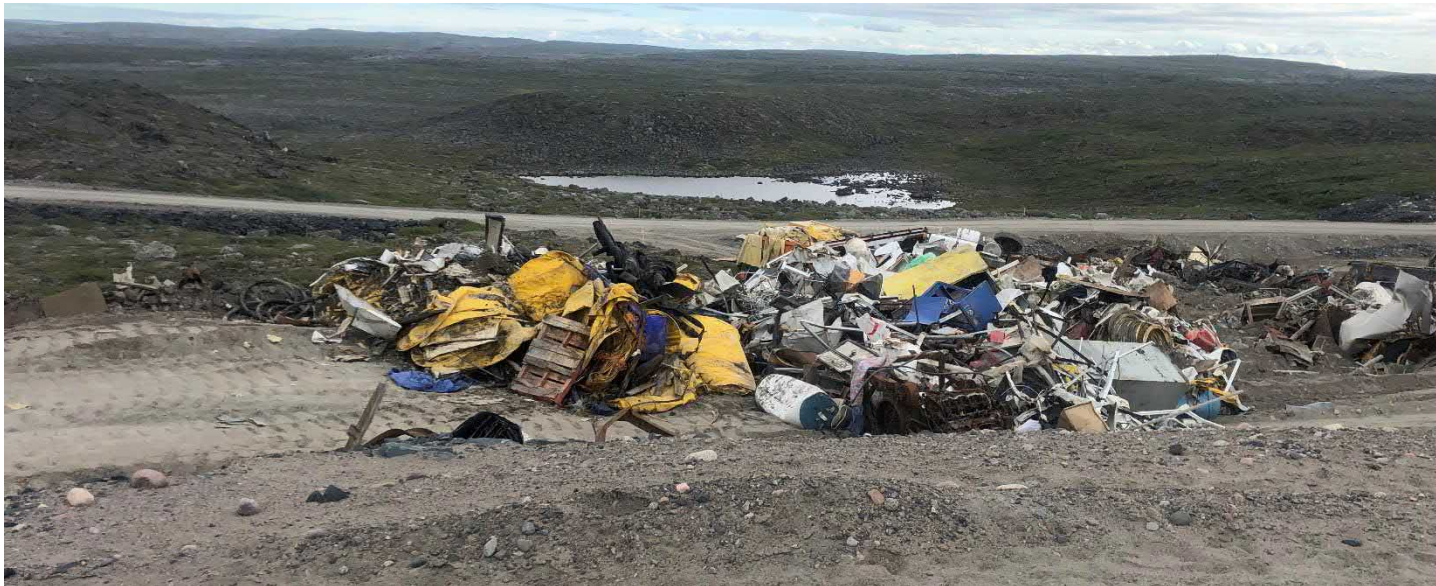
The north side of the site facing south on August 2, 2021

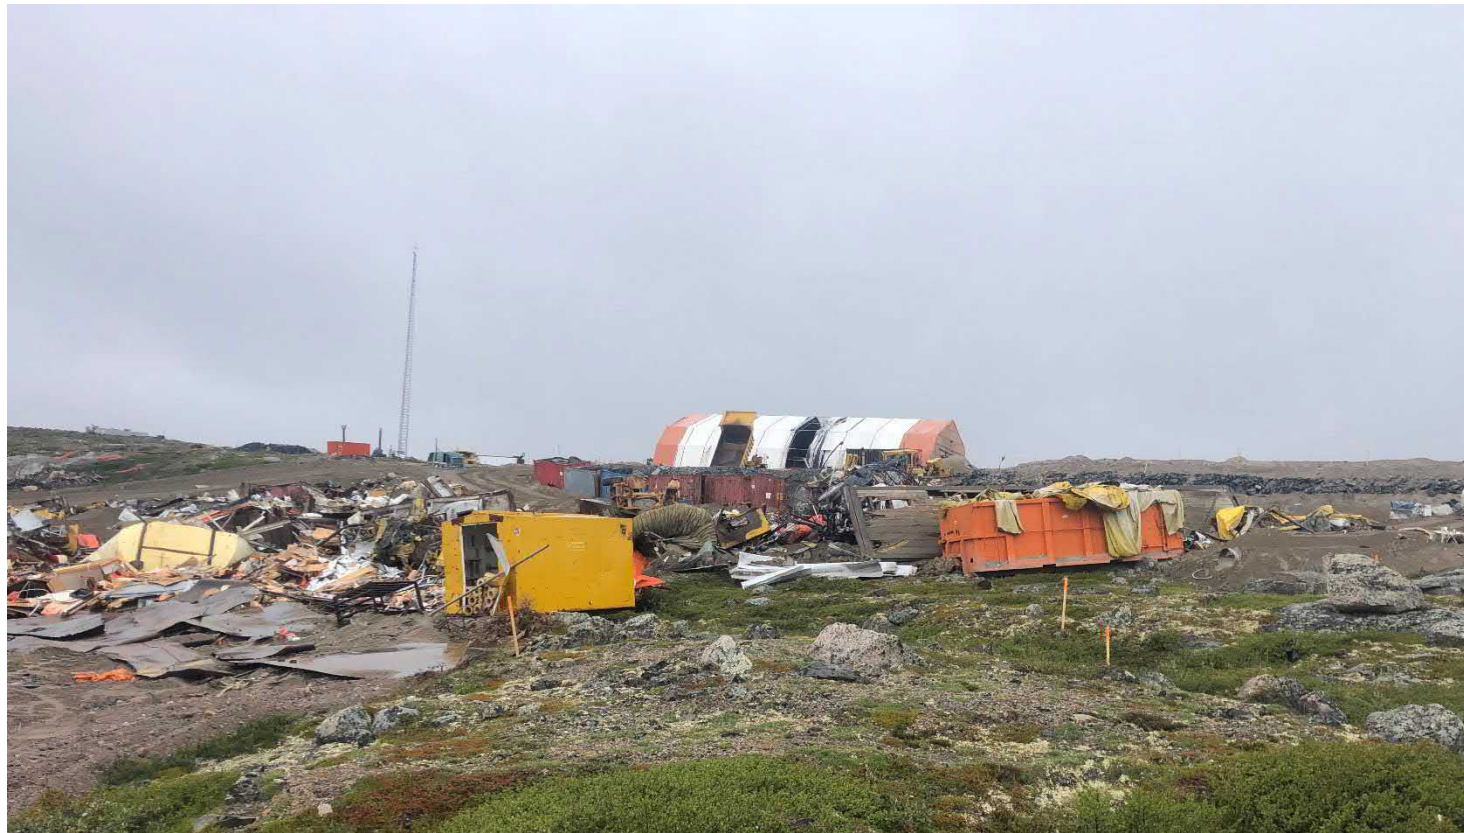
The south side of the site facing north on August 3, 2021

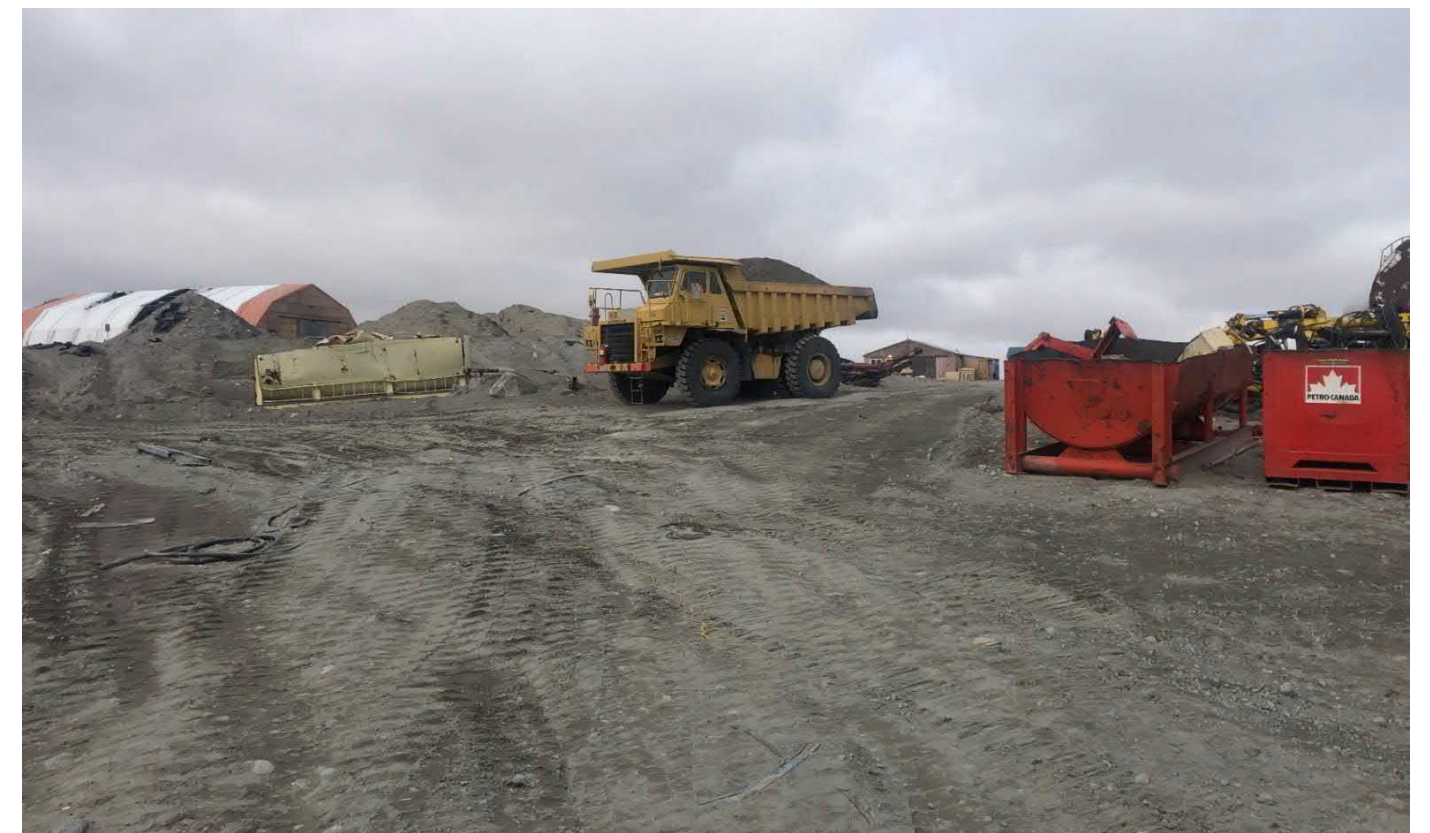
Unloading esker sand on August 3, 2021

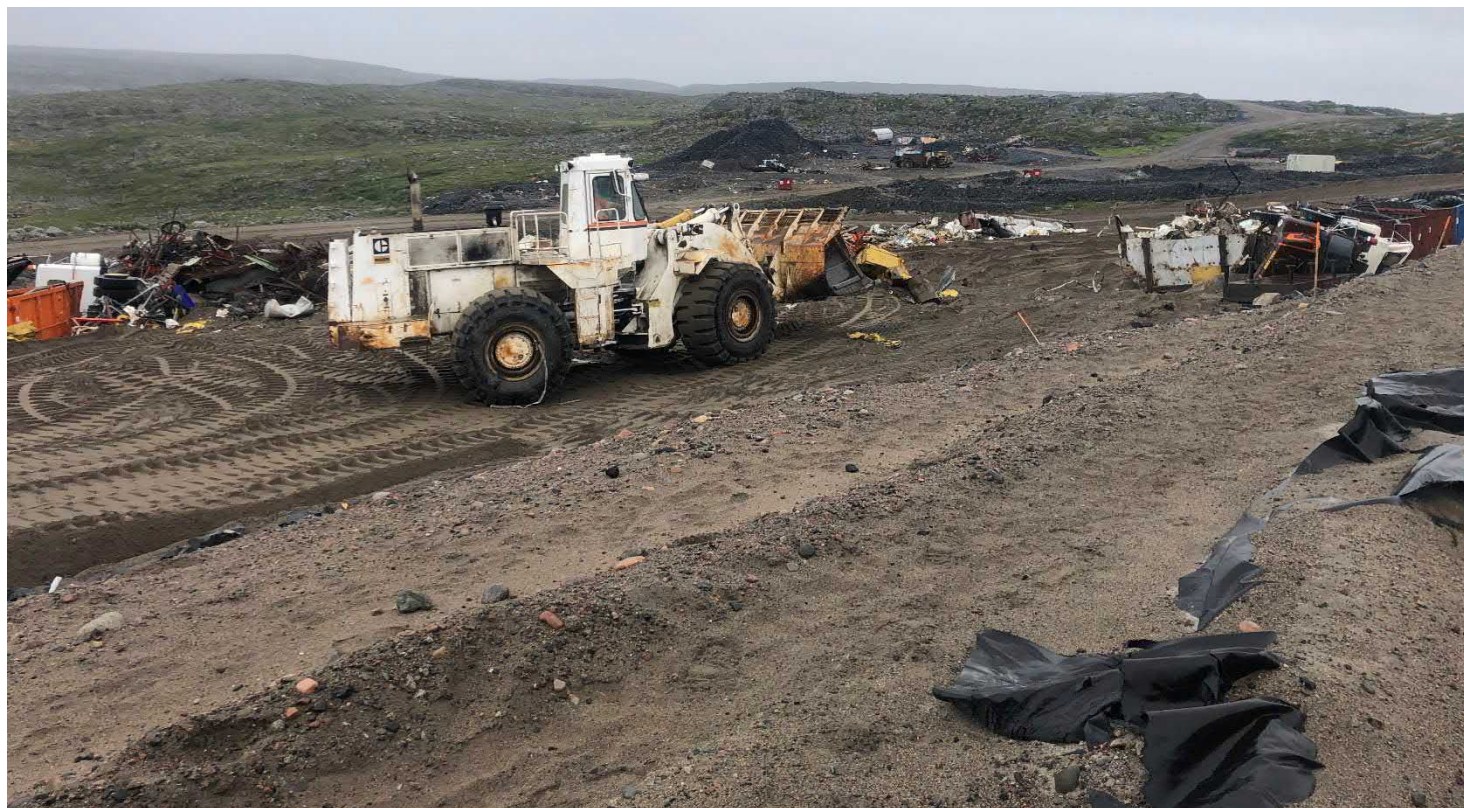
The northeast side of the site facing southwest on August 3, 2021

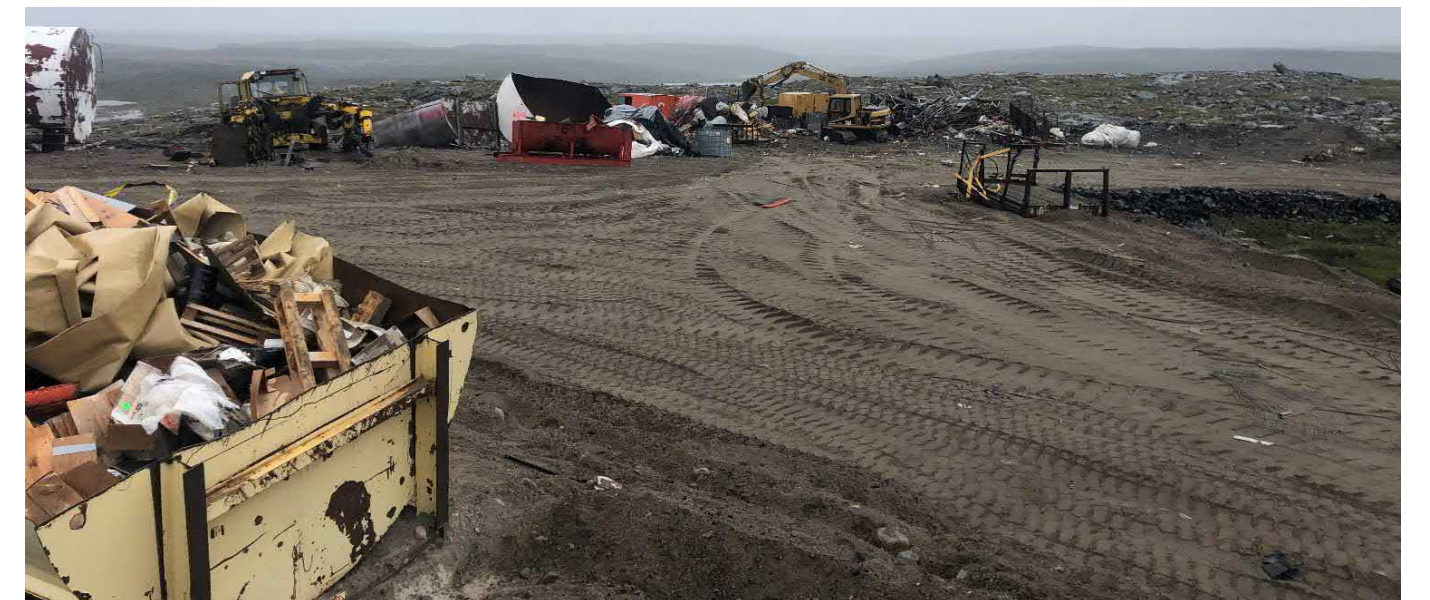
Loading waste in tanks on August 3, 2021

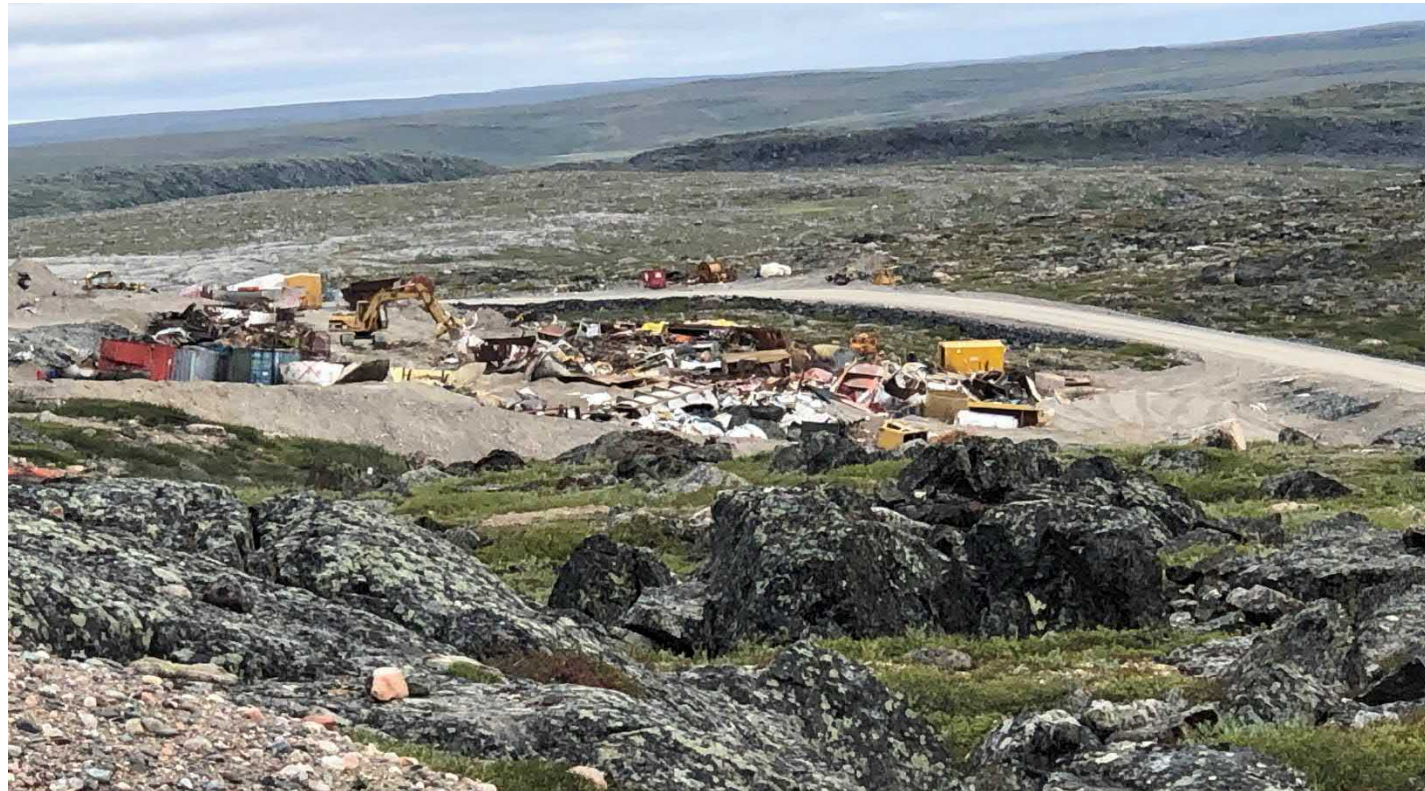
The west side of the site facing east with material placement on August 7, 2021

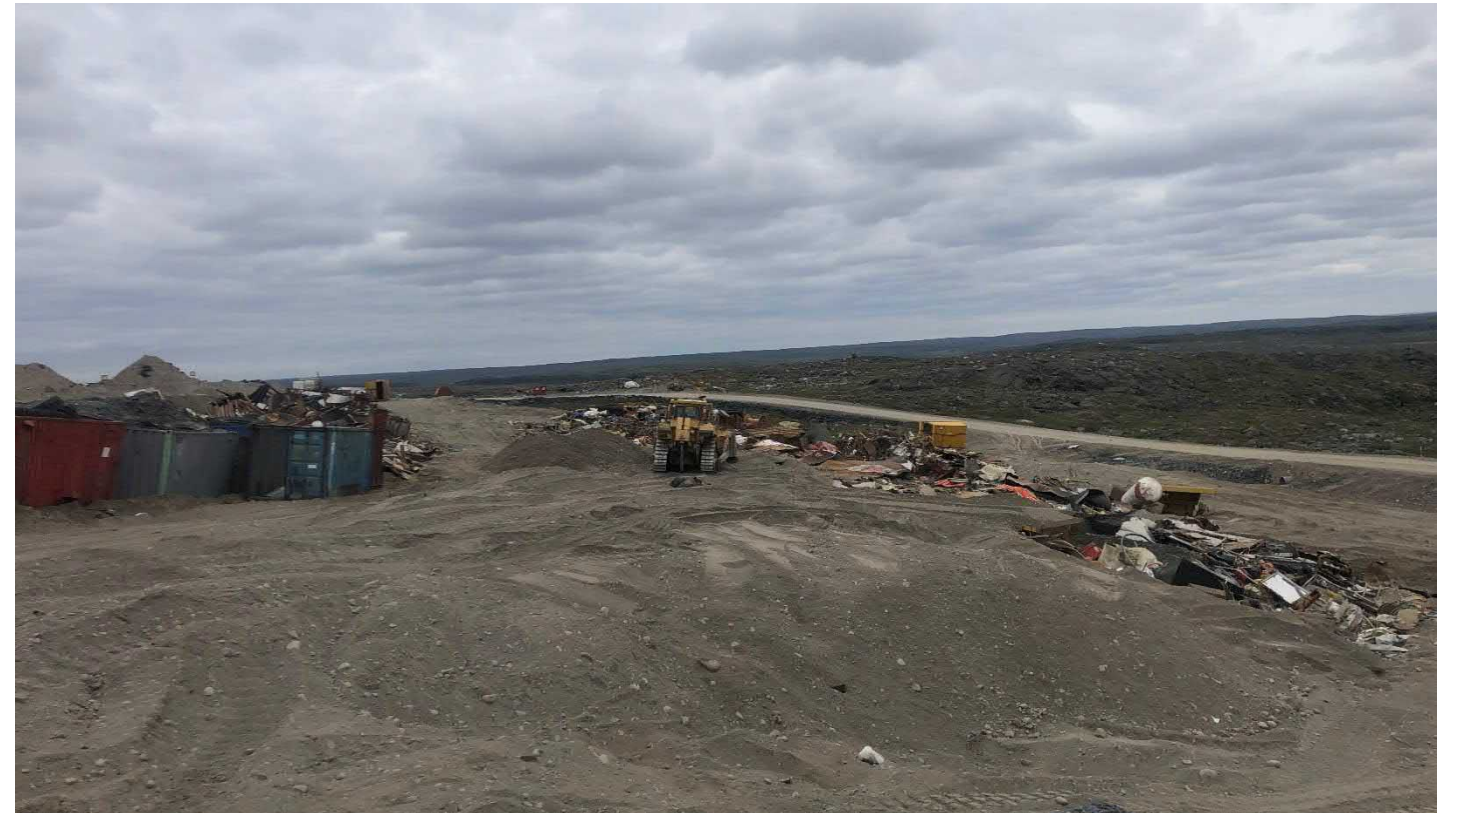
The west side of the site facing east on August 9, 2021

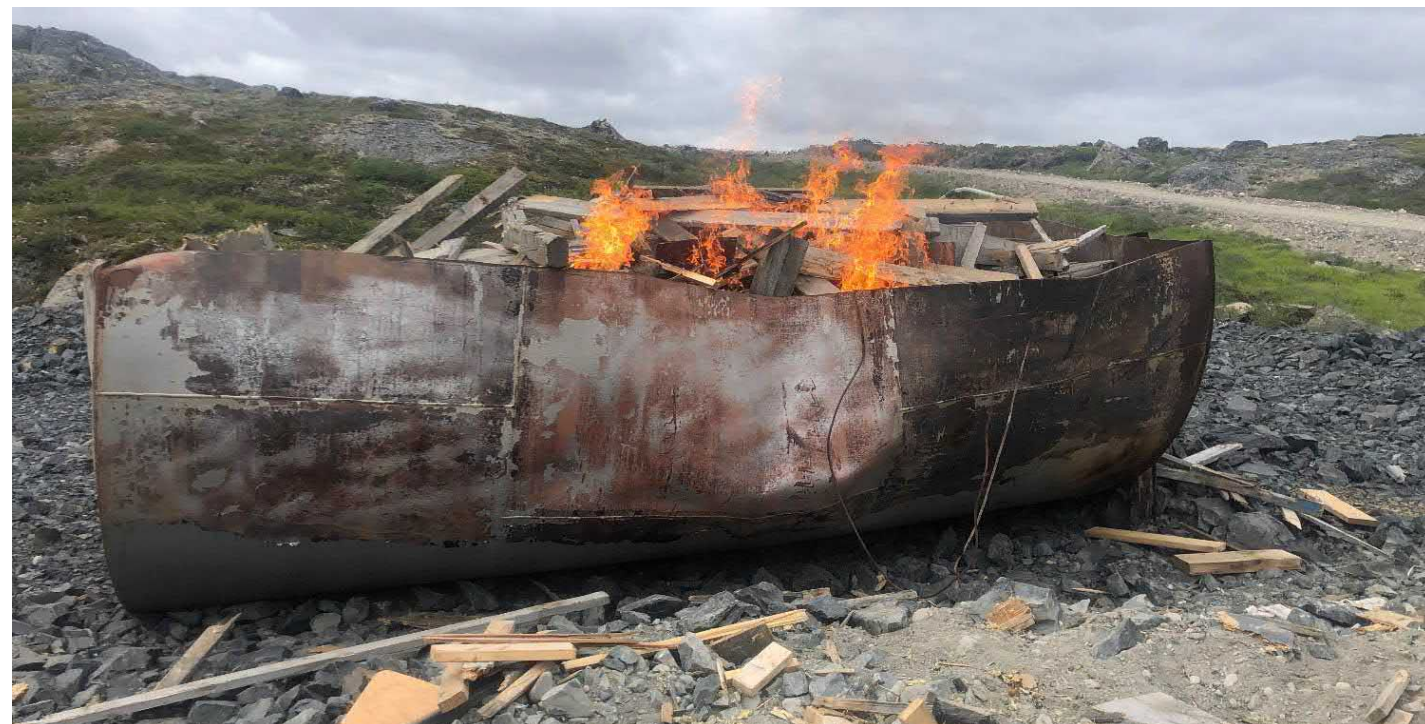
Burning of clean wood on August 9, 2021
