Interim Closure and Reclamation Plan
Ulu Gold Project
(including Hood River, Roma and other licensed projects)

Kitikmeot Region, Nunavut

NOVEMBER 2025

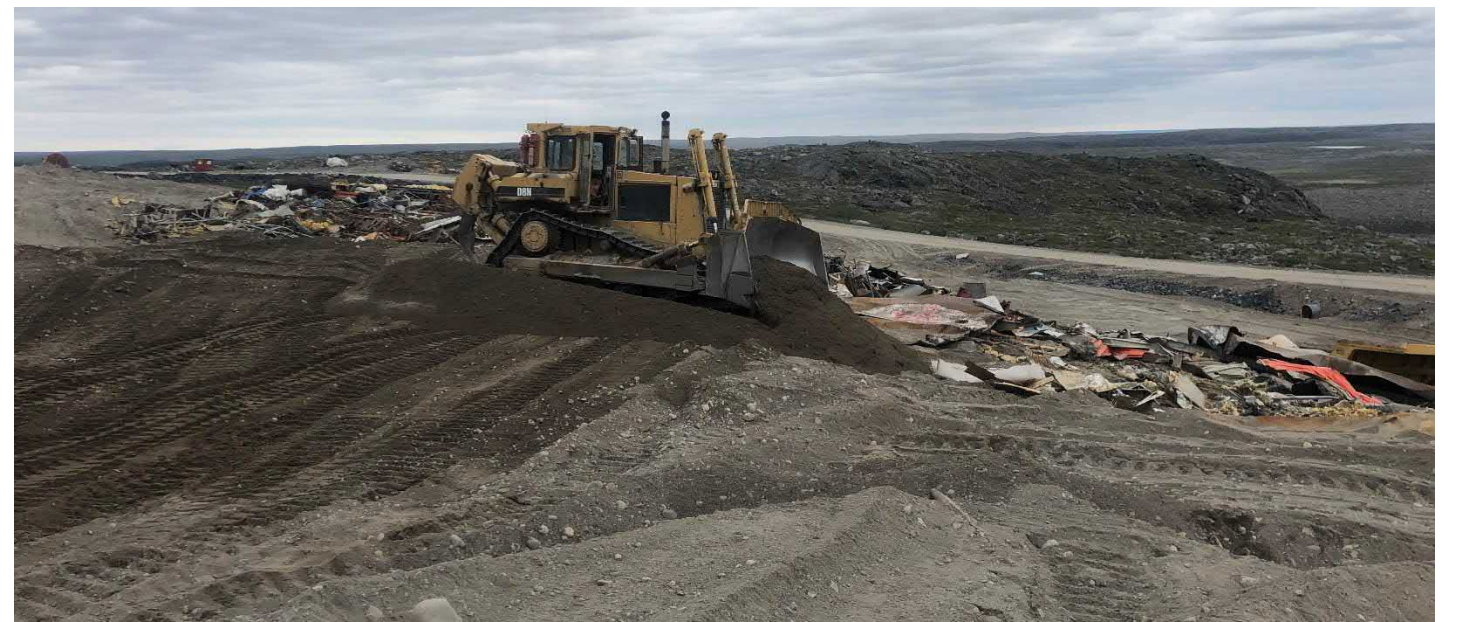
Placing esker sand on August 9, 2021

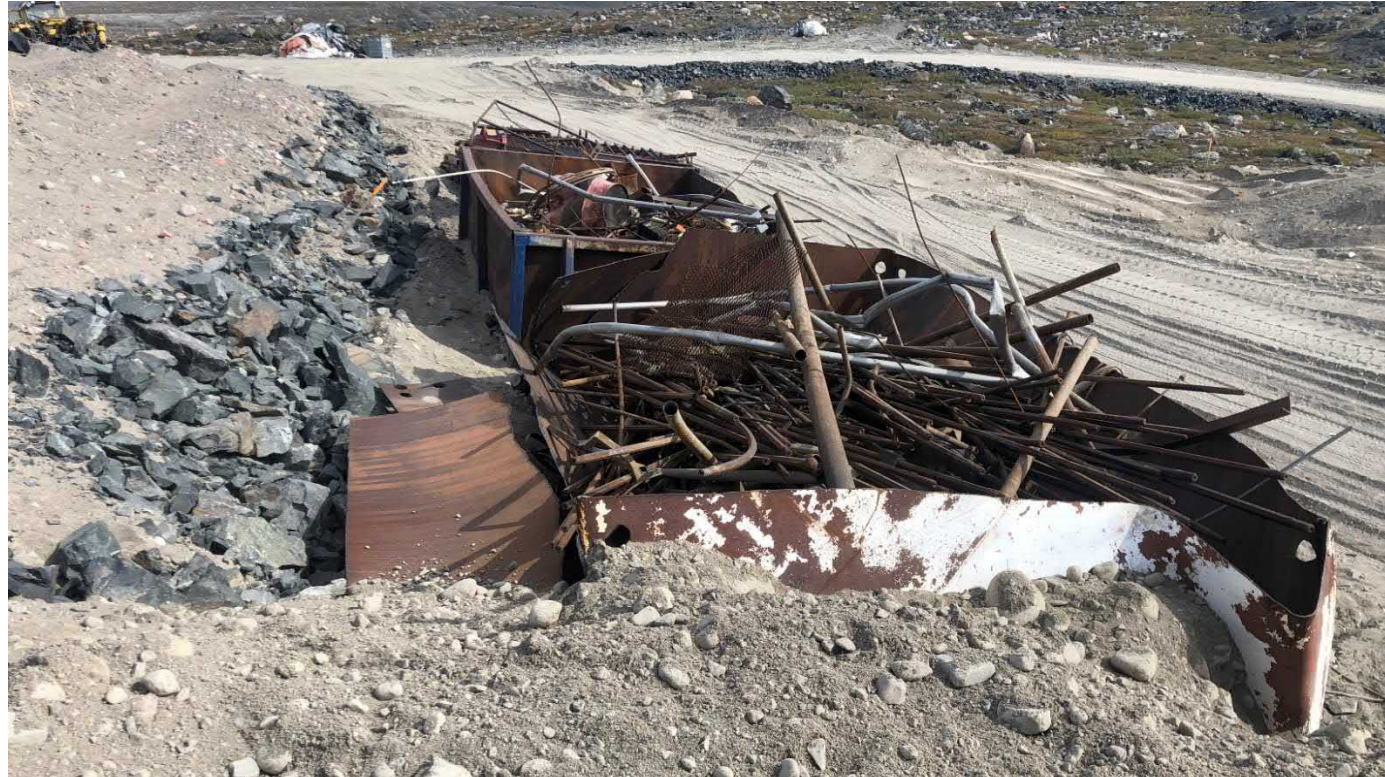
Steel in the shipping containers on August 16, 2021

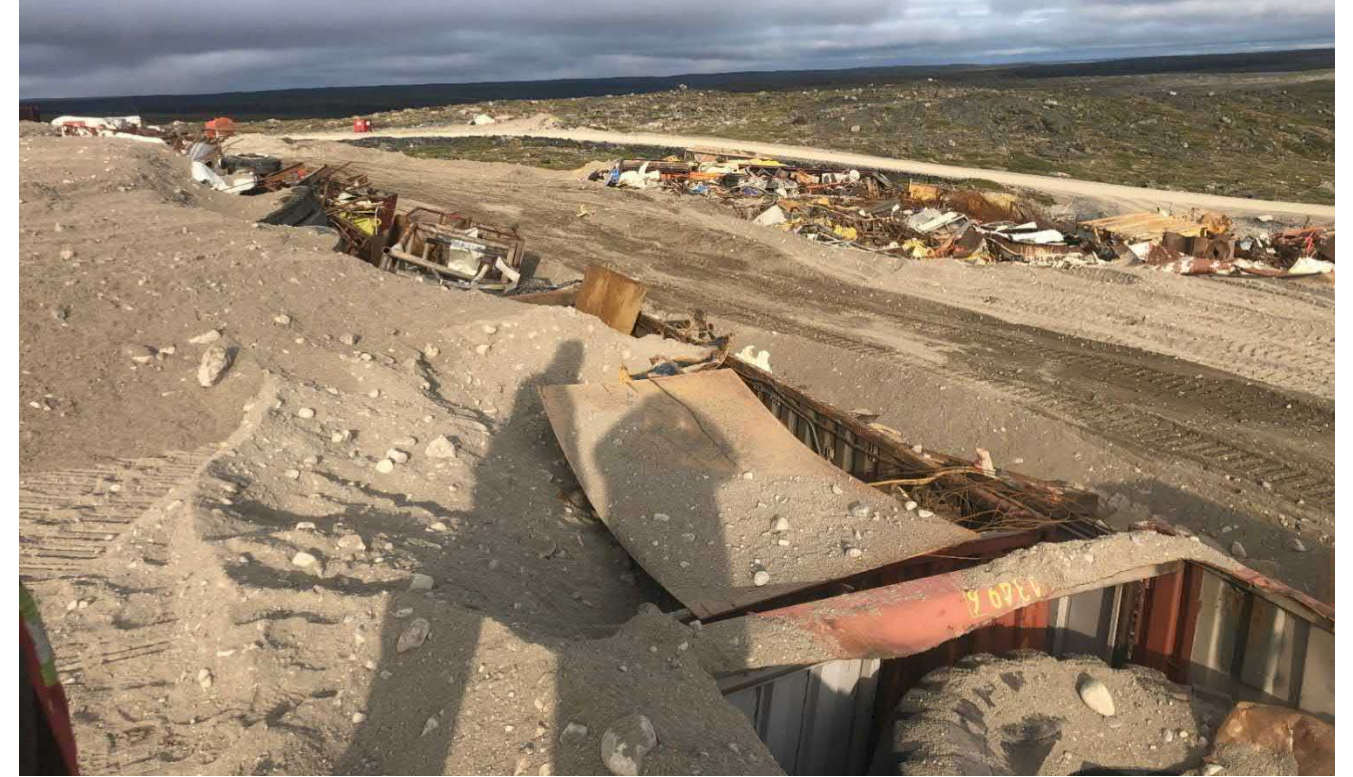
The northwest side of the site facing southeast on August 10, 2021

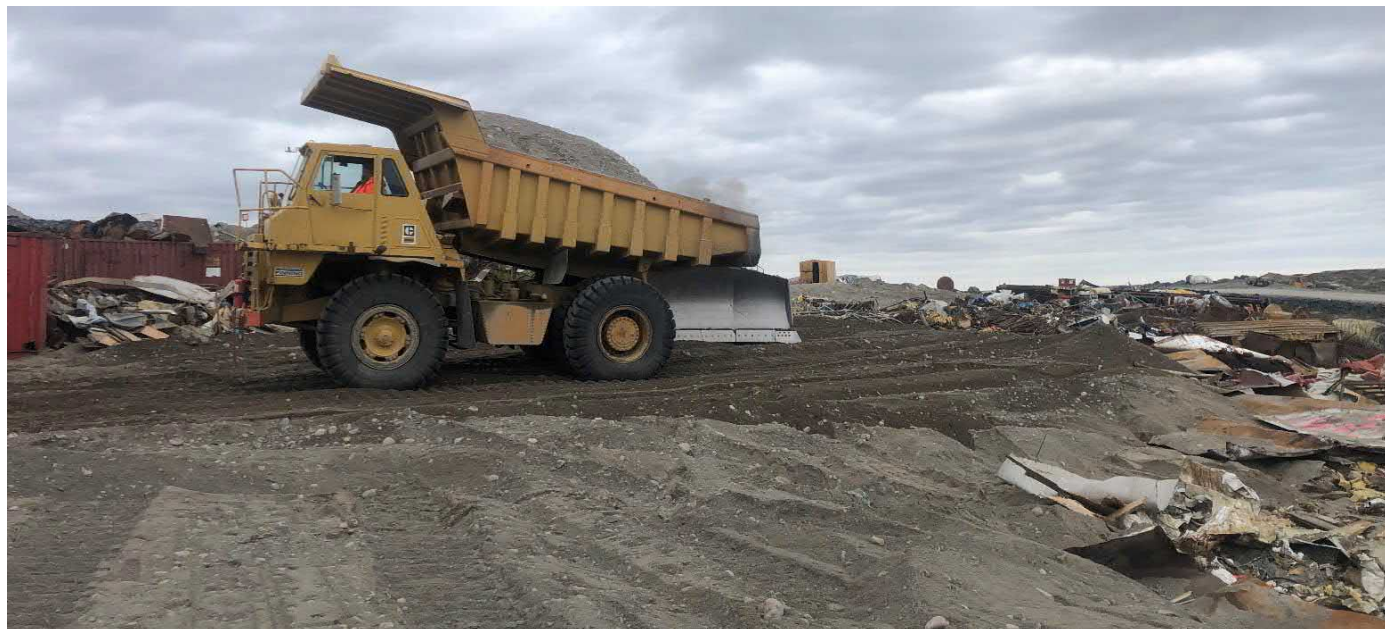
The north side of the site facing south with esker void fill and cover on August 9, 2021

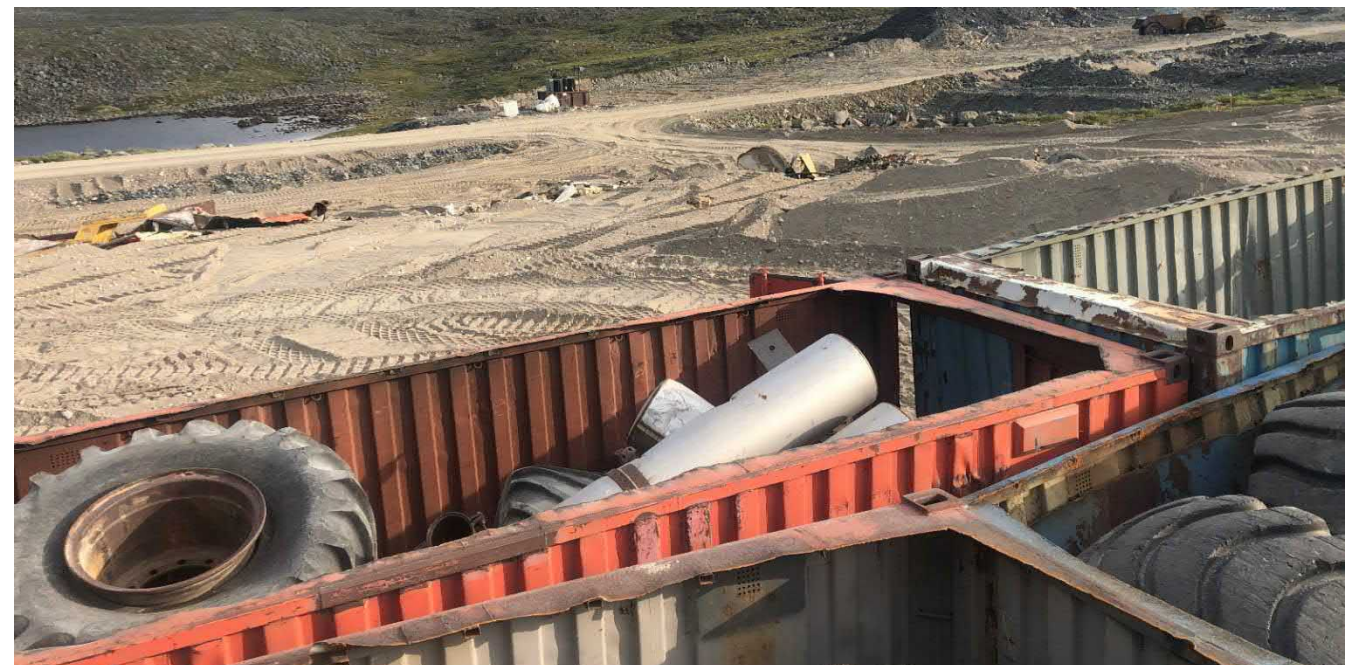
Tires in the shipping containers. August 10, 2021

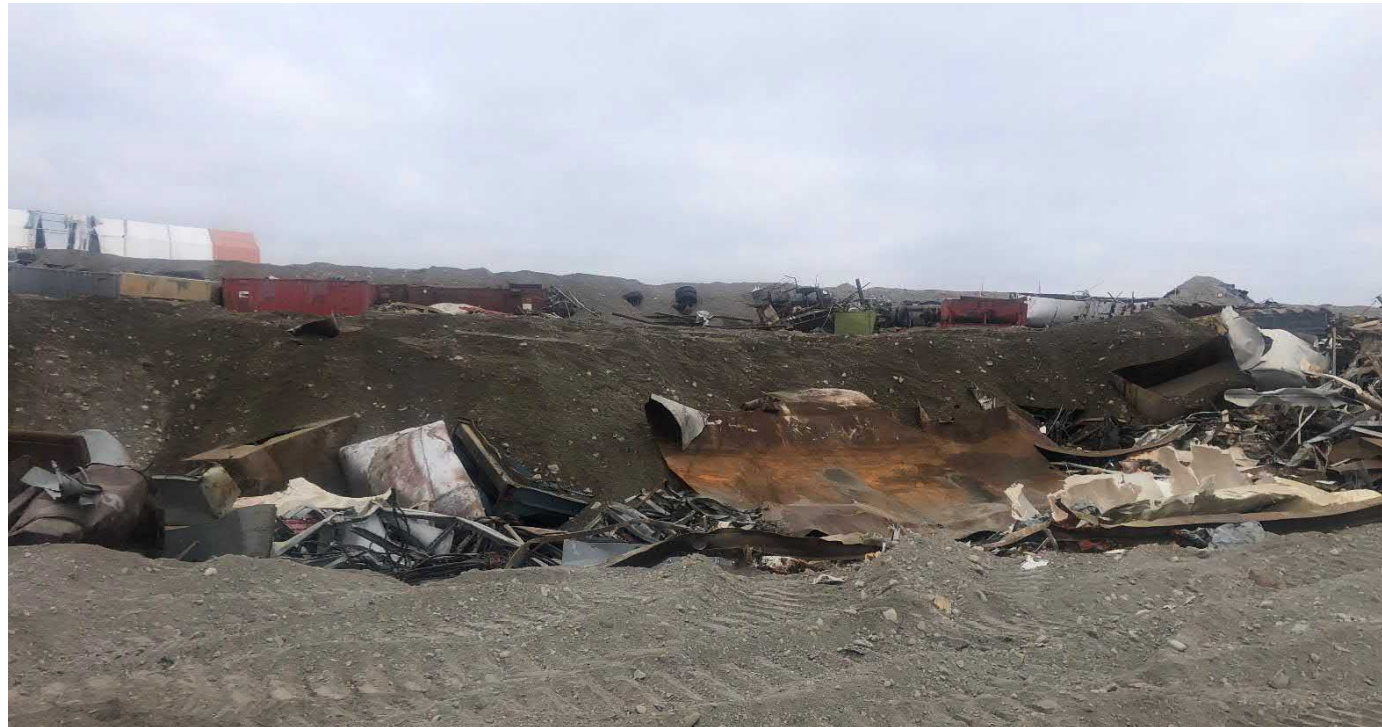
The south side of the site facing north on August 12, 2021

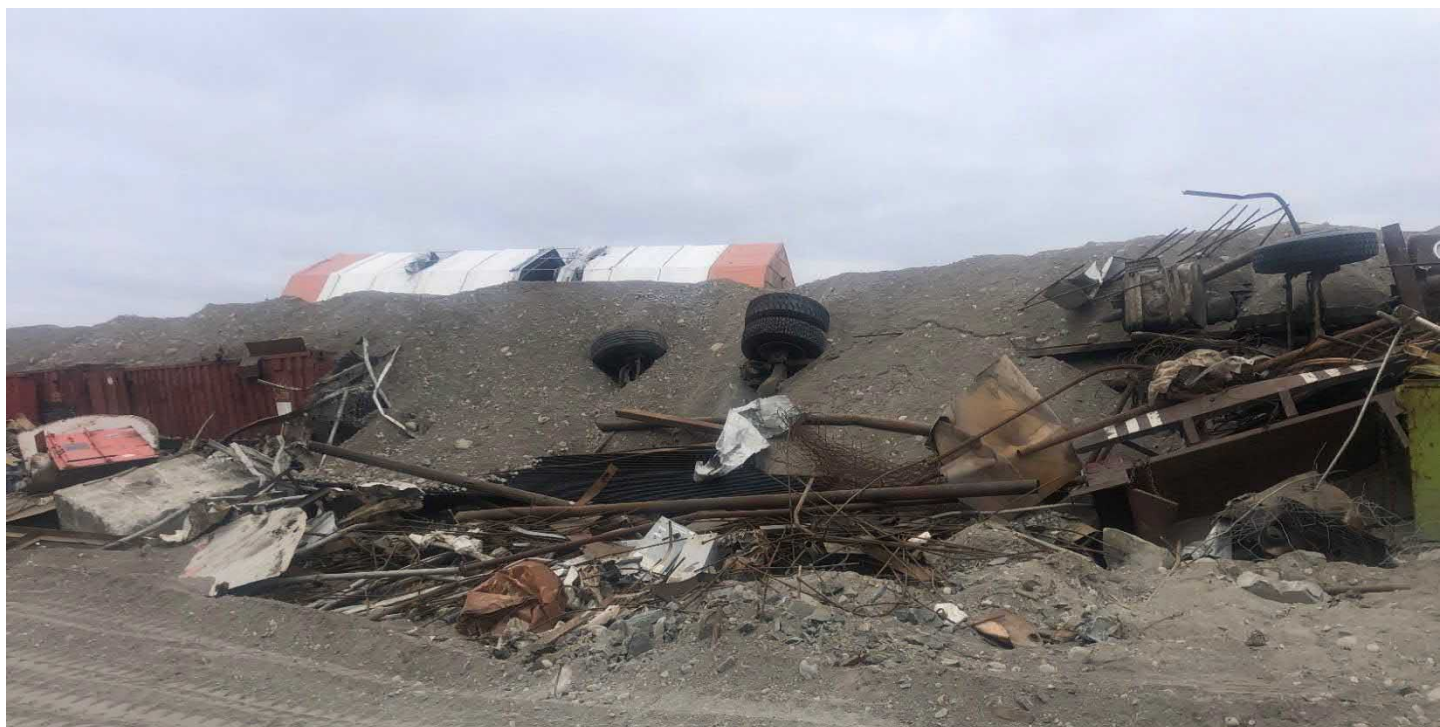
The south side of the site facing north on August 12, 2021

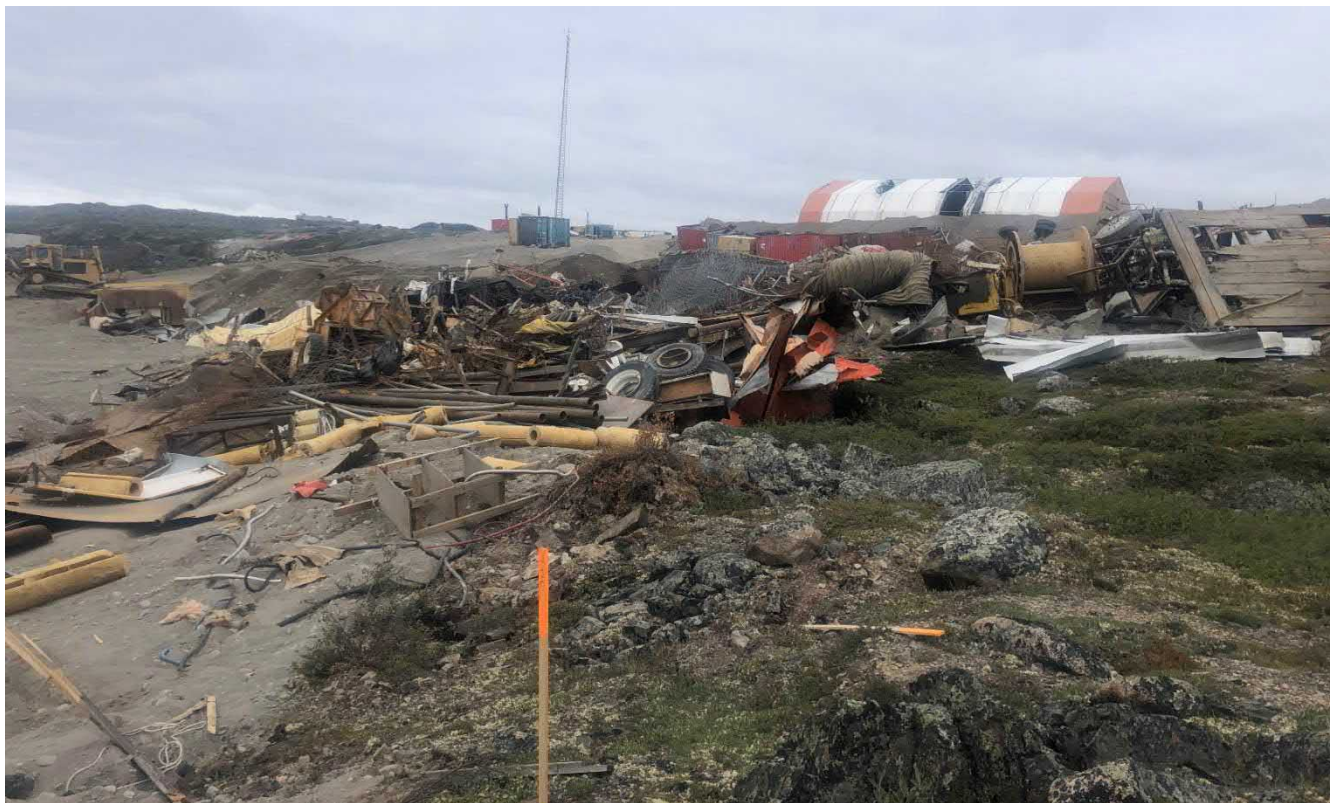
The east side of the site facing west on August 12, 2021

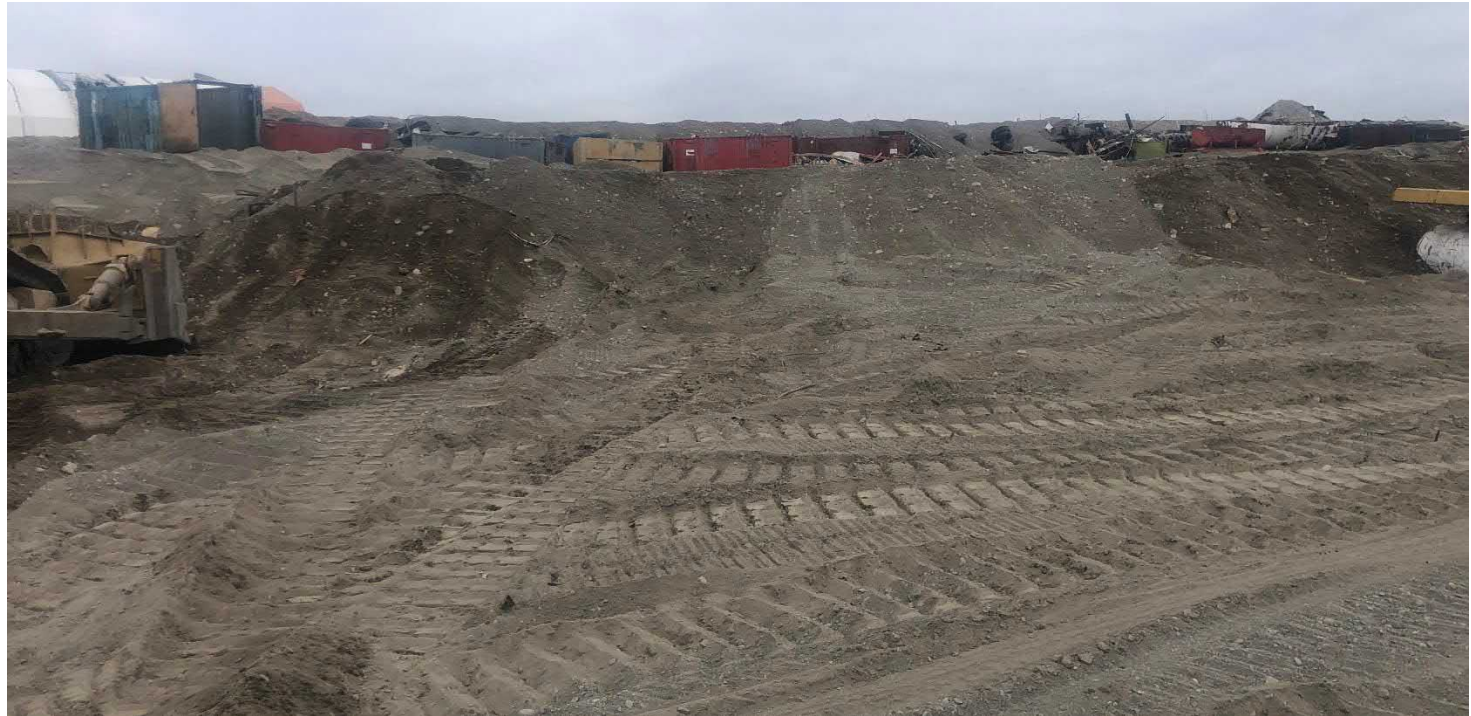
The south side of the site facing north. August 12, 2021

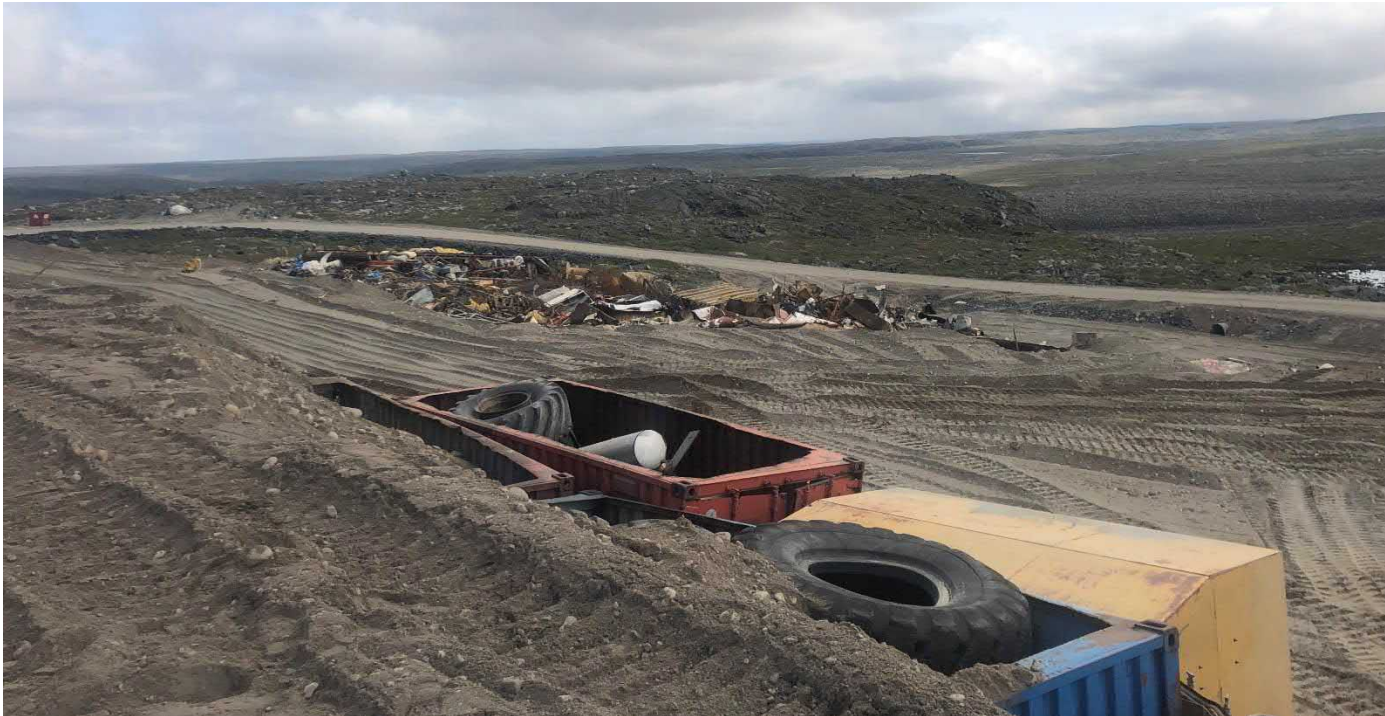
Esker sand placed over waste. August 10, 2021

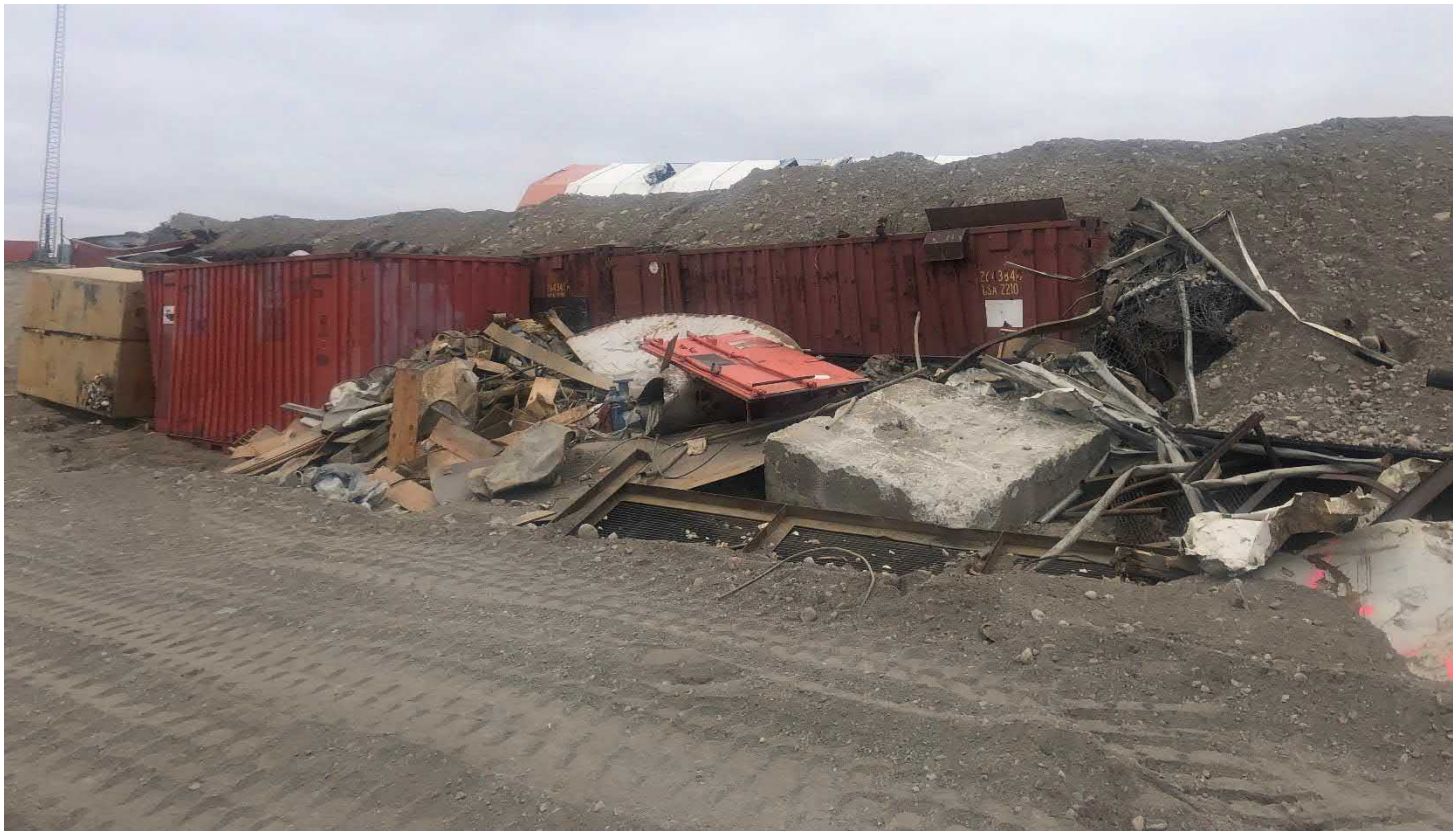
Concrete block placement on August 12, 2021

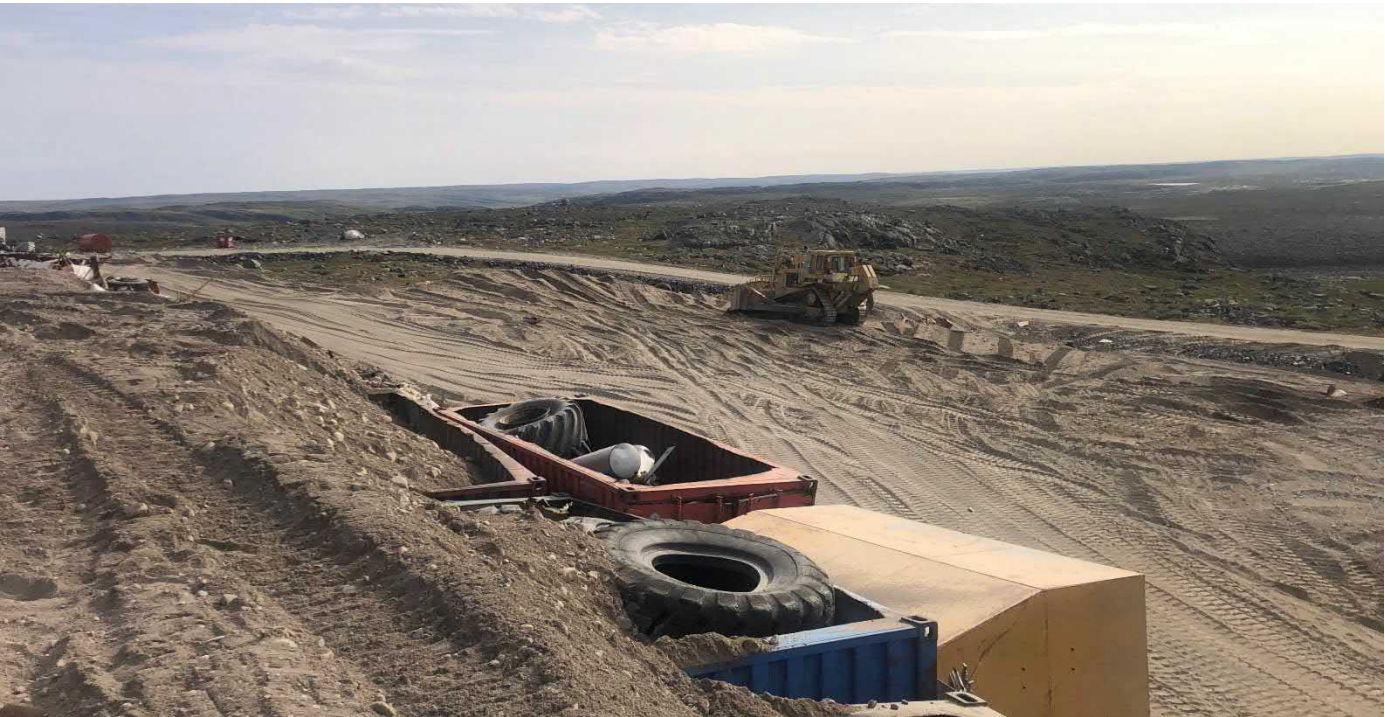
Esker sand placed over waste. August 13, 2021

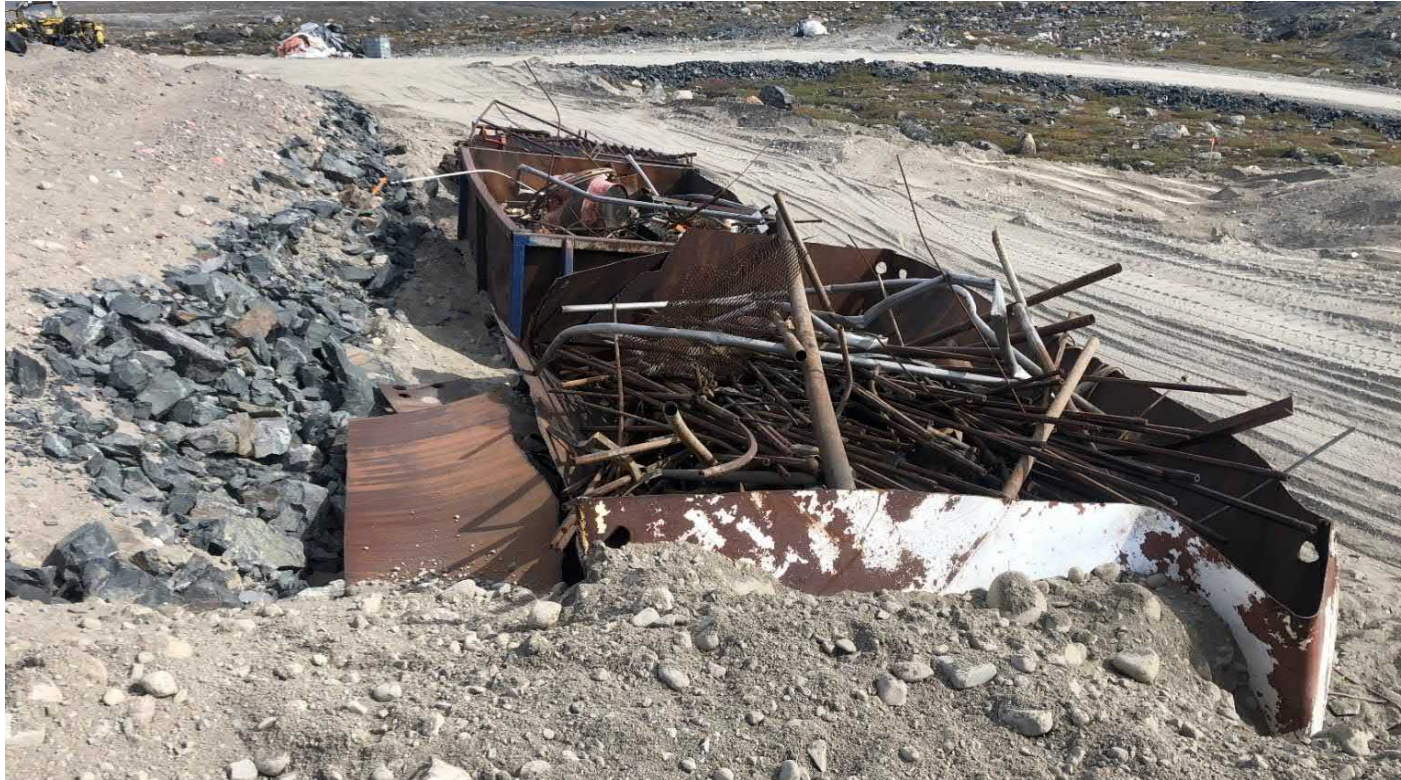
Steel in the shipping containers. August 16, 2021

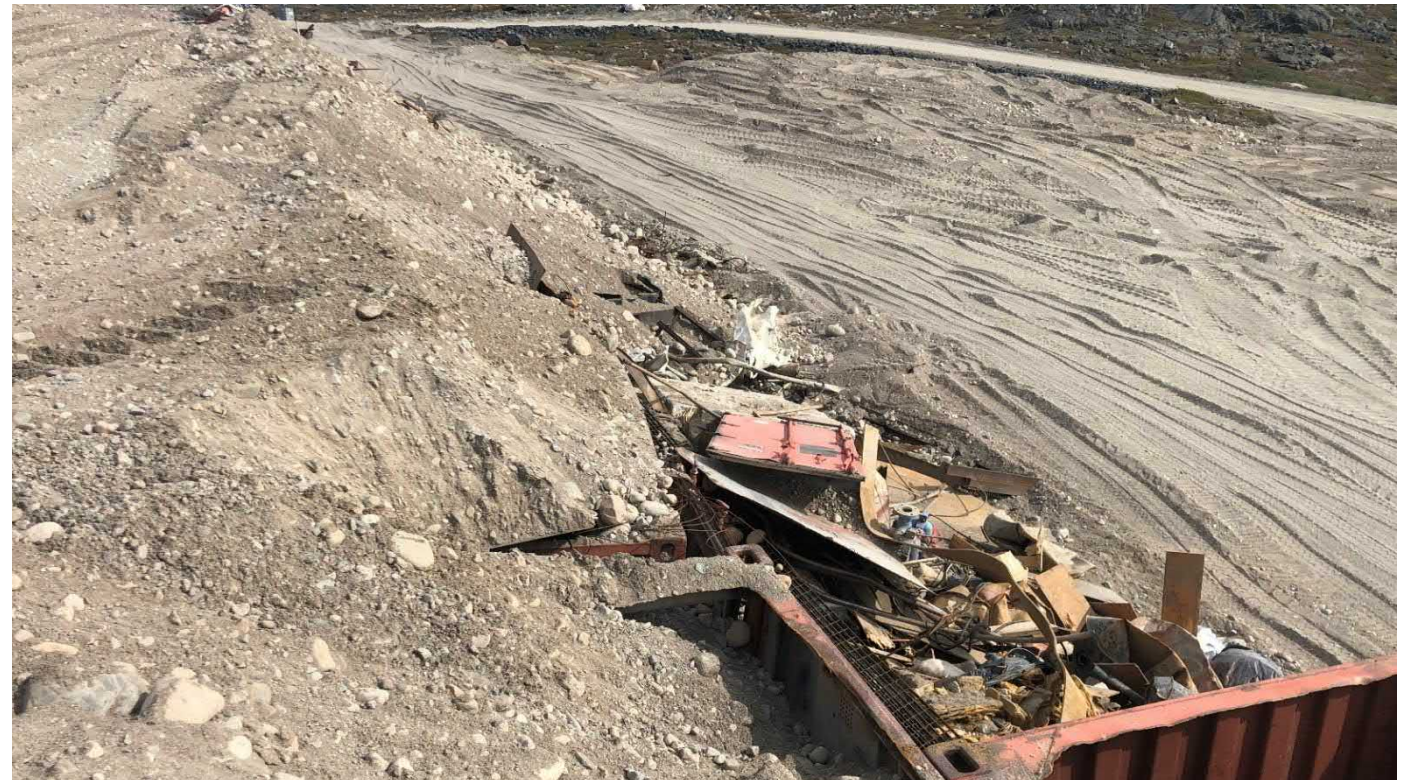
Esker sand cover. August 16, 2021

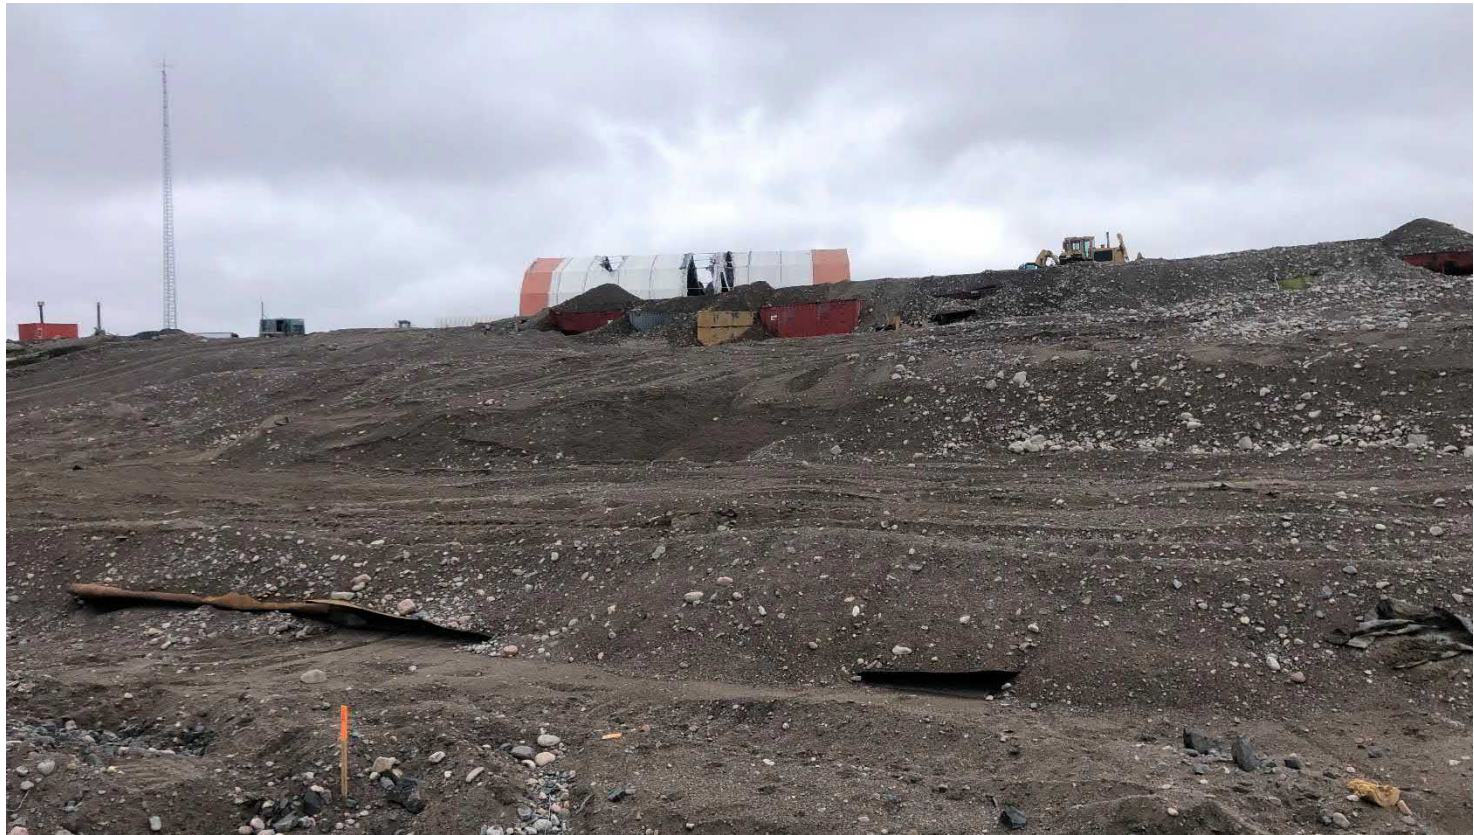
The south side of the site facing north on August 19, 2021

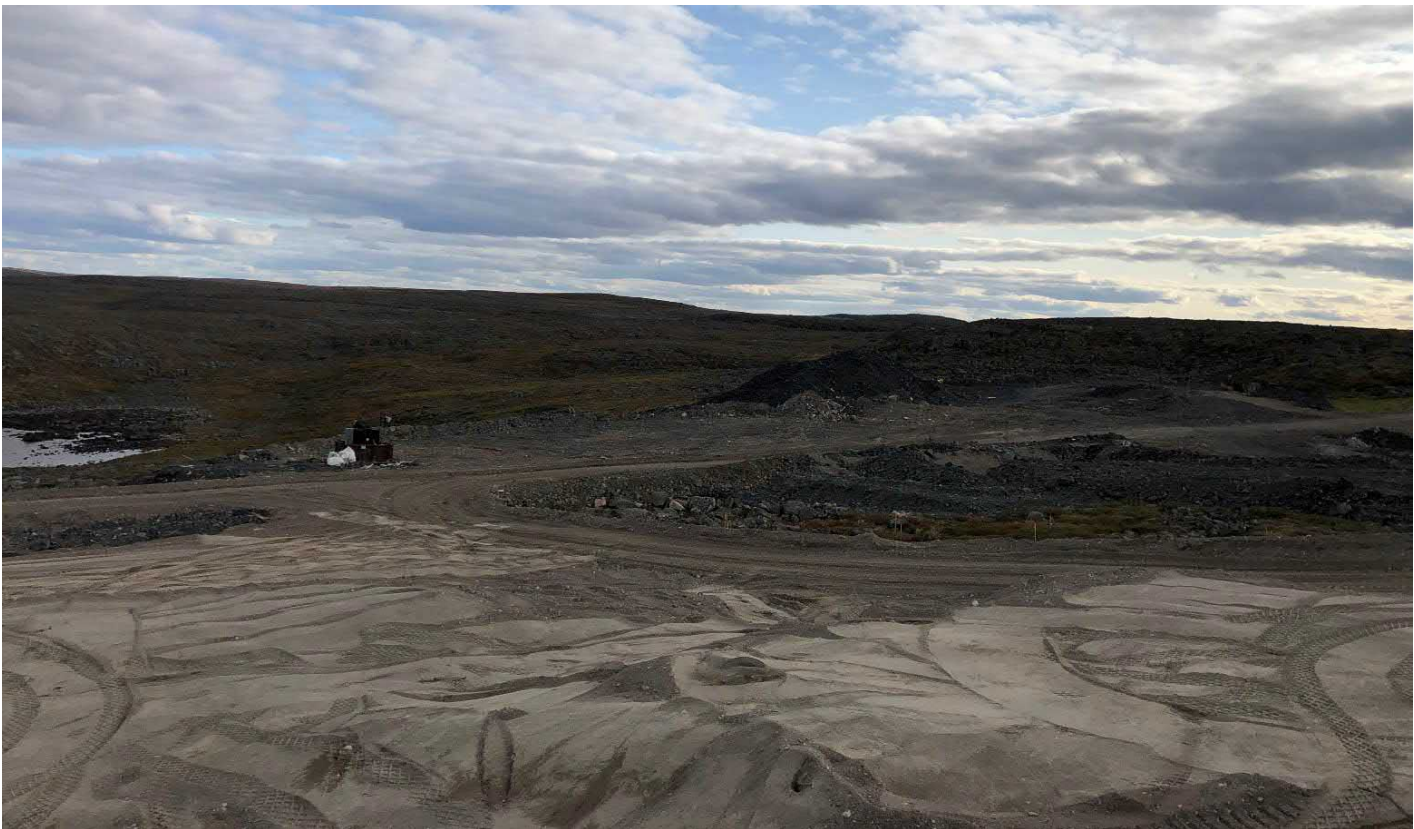
The north side of the site facing southwest with interim cover compaction on August 19, 2021

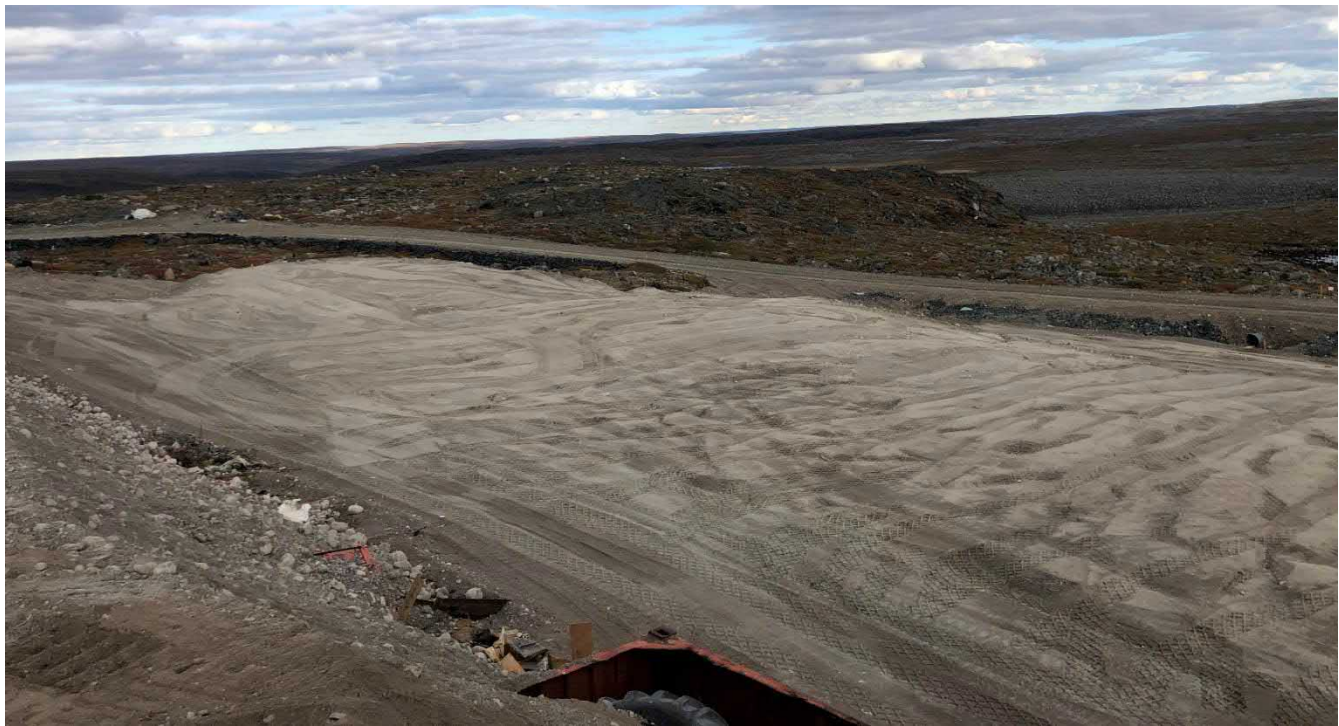
The north side of the site facing southeast with interim cover compaction on August 19, 2021
