**City of Iqaluit Geraldine Dam
Permanent Record File
Iqaluit, Nunavut**

PRODUCED FOR:
City of Iqaluit

CONCENTRIC ASSOCIATES INTERNATIONAL INCORPORATED

November 4, 2011

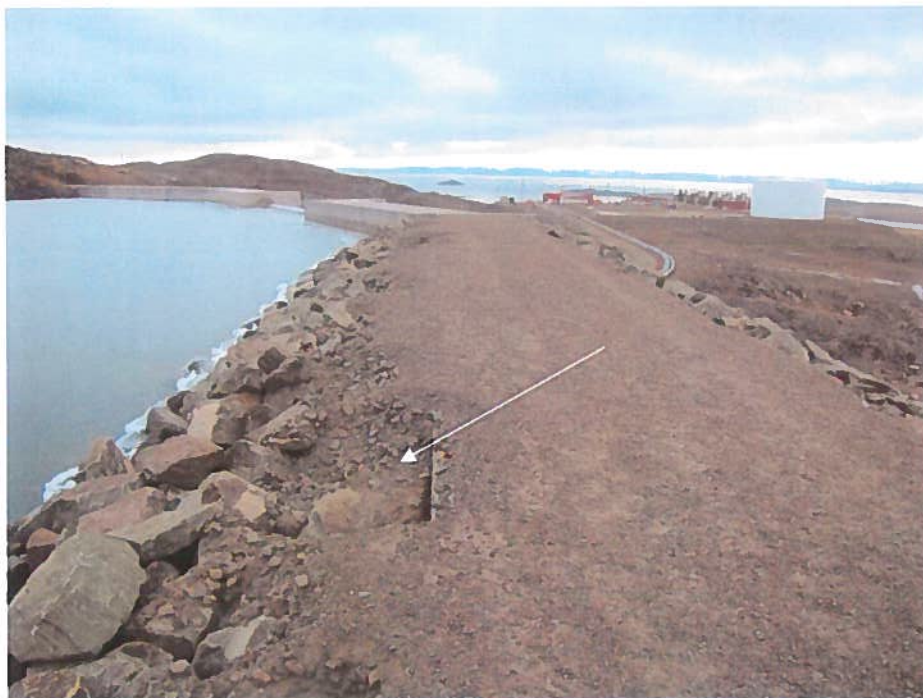
- The 2011 grouting program is to include berm repairs due to wave scour that occurred in the summer of 2010.

North Berm Localized Wave Scour; 2010.

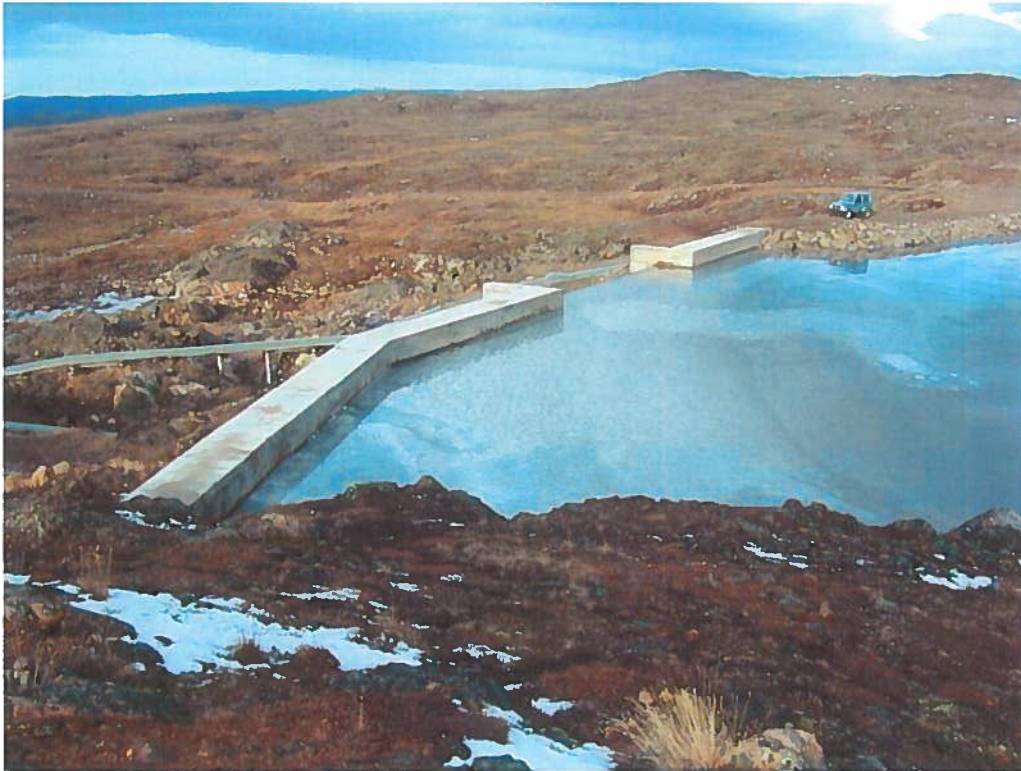
Photograph No. 1 – Lake Geraldine Dam overview, upstream side, looking northwest.

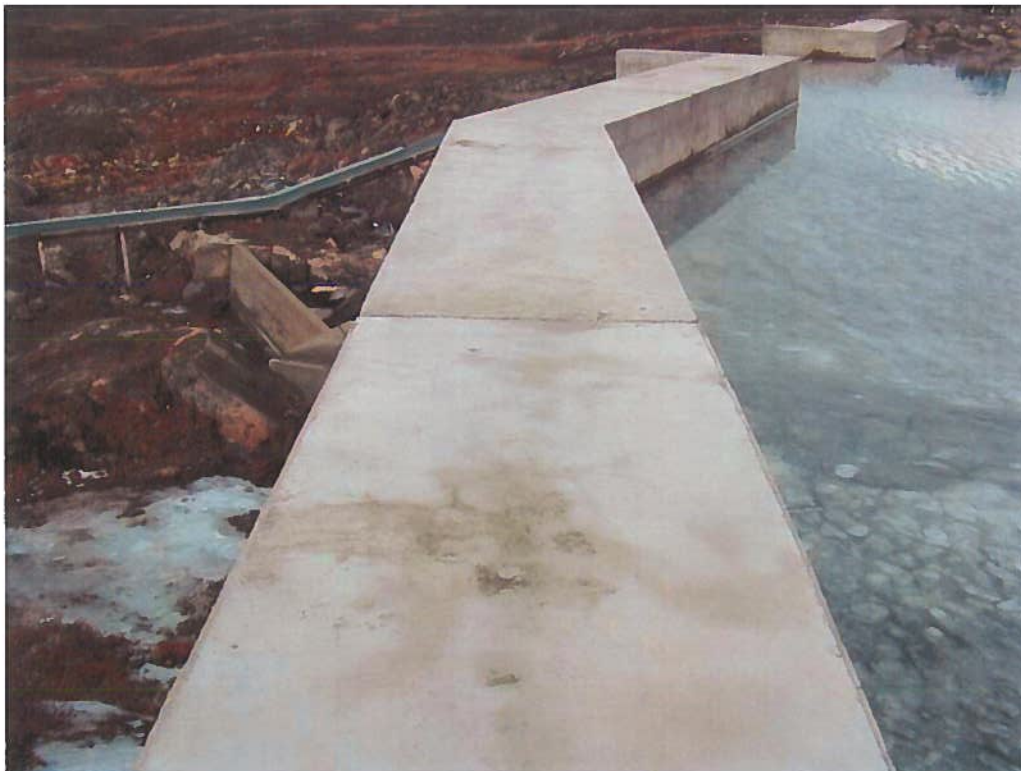
Photograph No. 2 – Top of Gravity Dam, looking northwest.

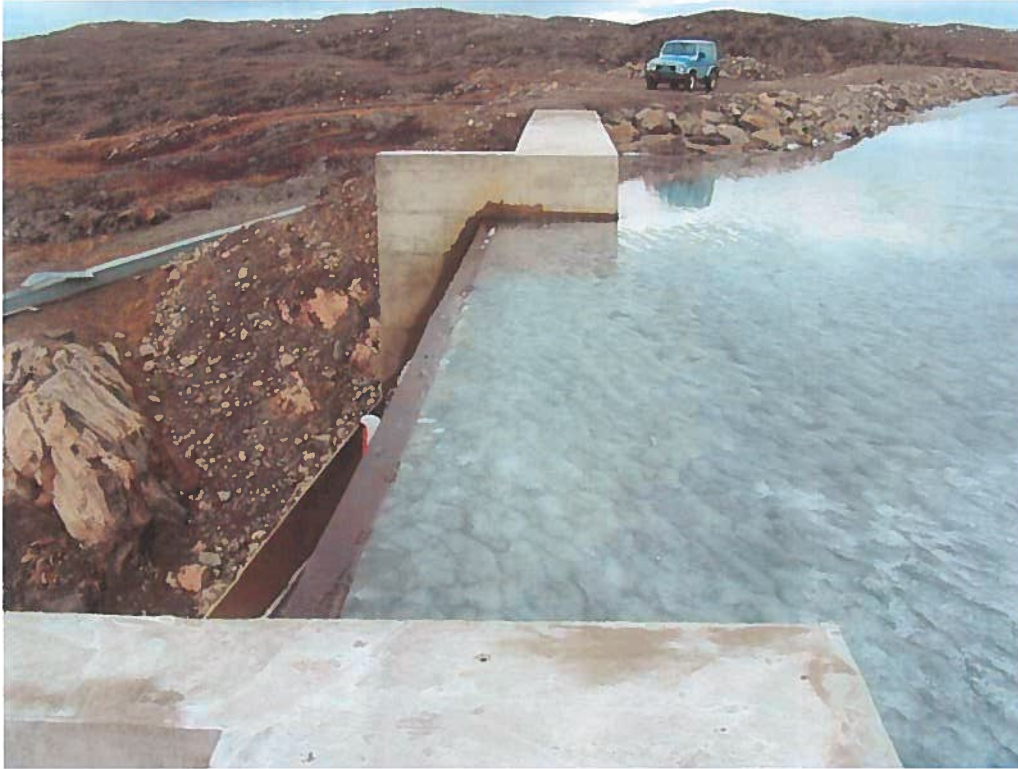
Photograph No. 3 – Spillway section, looking northwest.

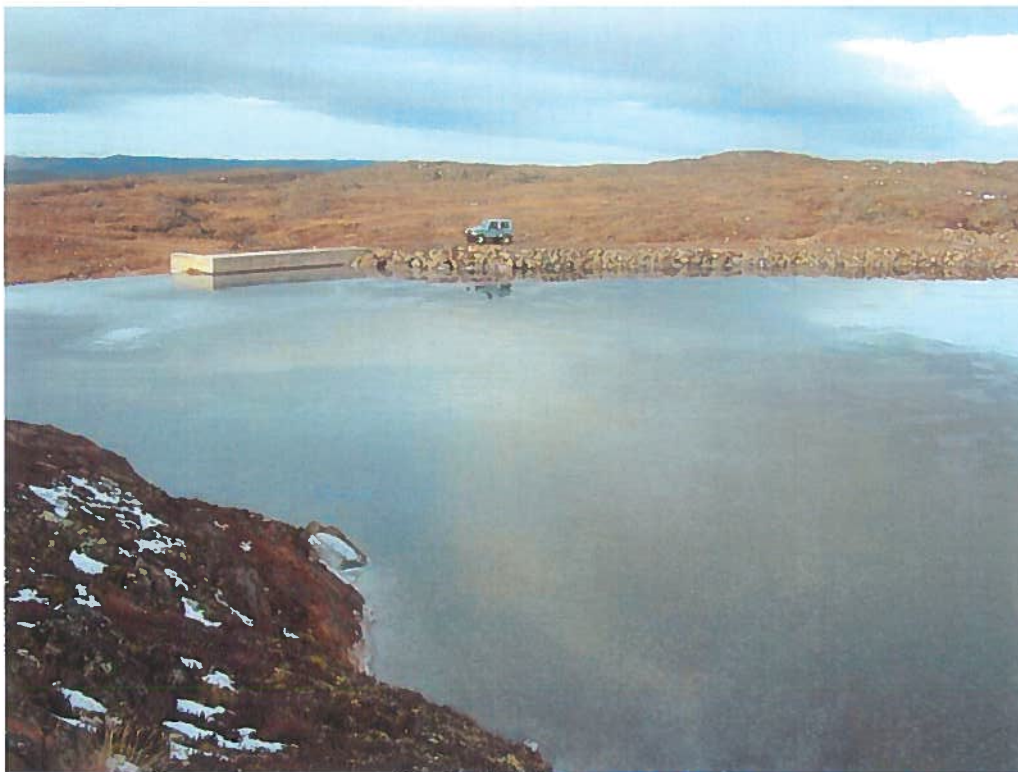
Photograph No. 4 – Lake Geraldine Reservoir, looking northwest to embankment portion of dam. Spillway section is at extreme left.

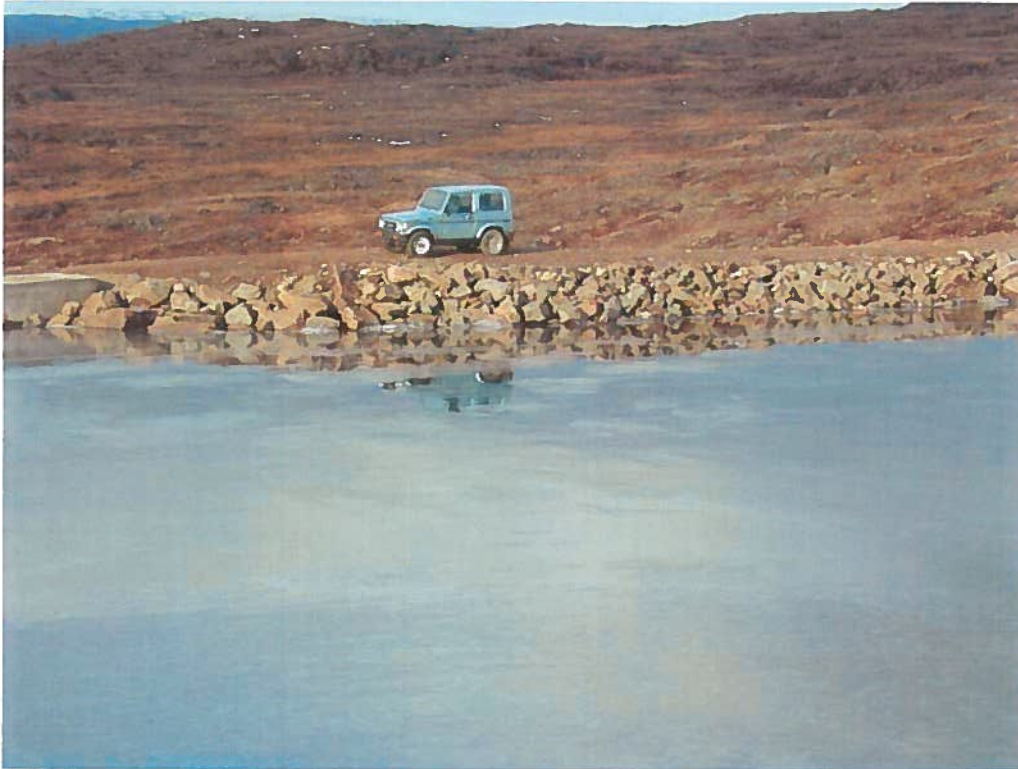
Photograph No. 5 – Close-up of embankment portion at tie-in with Gravity section (at left), upstream face.

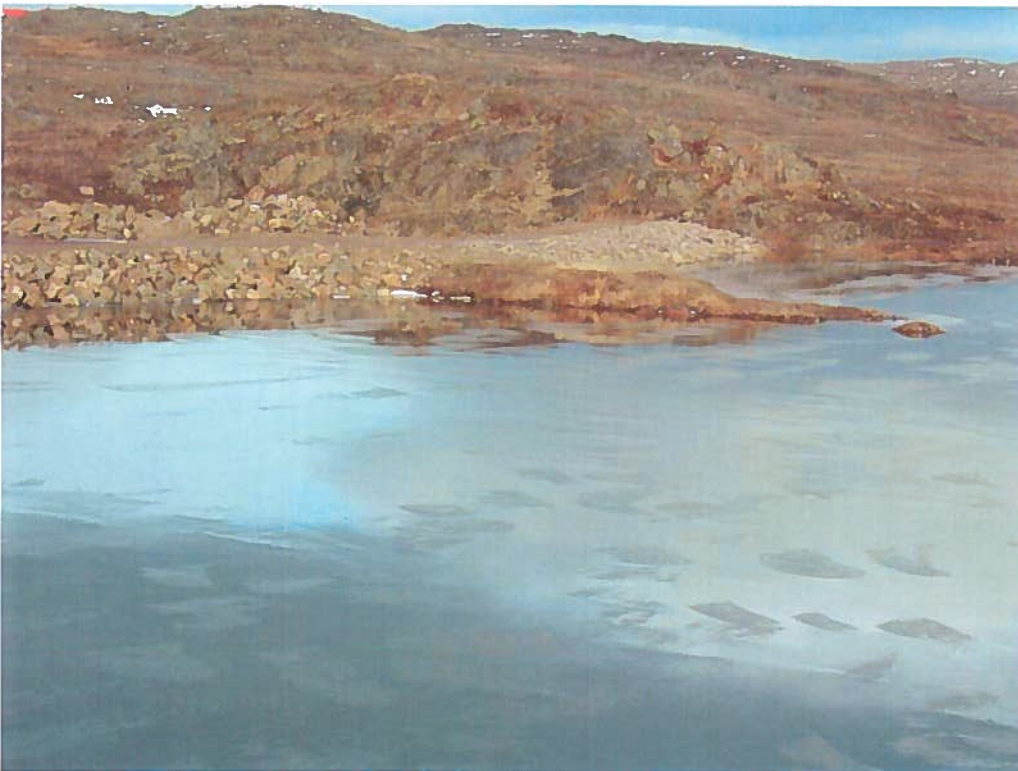
Photograph No. 6 – Close up of embankment portion at north termination, upstream face.

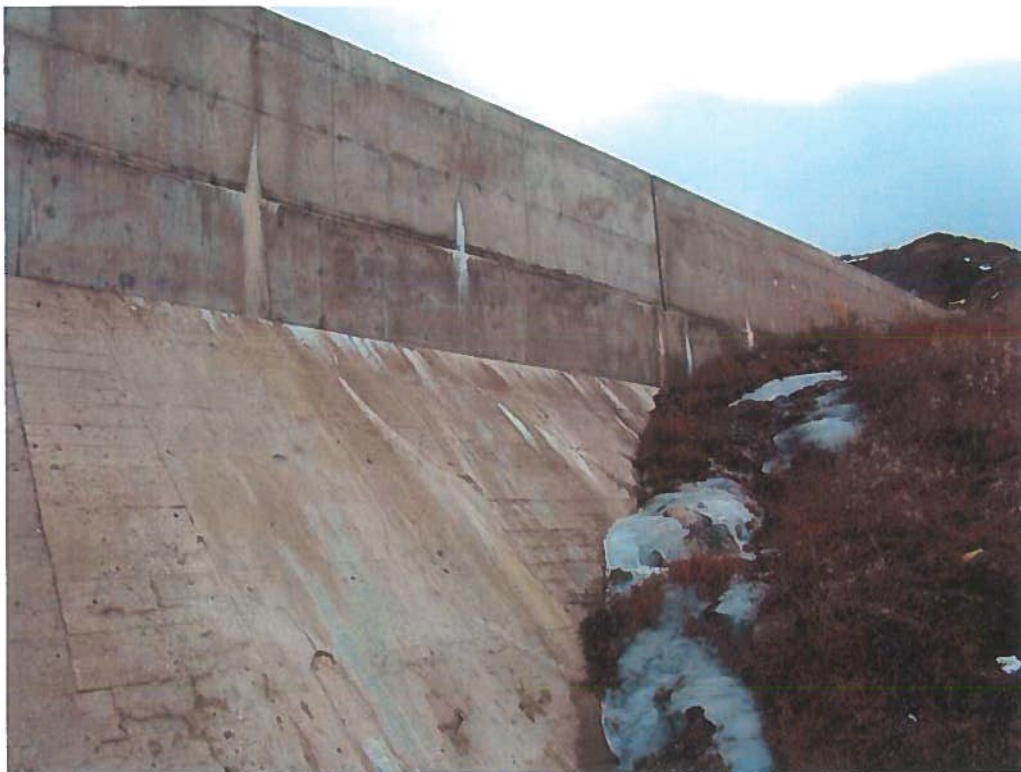
Photograph No. 10 – Southern terminus of Gravity section.

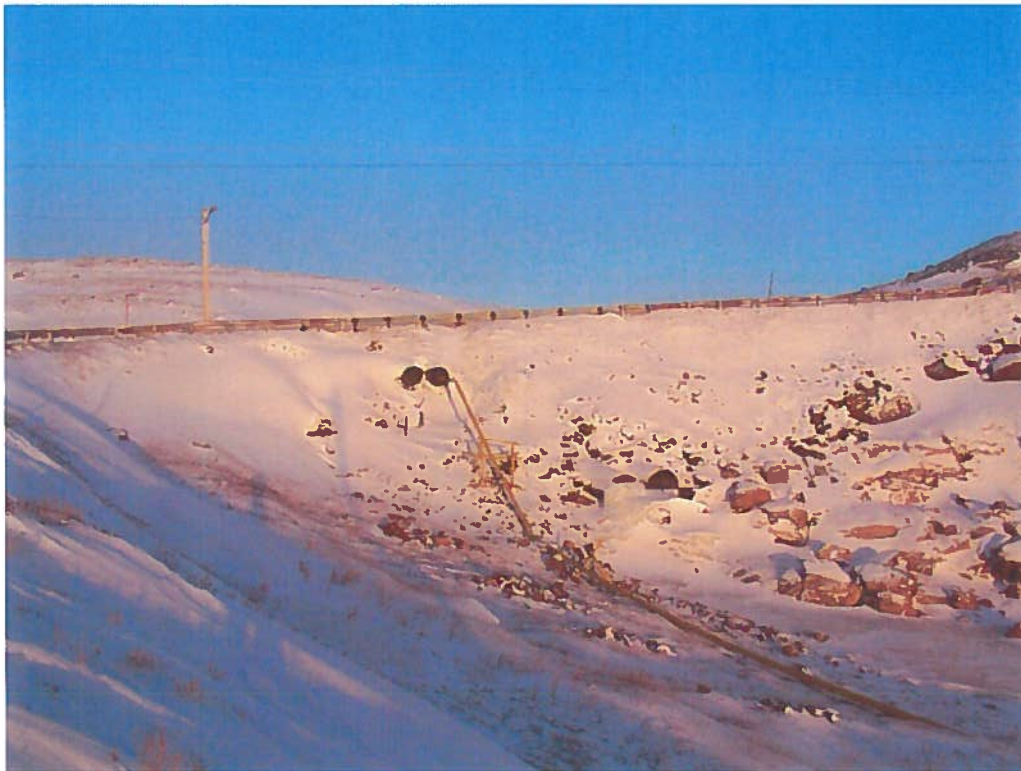
Photograph No. 2 – Looking upstream at Power Station Road Crossing. This crossing would be the first washed out (#1) in the event of a dam breach.

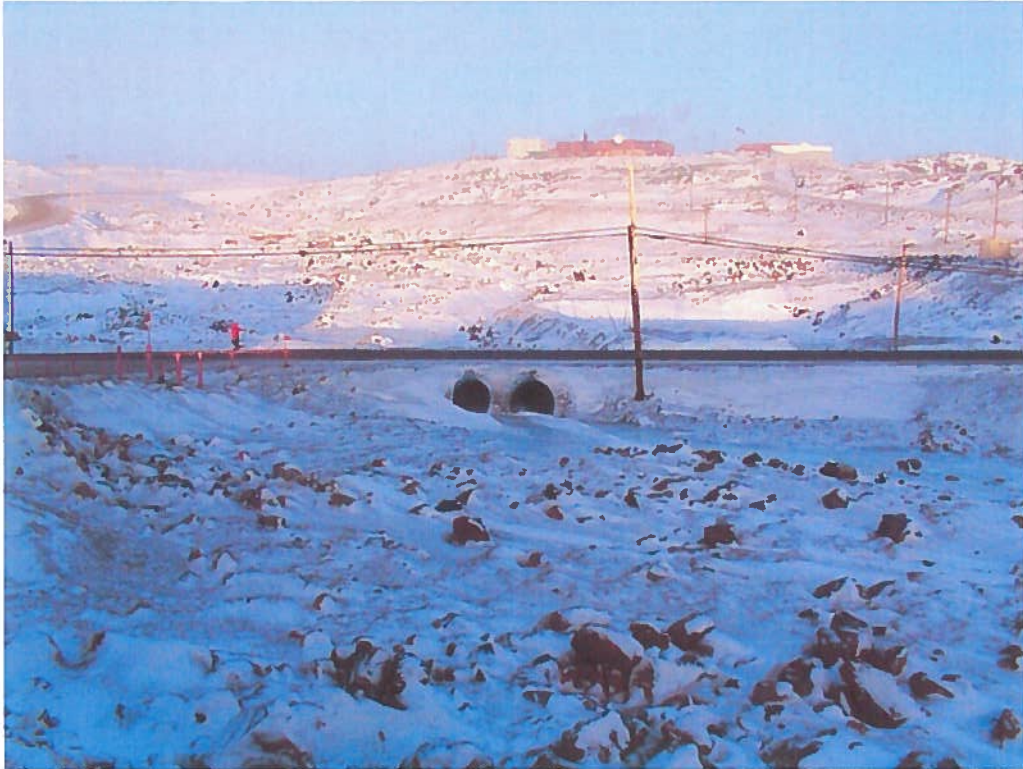
Photograph No. 3 – Looking upstream at Apex Road Crossing, Power Station in background. A second washout (#2) would be expected here.

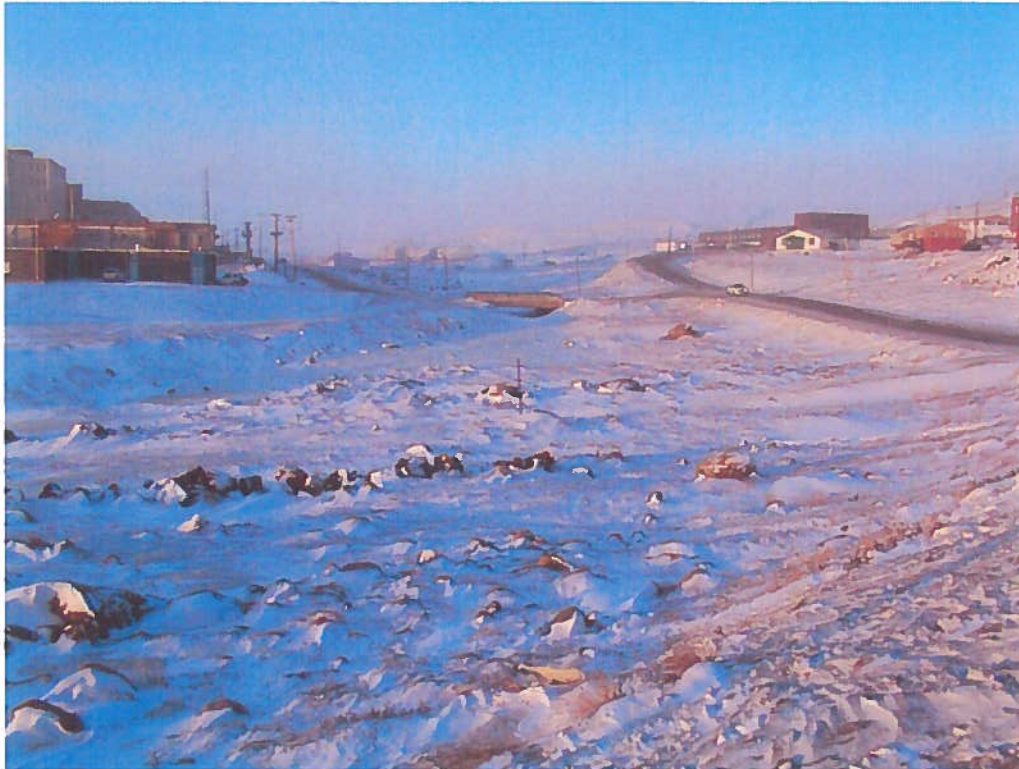
Photograph No. 5 – Further downstream, looking north at bridge to Frobisher Inn. This bridge would likely be lost in the event of a dam breach.

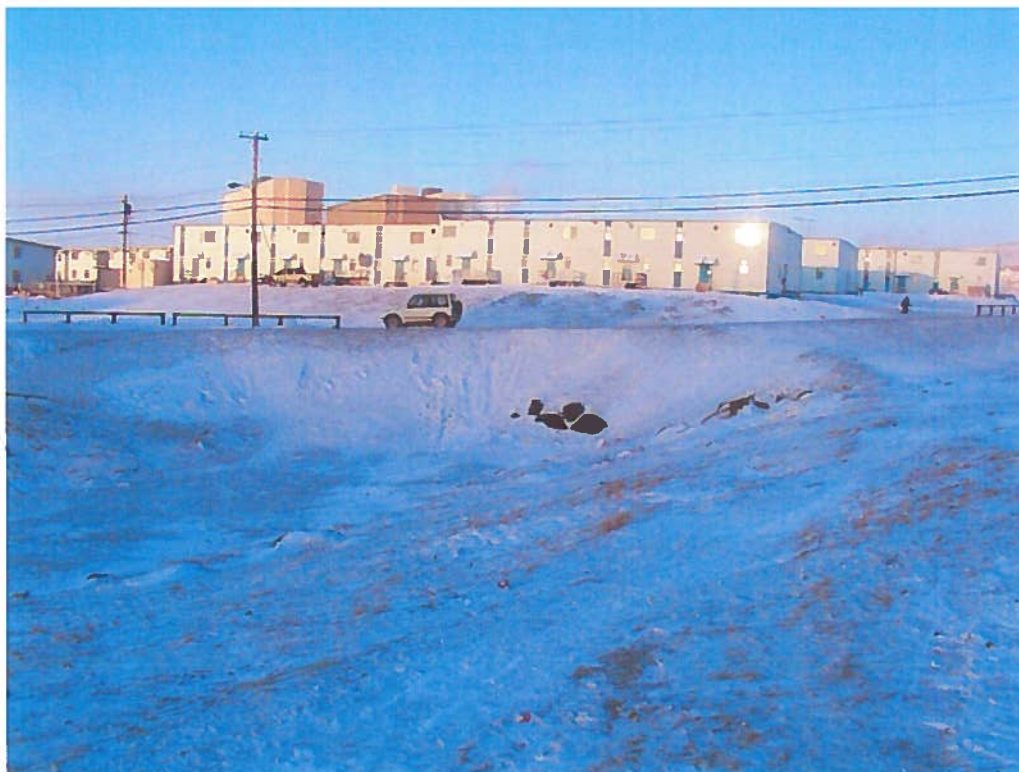
Photograph No. 6 – Looking upstream at UIVVAQ Road Crossing, which would be road washout #3.

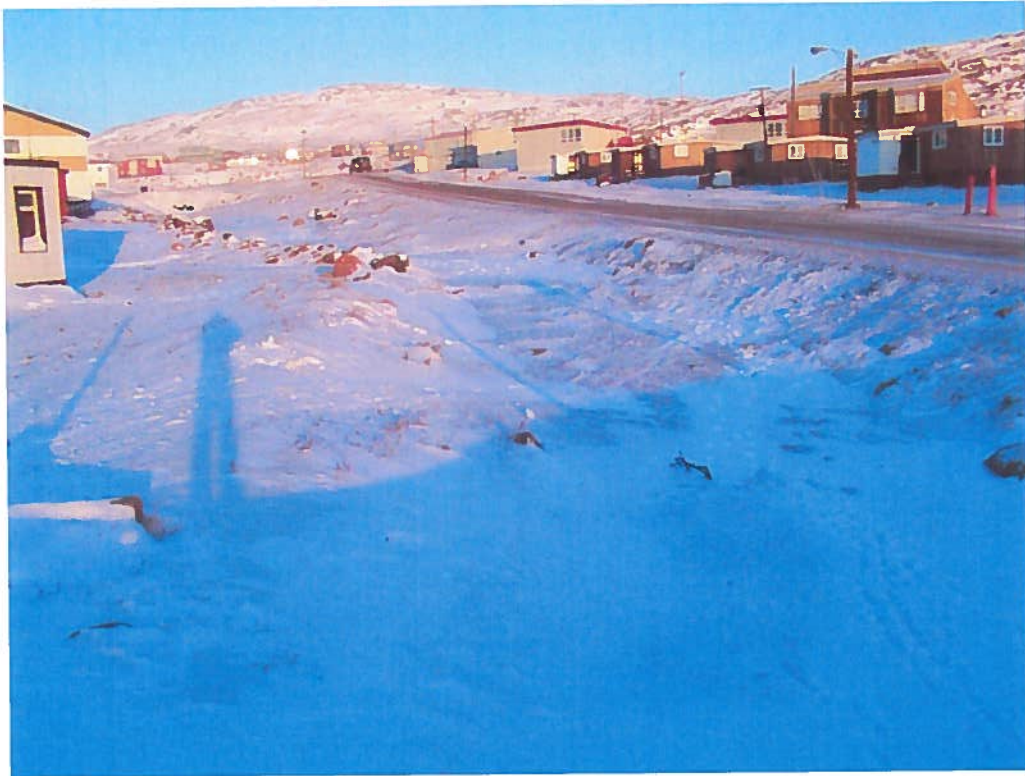
Photograph No. 7 – Further downstream, looking northeast along Nanvq Street. Housing is in the damage path.

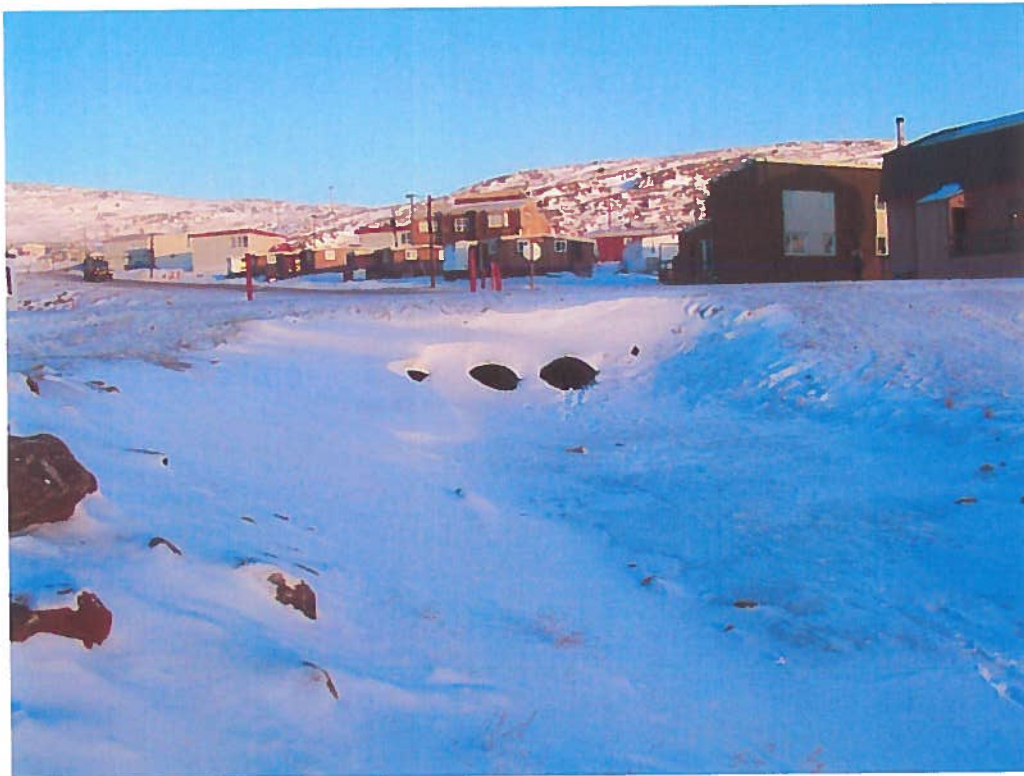
Photograph No. 8 – Moving further downstream to Ikaluit Street Crossing, which would be washout #4.

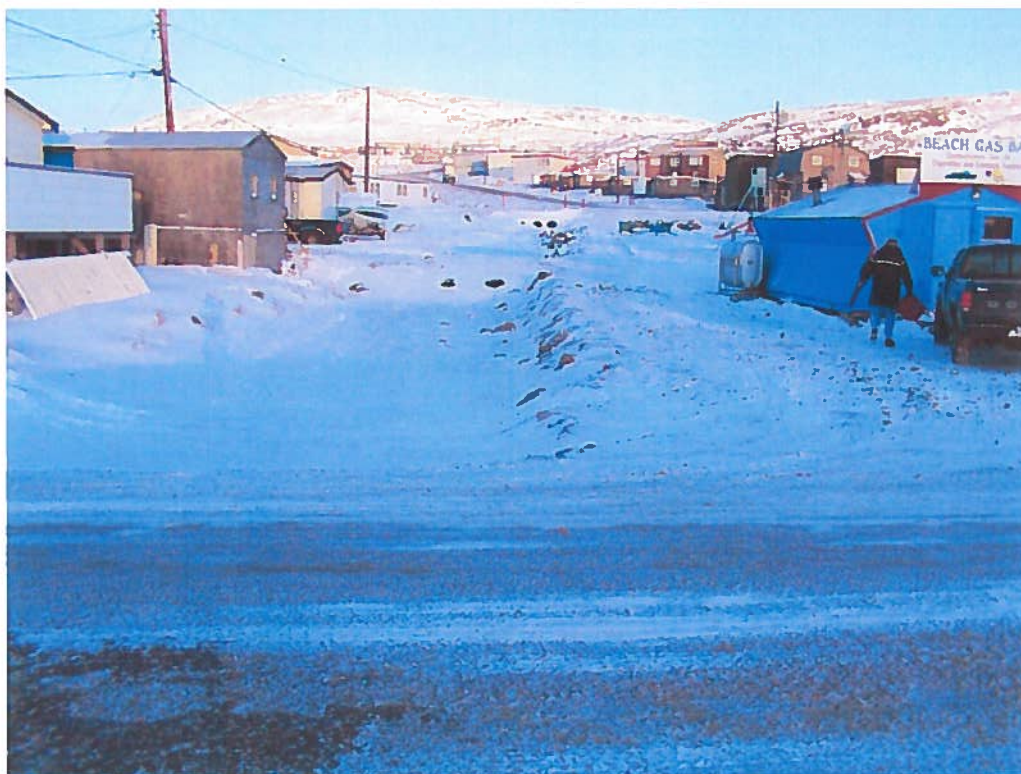
Photograph No. 9 – Moving further downstream to Sinnz Street Crossing, which would be washout #5. All buildings are in damage path.

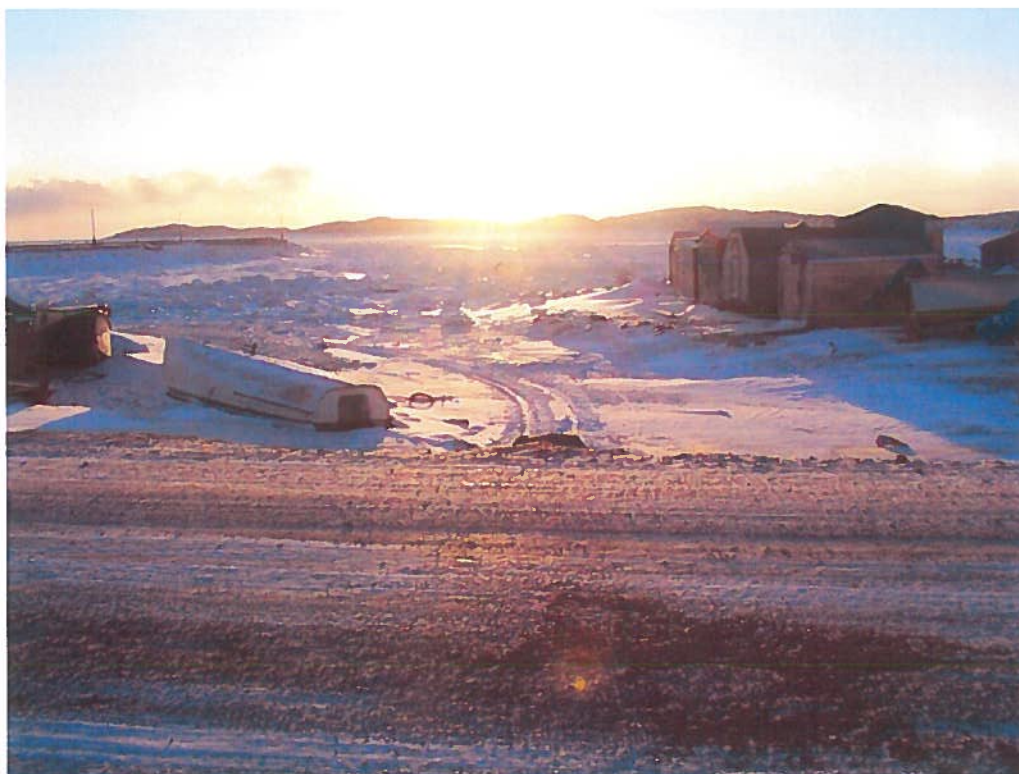
Photograph No. 10 – Terminus of Breach Flow at Frobisher Bay Beach.

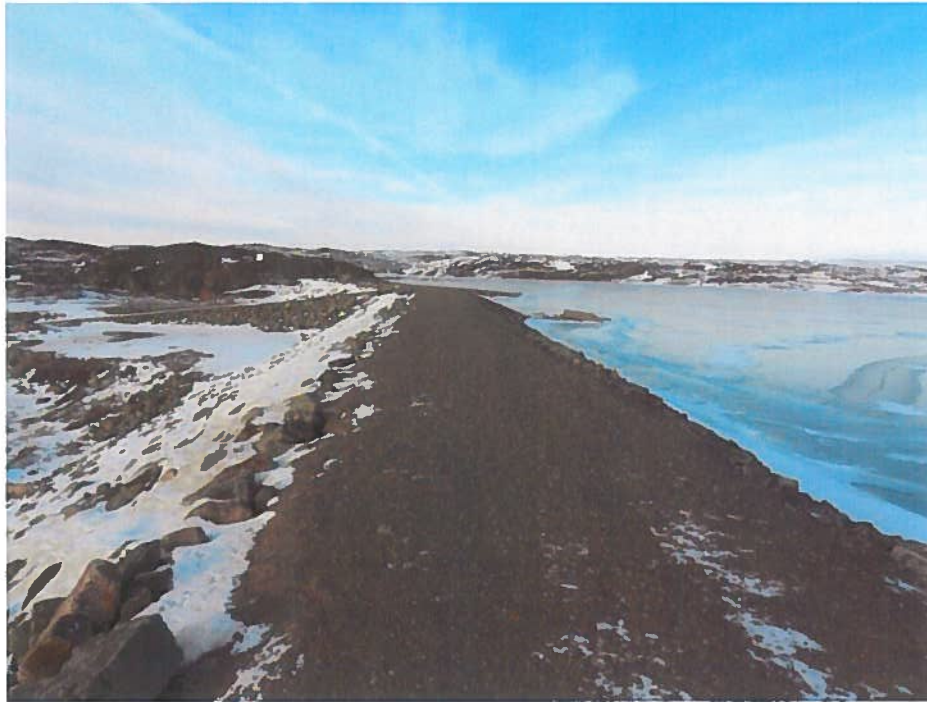
Photograph 1
Overview of North berm.

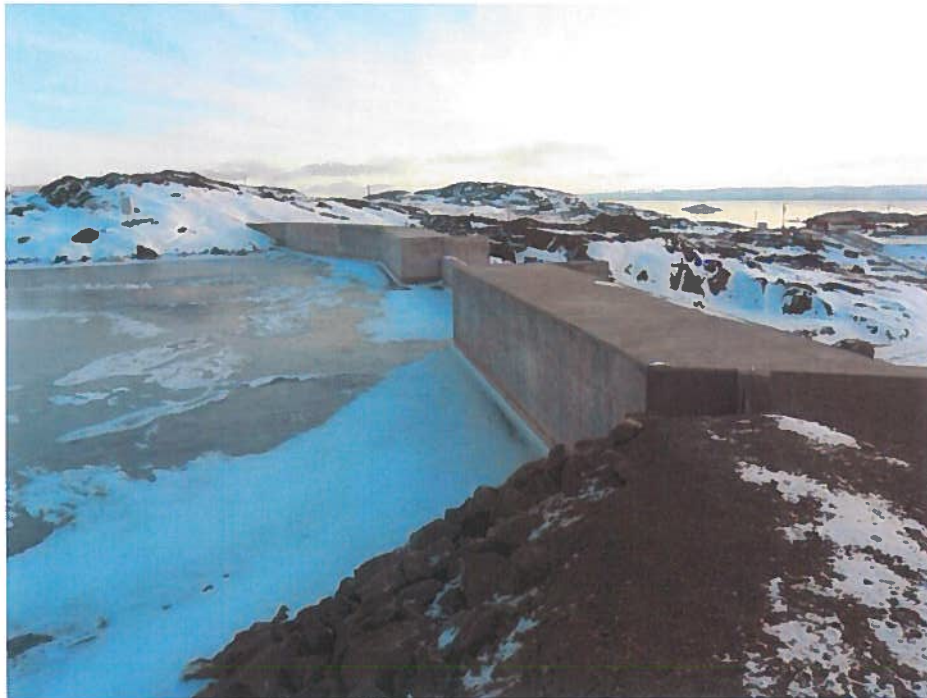
Photograph 2
Overview of upstream face of concrete structure.

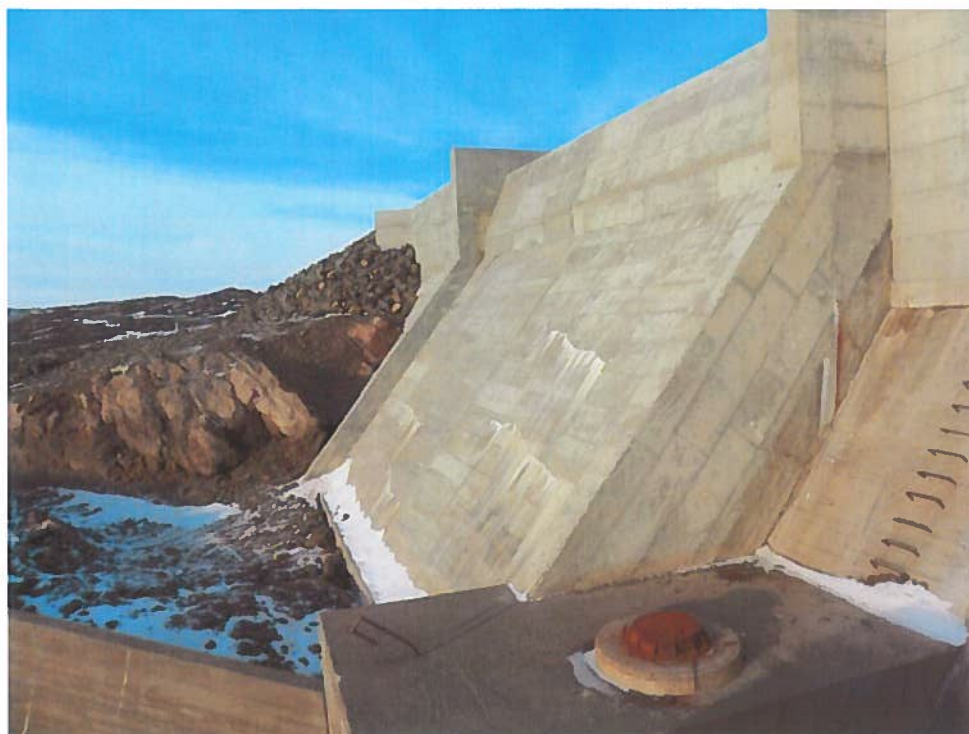
Photograph 3
Overview of spillway section, downstream face.

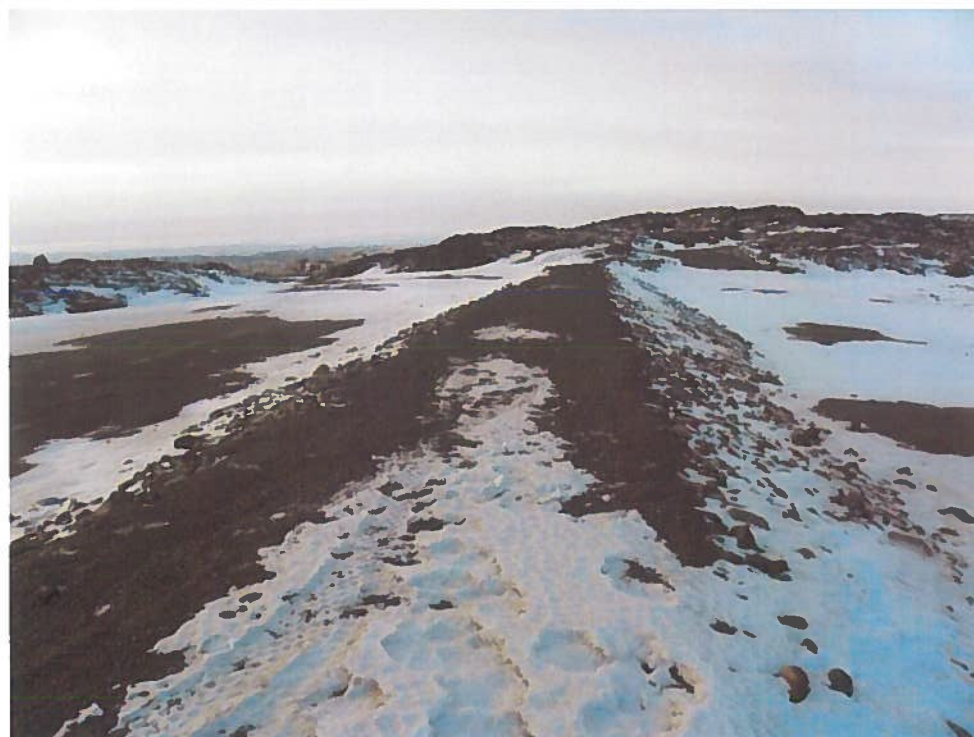
Photograph 4
Overview of South berm.

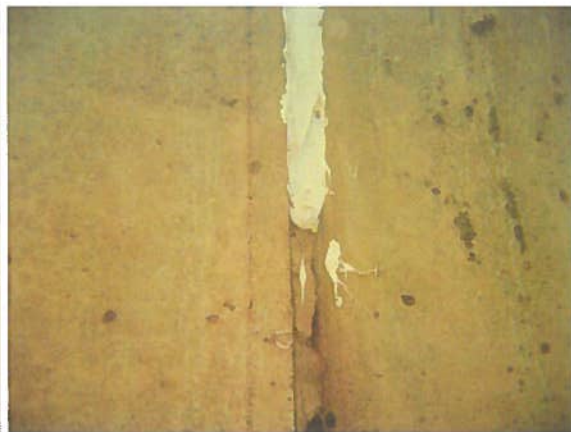
The photos below show the sealant in the expansion joints. This sealant does not go beyond the new concrete. The photos clearly show that there was no sealant in the joint previous to the placement of the sealant shown. All of the expansion joints look like this. More visual evidence can be seen in the video that was produced.

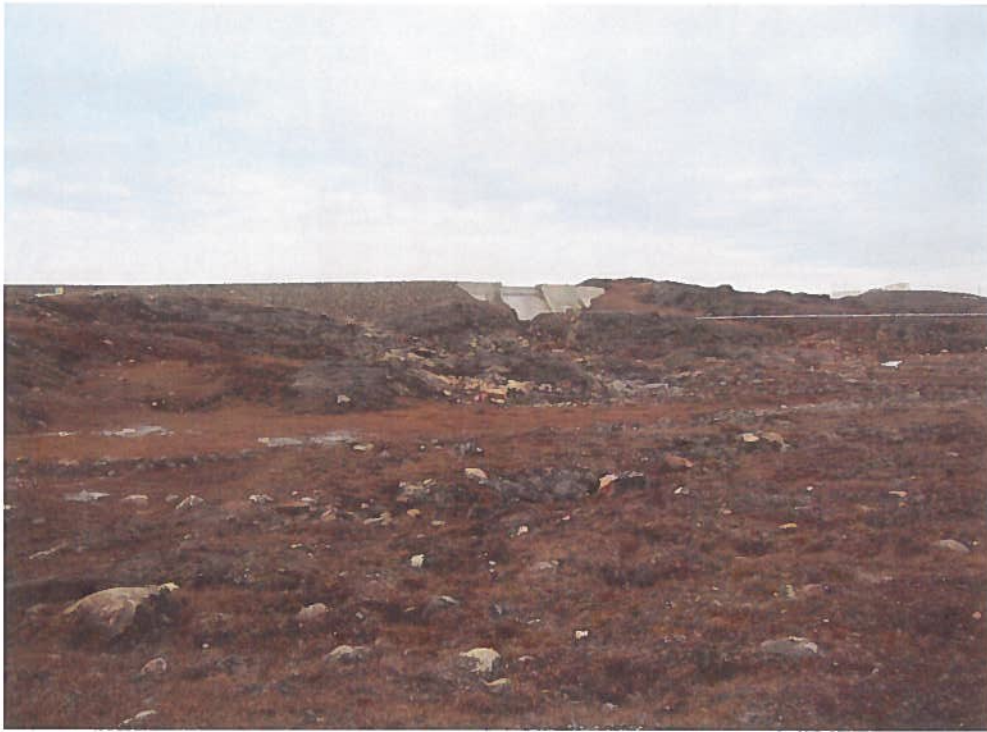
Photograph 1
Overview of Dam Structure; from the Northwest.

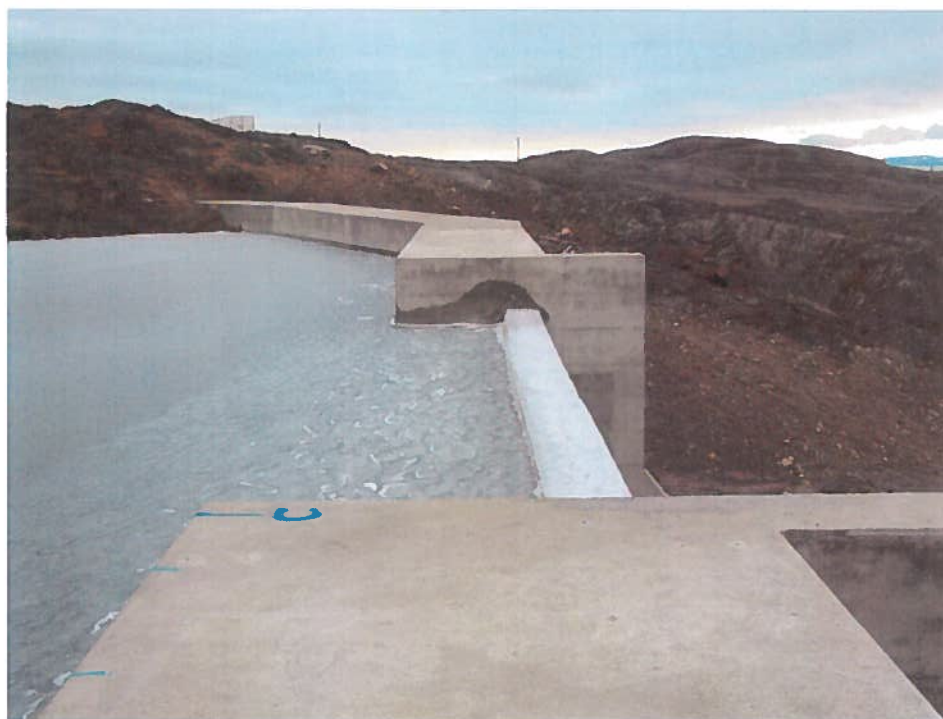
Photograph 5

- The visible concrete portions of the dam structure are in general unchanged from that observed for the 2009 DSI.
- The level of the Lake Geraldine reservoir has increased at least 0.6 metres since October 2009. The water level was within approximately 0.2m of the spillway crest at the time of our recent inspection; i.e. close to capacity.

Overview of spillway; note water level near capacity; approx. 0.6m higher than October 2009.

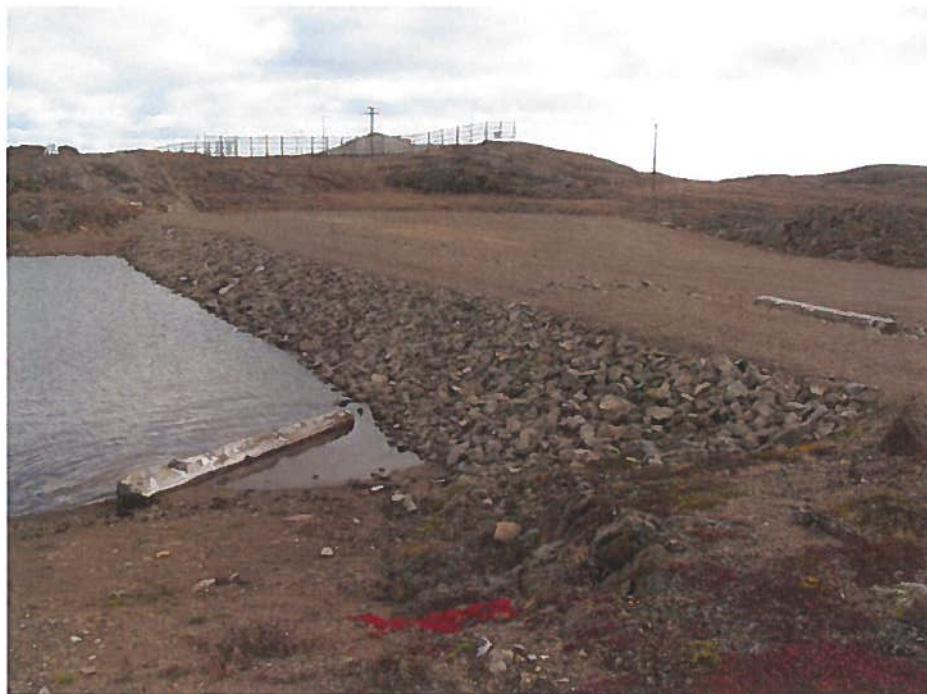
Photograph 1
Overview of South berm.

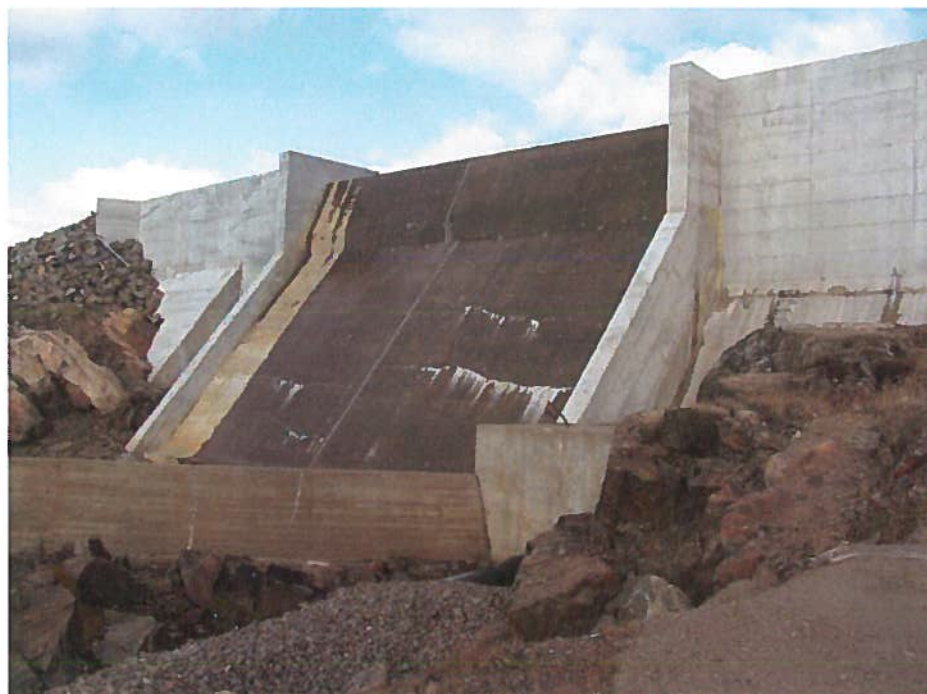
Photograph 2
Overview of spillway – note overtopping (maximum lake level)

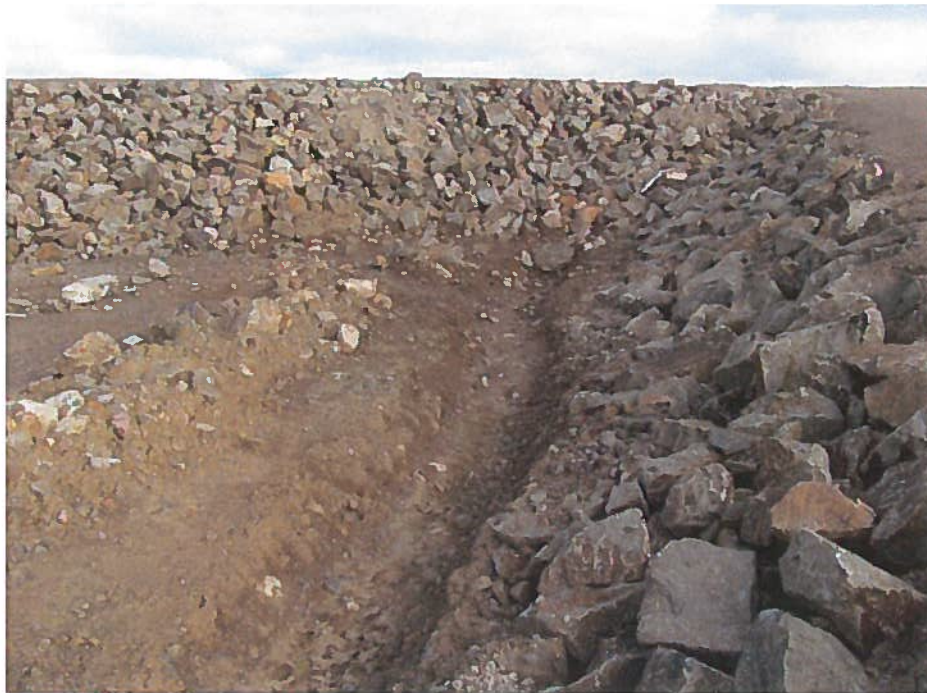
Through leakage in the north berm was observed on both the north and south sides of the vehicular access ramp.

Photograph 5
North side of access ramp – note previously wet area now dry.
