# DEVELOPMENT OF A MASTER DRAINAGE PLAN – FINAL SUBMISSION

City of Iqaluit

Nunami Stantec Ltd.  
1088C Noble House, PO Box 1779,  
Iqaluit NU X0A 0H0

144902610  
May 3, 2019

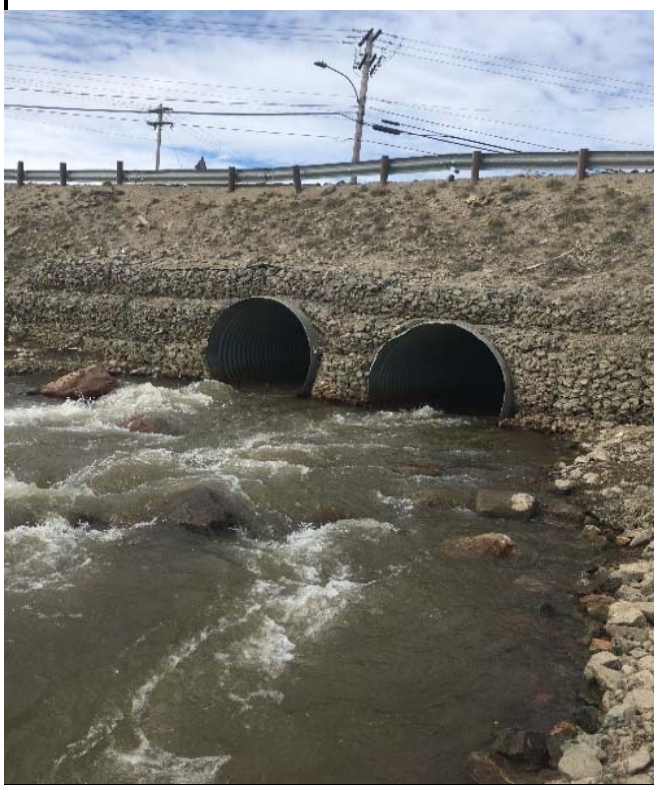
South of  
Crossing 1 (2  
x 1800 mm  
dia.) - Early  
Spring  
Melt-off

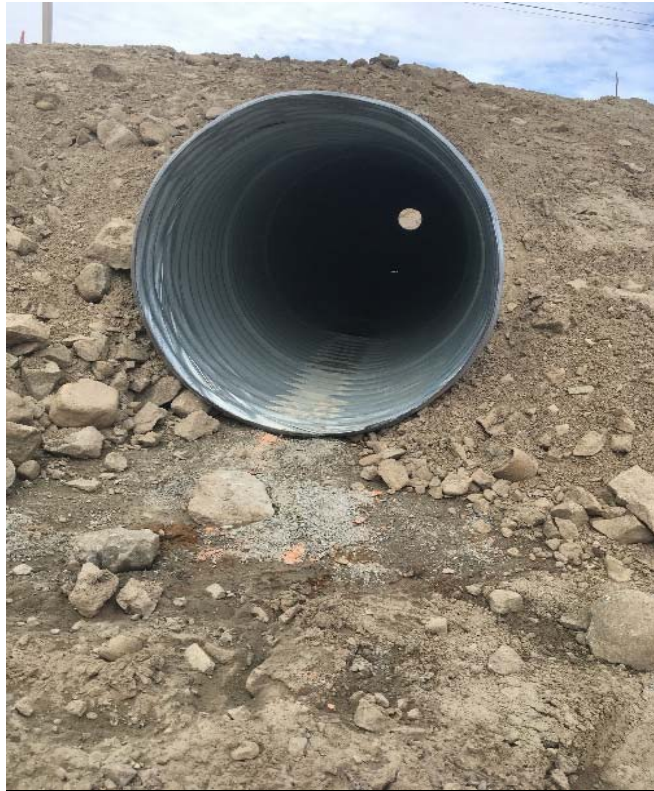
South of  
Crossing 4  
(800 mm dia.)  
- not  
receiving any  
flow

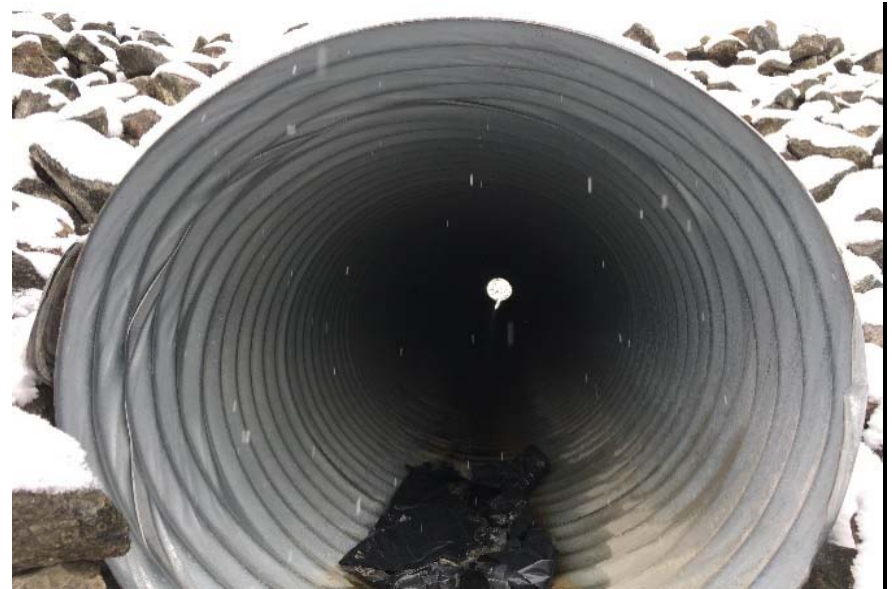
North of Crossing 4 (800 mm dia.) looking  
Upstream - Garbage in the pipe

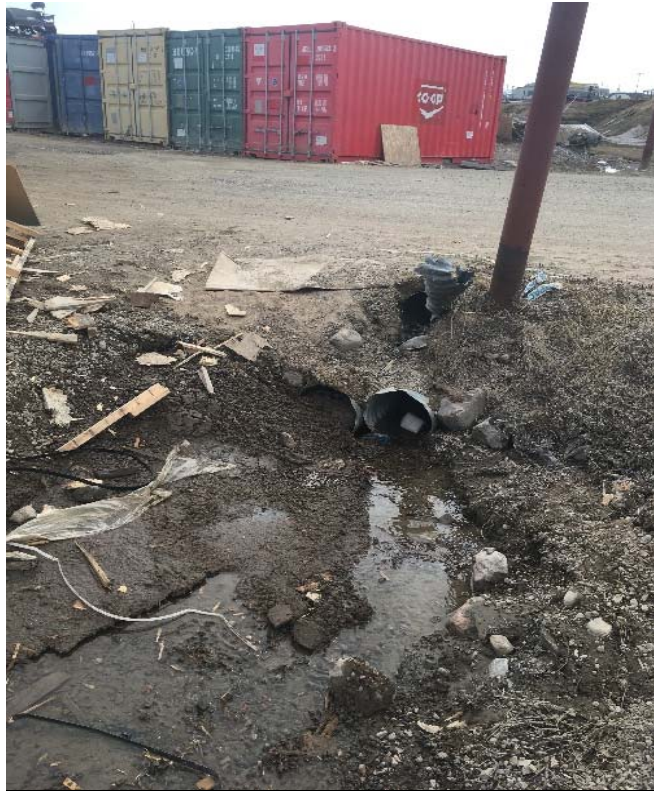
North of  
Crossing 5 (3  
x 300 mm  
dia.) -  
Garbage  
accumulated

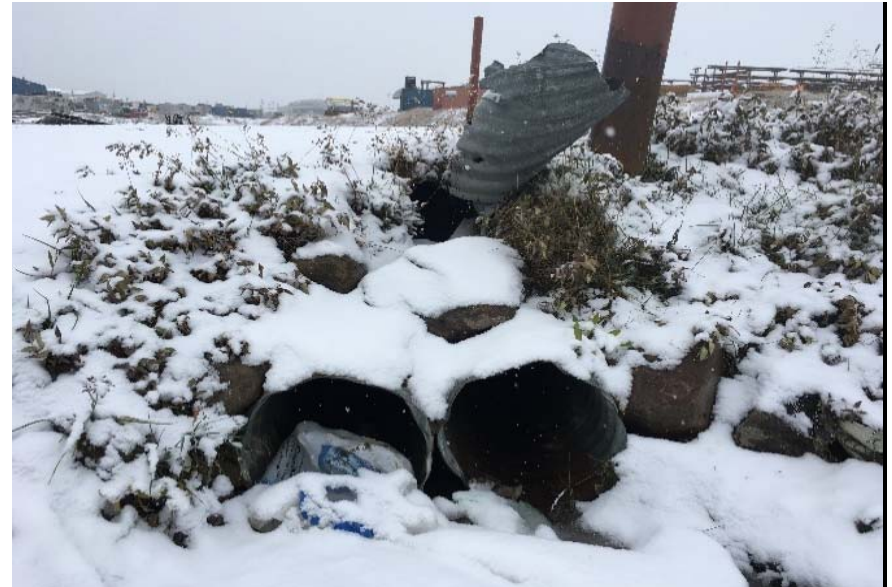
North of Crossing 5 (3 x 300 mm dia.) looking  
Upstream - Garbage in the pipe

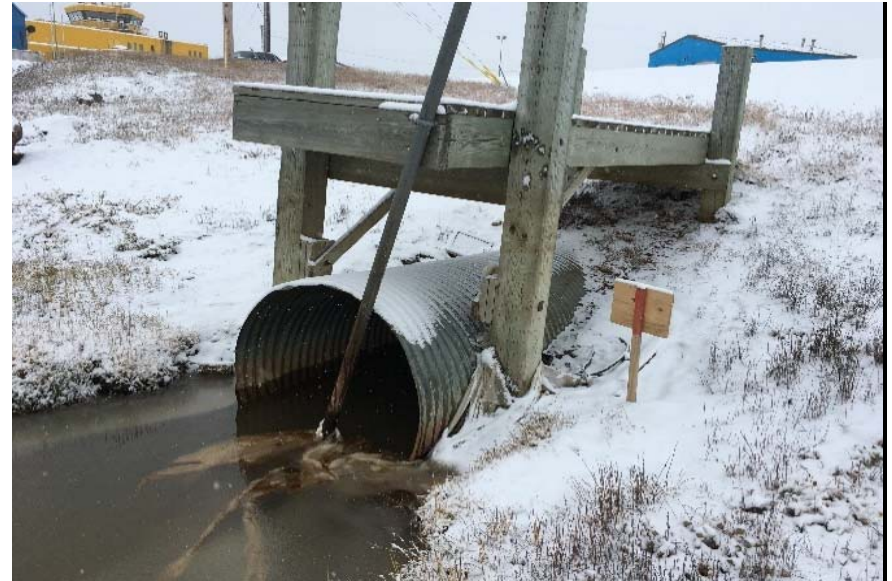
East of Crossing 6B (600 mm dia.) - Appears to be  
garbage in the stream

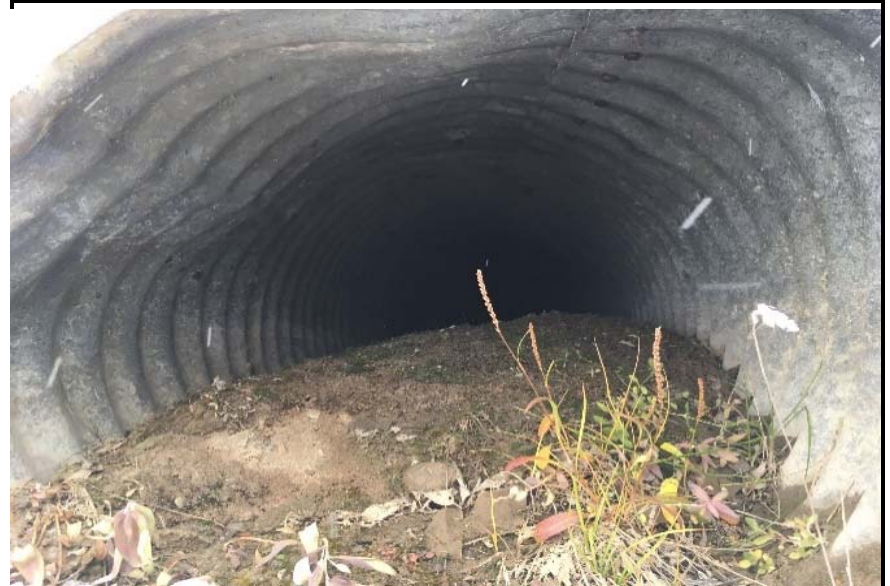
South of Crossing 7 (600 mm dia.) - Sediment  
buildup in the pipe

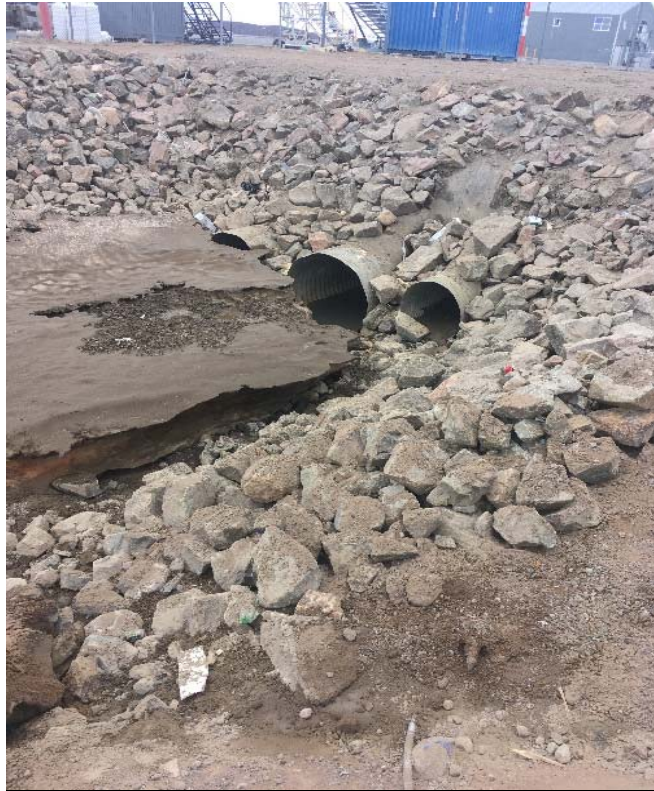
East of  
Crossing 8 (2  
x 1000 mm  
dia. and 1 x  
1600 mm  
dia.) - Snow  
about to melt

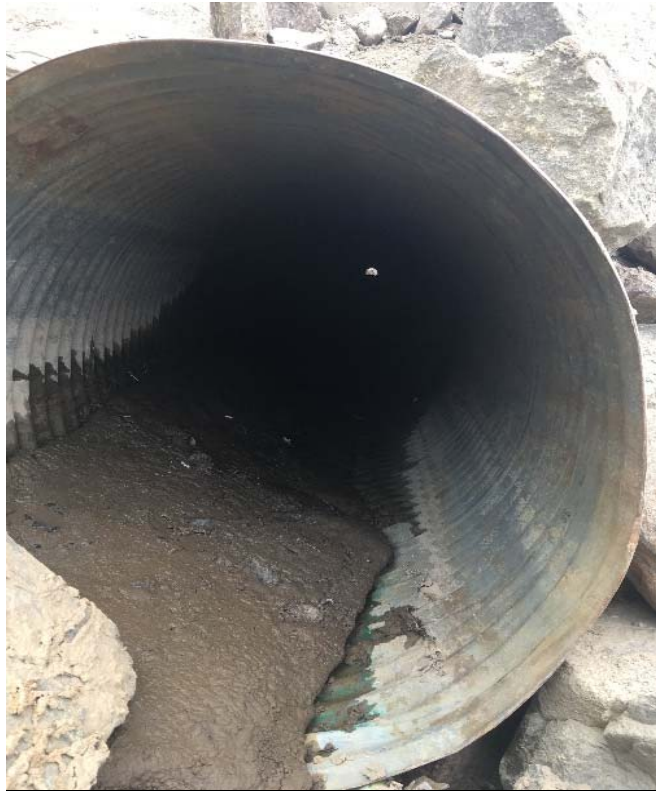
East of  
Crossing 8  
(1600 mm  
dia.) closeup -  
Sediment  
buildup inside  
the pipe

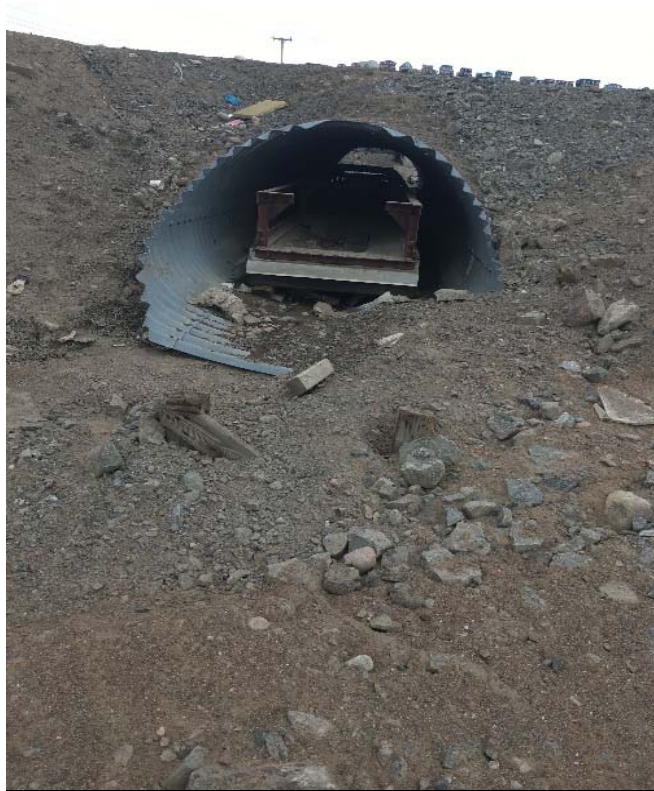
West of  
Crossing 9  
(2100 mm  
dia.) -  
Furniture  
inside the  
pipe

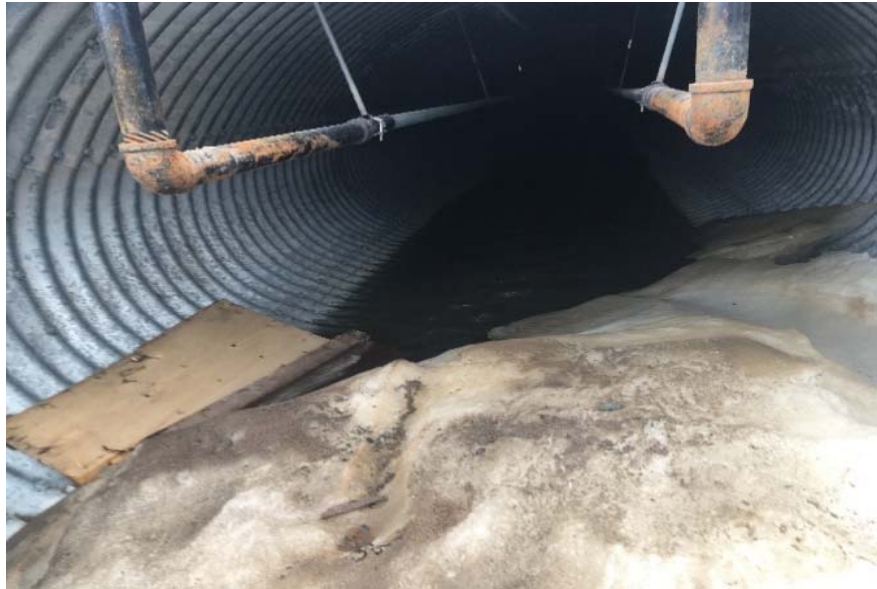
East of Crossing 10 (3100 mm dia.) - Snow melt

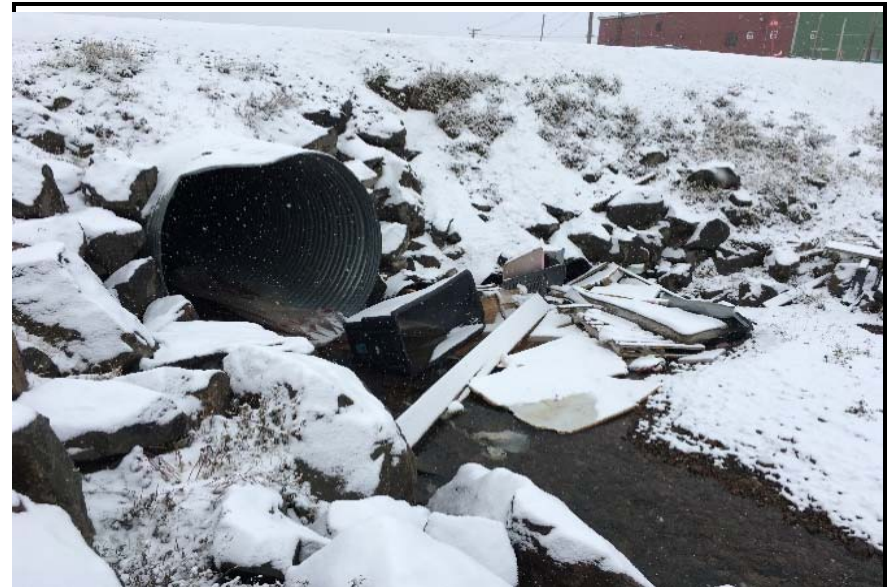
North of Crossing 12 (3 x 1000 mm dia. and 1 x  
2100 mm dia.) looking Upstream - Garbage buildup  
infront of pipe

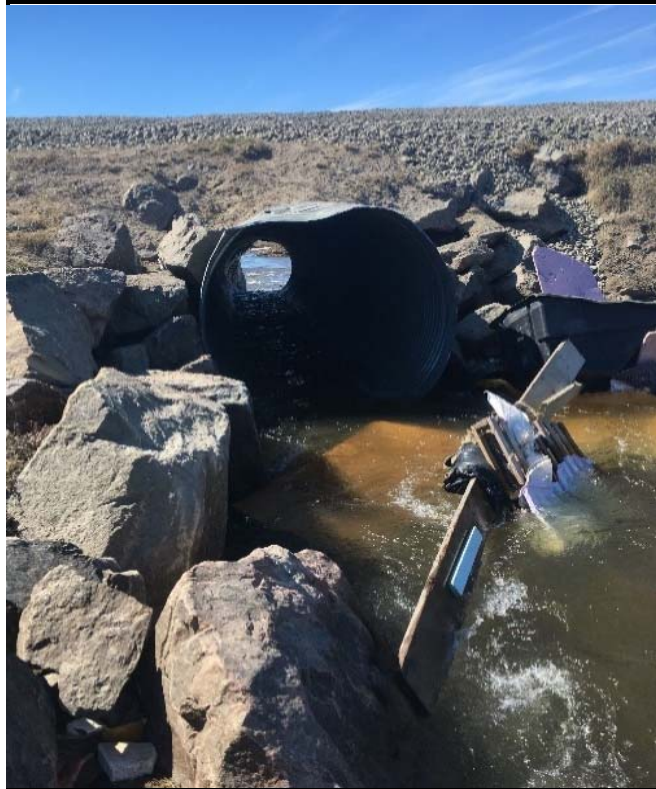
North of  
Crossing 12 (3  
x 1000 mm  
dia. and 1 x  
2100 mm  
dia.) -  
Garbage in  
the stream

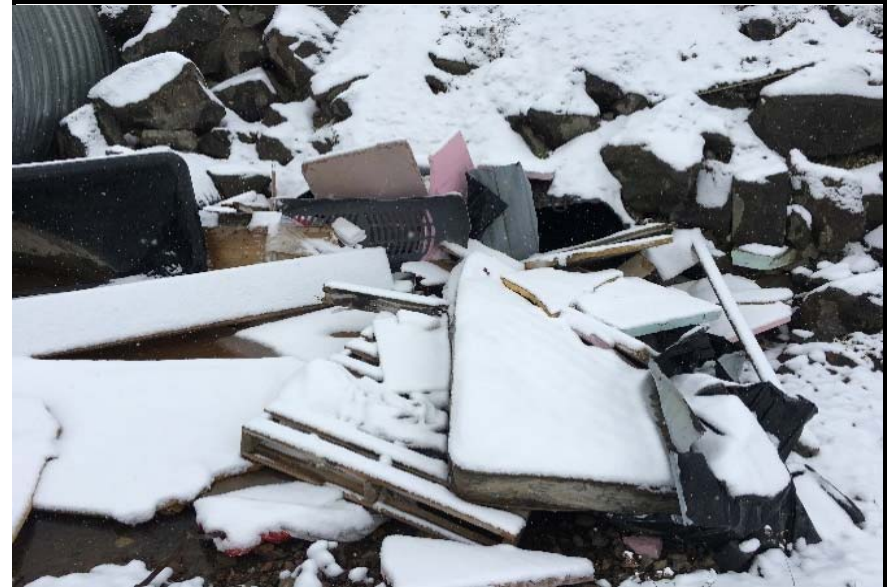
North of Crossing 12 (3 x 1000 mm dia. and 1 x  
2100 mm dia.) looking Upstream - Wooden Pallets  
and Garbage

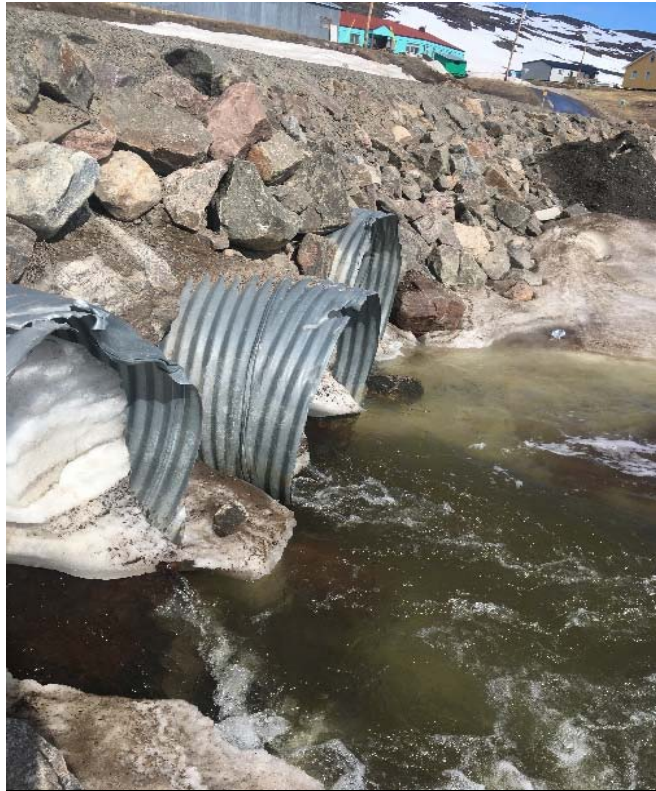
Cluster 2 of 3  
Culverts (3 x  
1100 mm  
dia.) on south  
side of road -  
Blocked due  
to snow

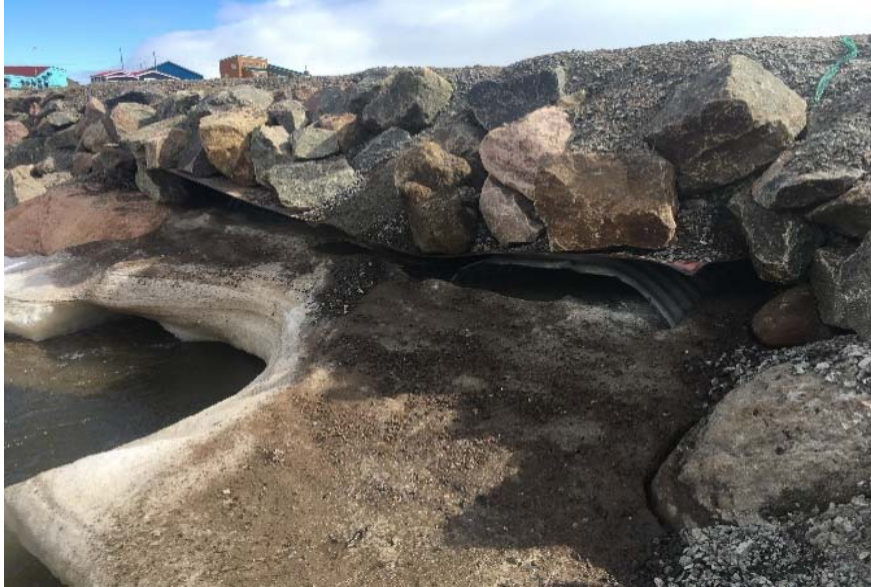
Cluster 2 (3 x 1100 mm dia.) taken from North side of road - Blocked due to snow

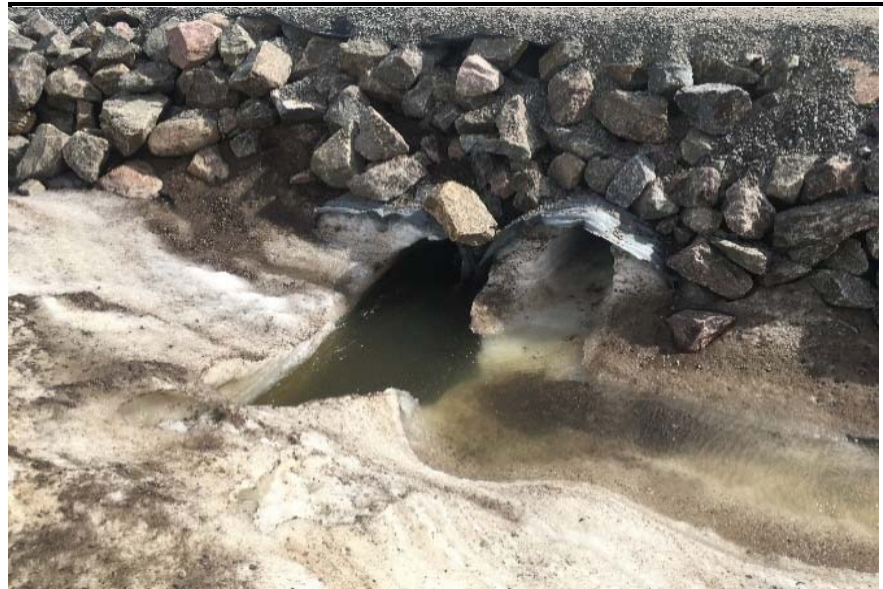
Cluster 1 (4 x 9400 mm dia.) taken from north side of  
road - Blocked due to snow

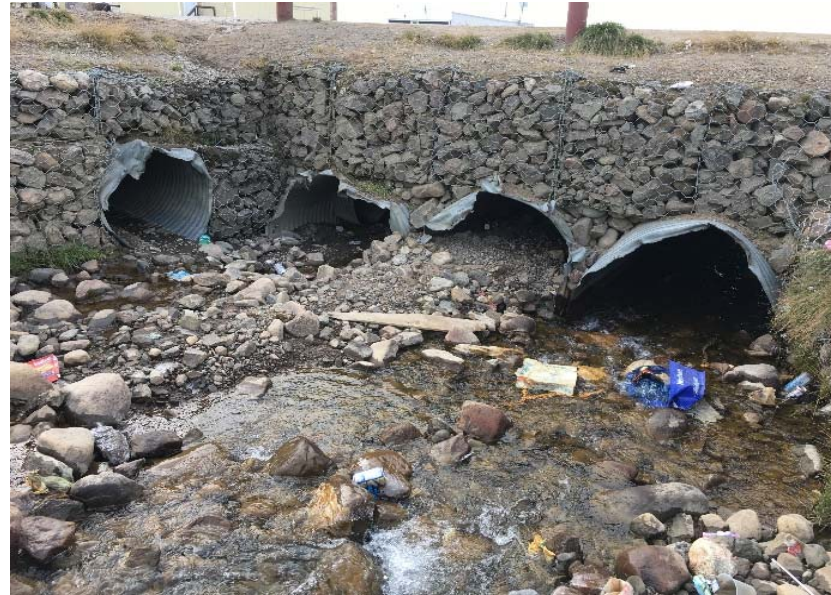
Upstream of Crossing 2 (3 x 1200 mm dia.) -  
Garbage in front of the pipe

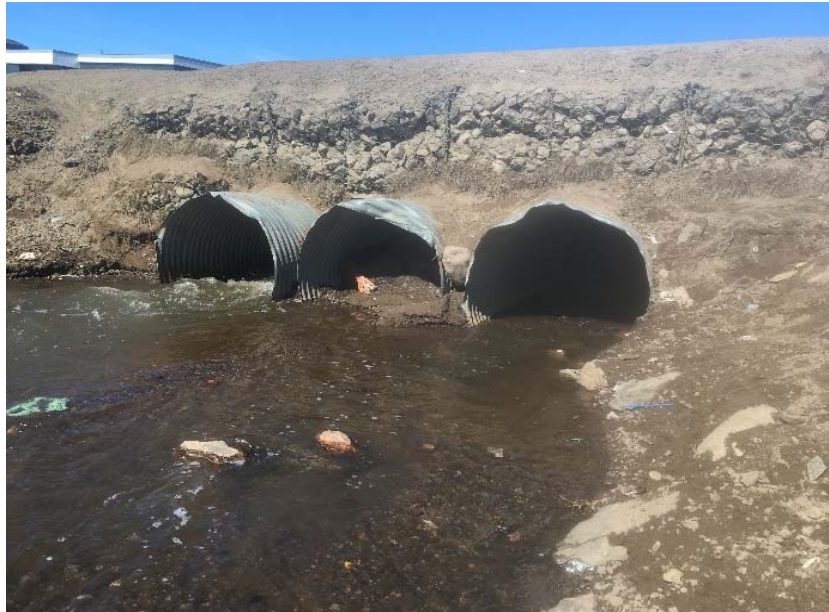
South of Crossing 2 (3 x 1200 mm dia.) - Garbage in the stream, pipe not in good shape

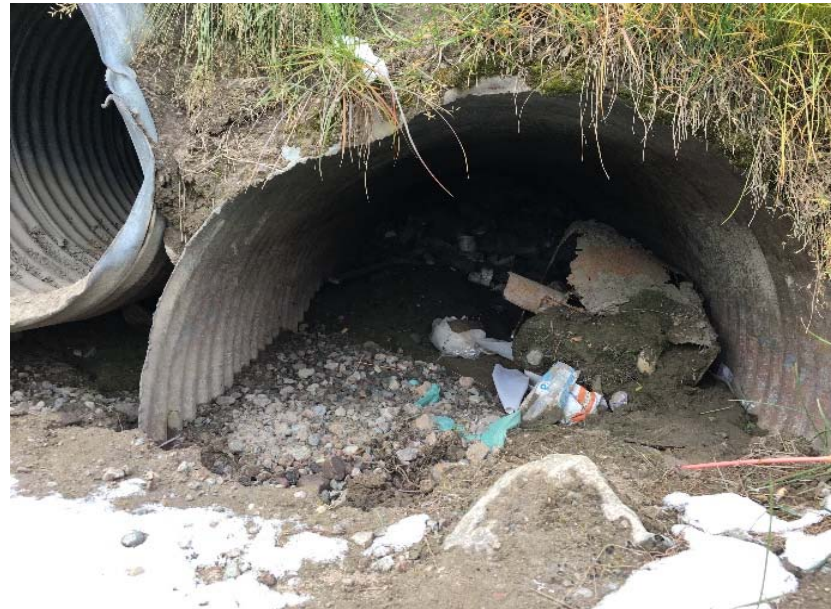
Upstream of Crossing 3 (1500 mm dia.) - Garbage and sediment buildup inside the pipe

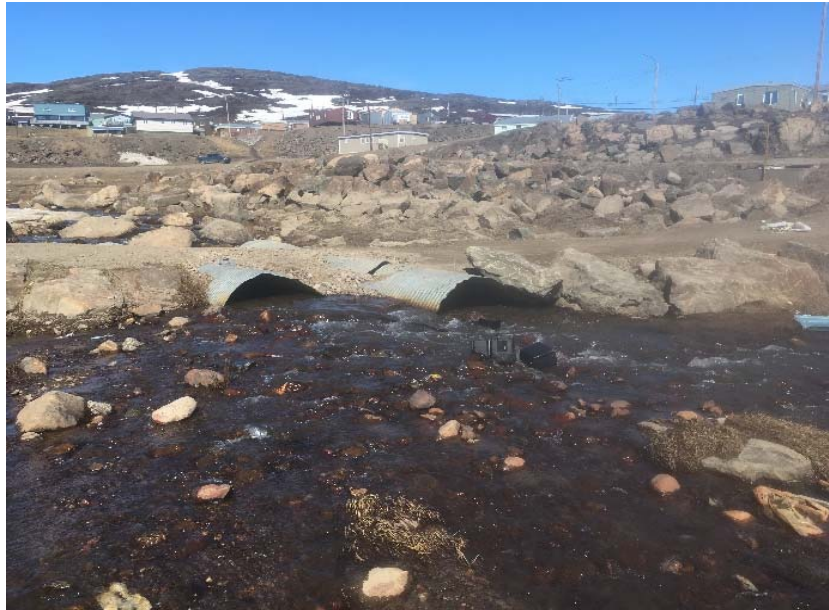
Crossing 4 (2 x 1350 mm dia.) looking North - Pipes half buried in the substrate

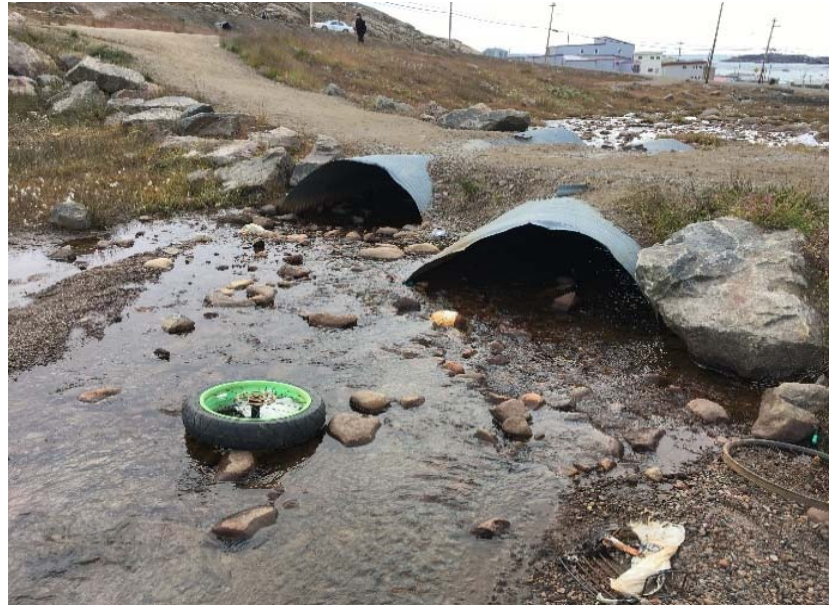
Upstream of Crossing 4 (2 x 1350 mm dia.) - Tire seen in the stream, pipes half buried in the substrate

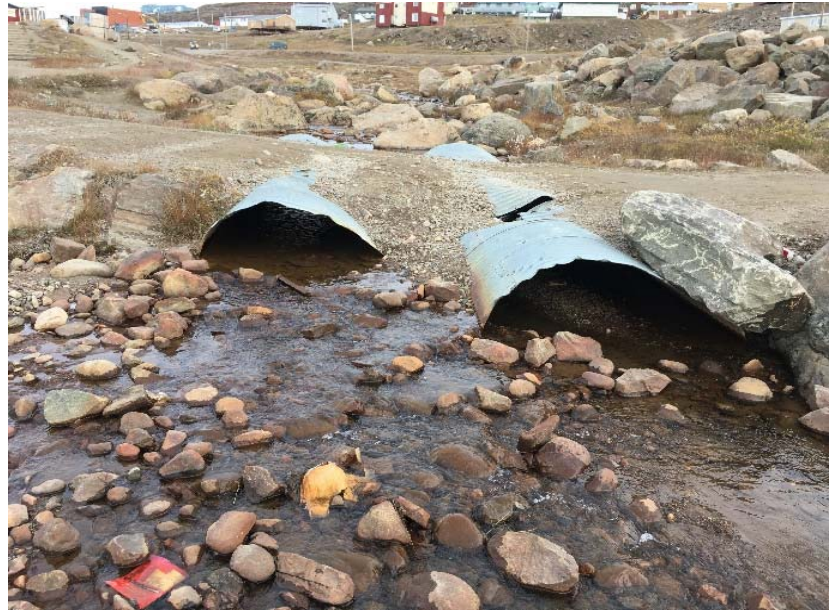
Downstream of Crossing 4 (2 x 1350 mm dia.) -  
Garbage in the stream

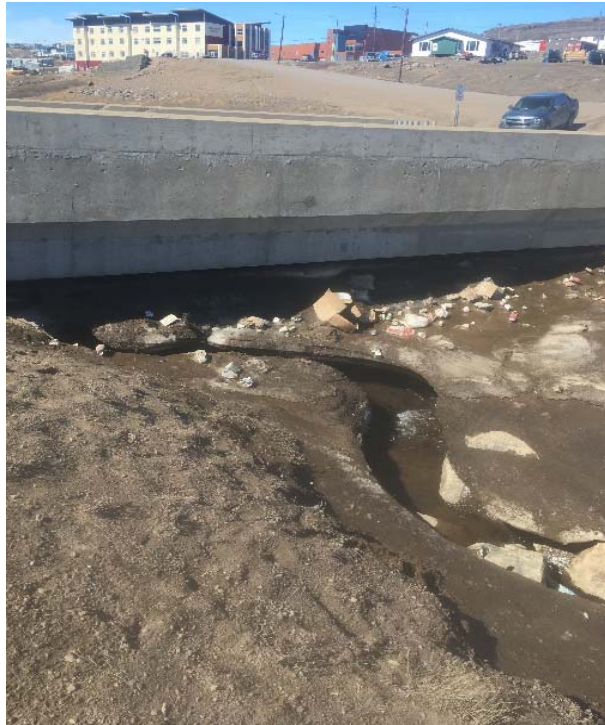
Crossing 5  
looking West  
- Clear span  
bridge, 13 m  
wide over a  
channel with  
7m wide  
bankful.  
Unstable  
bank on  
downstram  
left

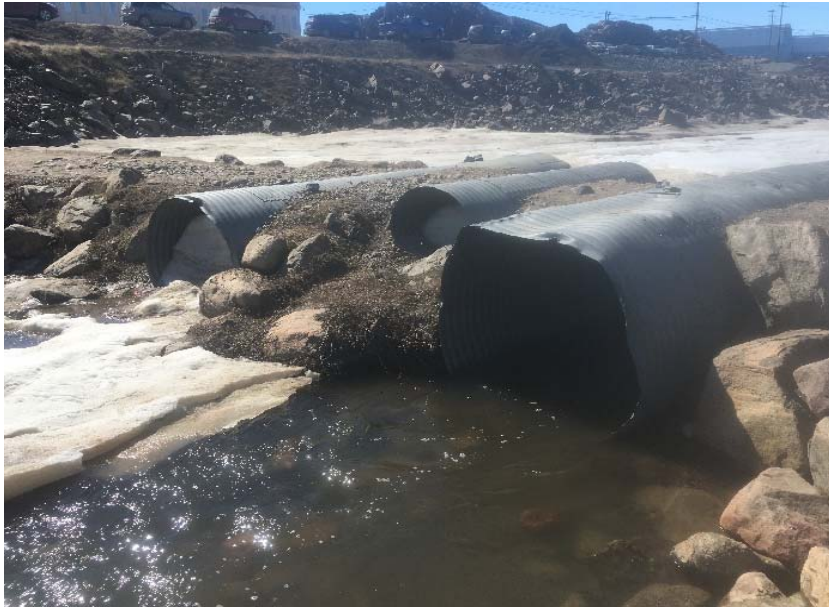
Crossing 6 ( 2 x 1300 mm dia. and 1 x 800 mm dia. overflow) looking South West - Blocked due to snow

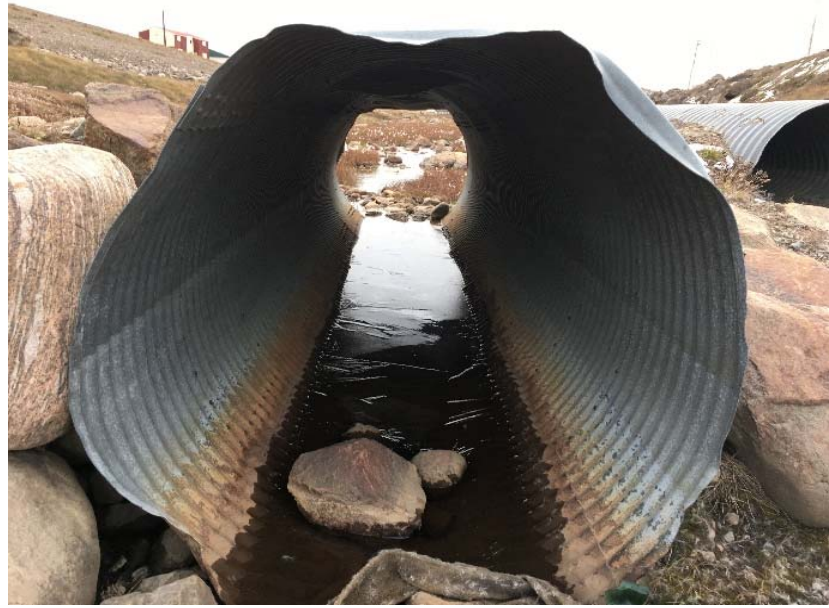
Upstream of Crossing 6 (1300 mm dia.) - Deflected Pipe

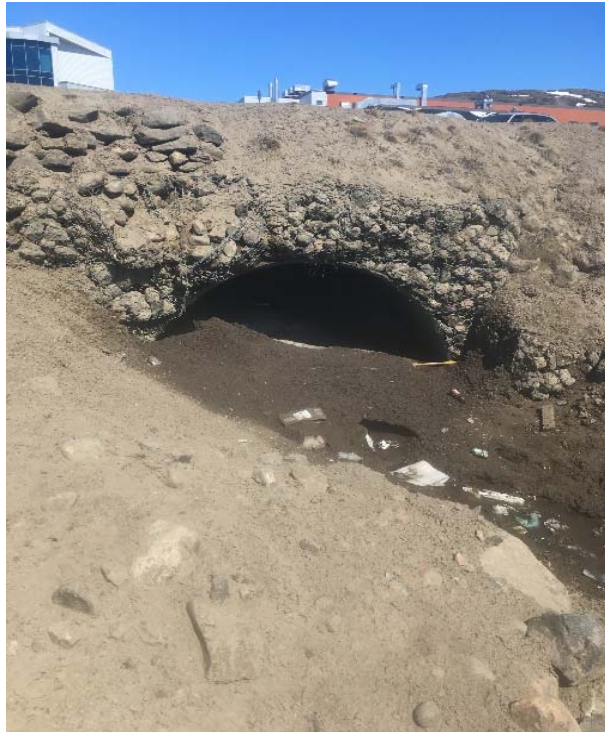
South of  
Crossing 7  
(3200 mm  
dia.) looking  
North - Pipe  
not  
accessible  
due to  
sediment  
buildup

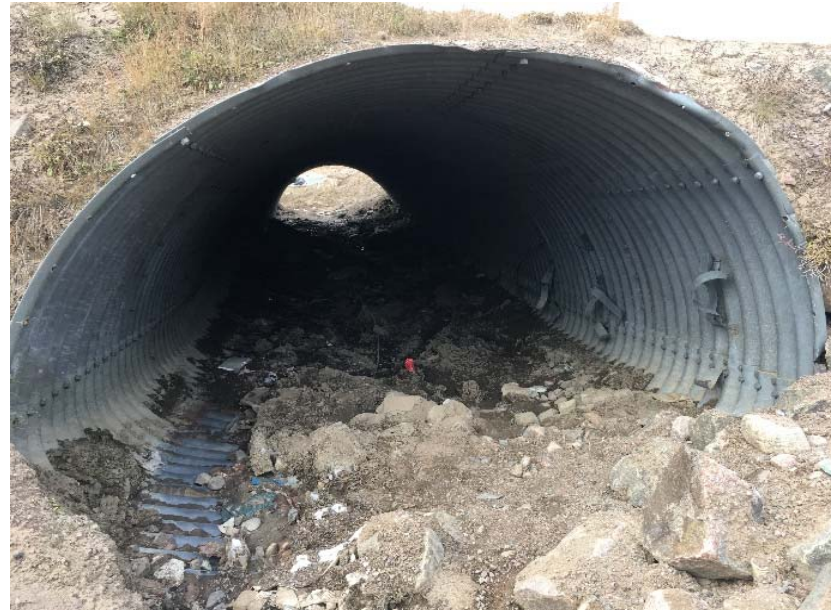
Upstream of Crossing 7 (3200 mm dia.) - Sediment  
Buildup inside the pipe

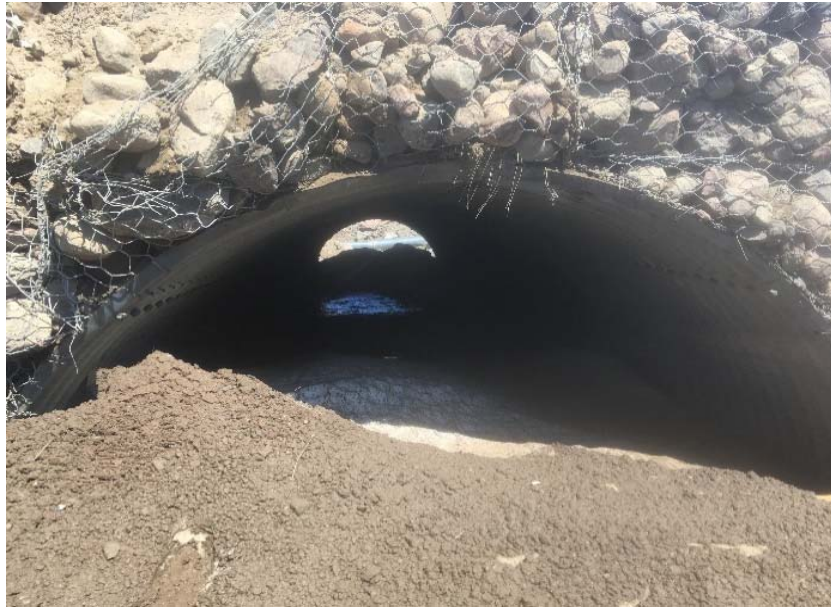
South of Crossing 7 (3200 mm dia.) looking North -  
Sediment Buildup

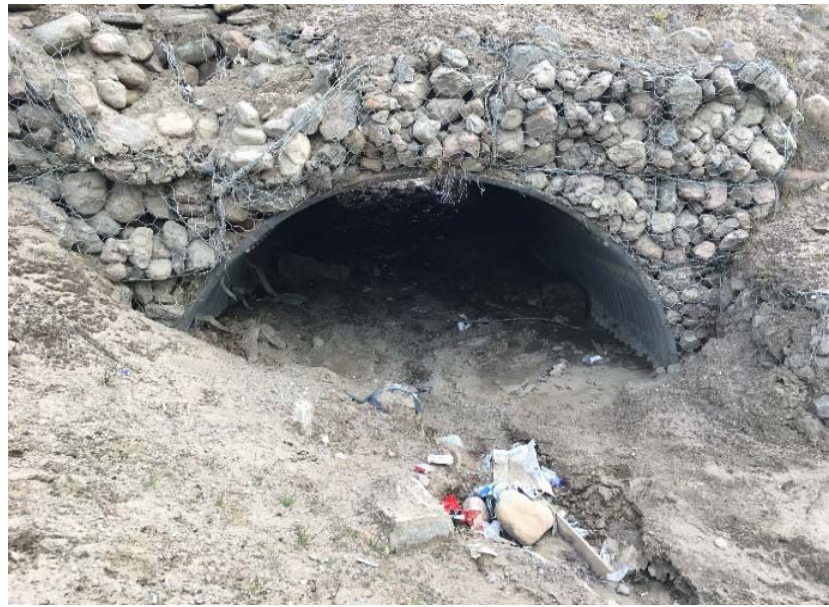
Downstream of Crossing 7 (3200 mm dia.) - Garbage  
infront of pipe

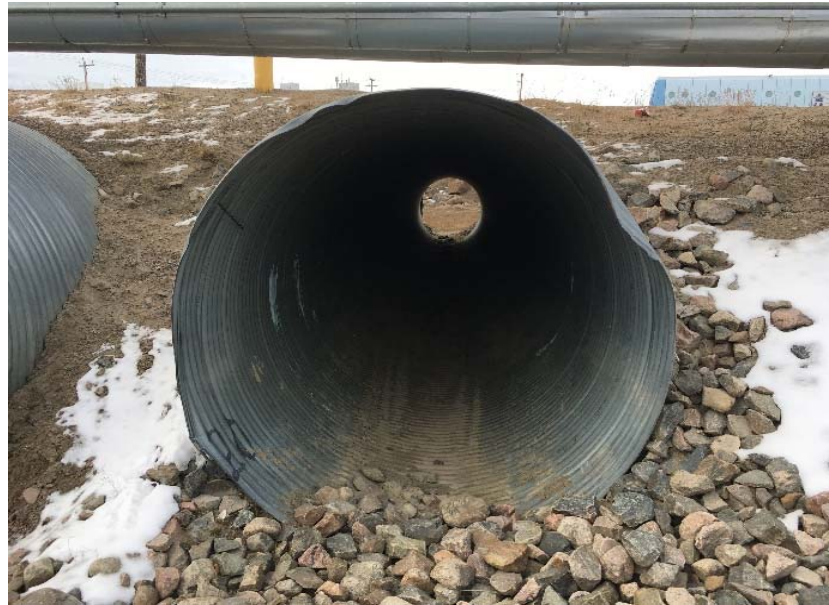
Upstream of Crossing 8 (1950 mm dia.) - Sediment  
buildup in front of pipe

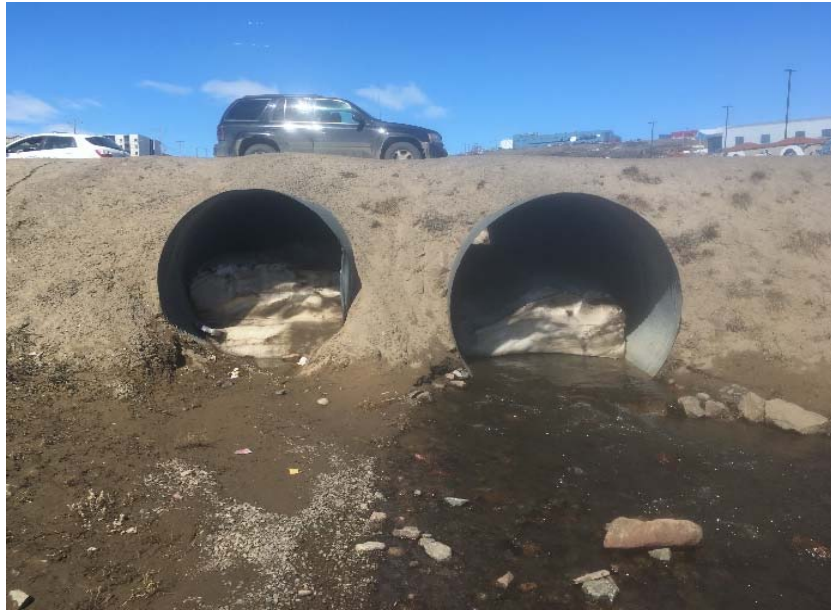
South of Crossing 8 (2 x 1950 mm dia.) looking North  
- Blocked due to snow

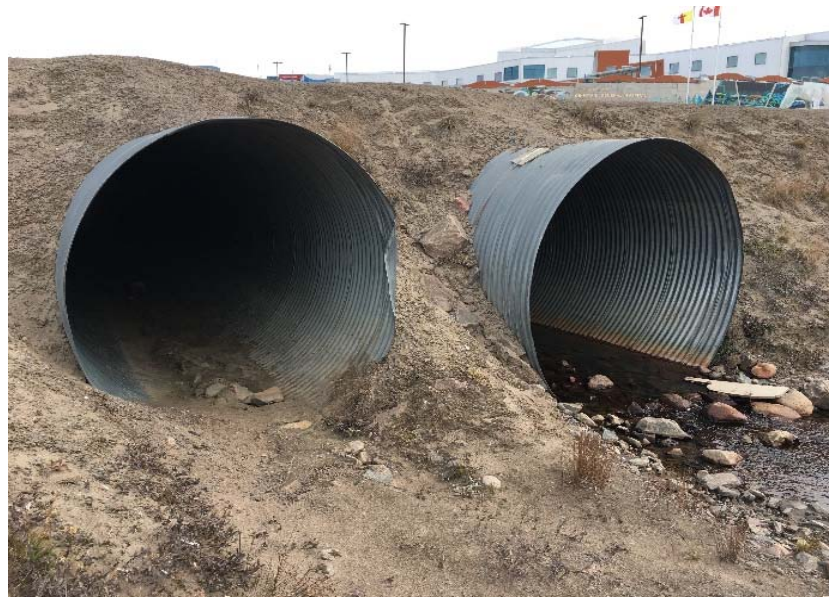
Downstream of Crossing 8 (2 x 1950 mm dia.)

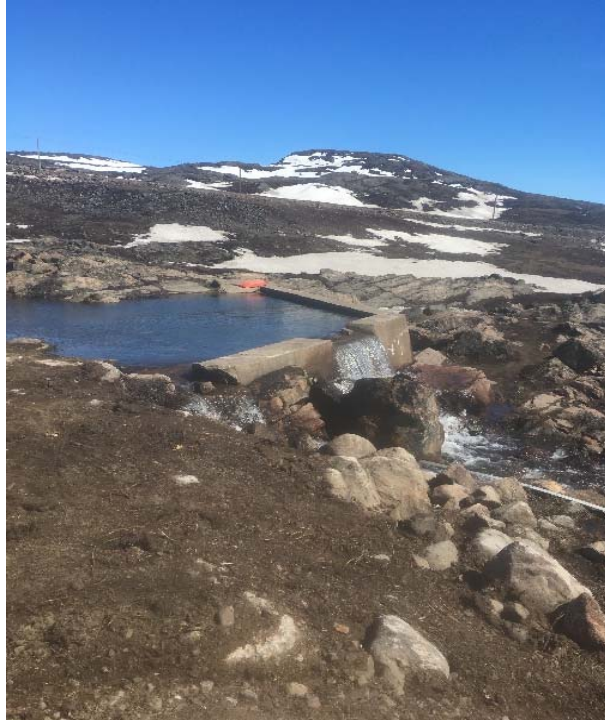
Crossing 9  
looking  
South -  
Concrete  
dam, over 1  
m drop.  
Complete  
barrier, no  
flow over  
structure,  
water flows  
through rock  
debris under  
structure

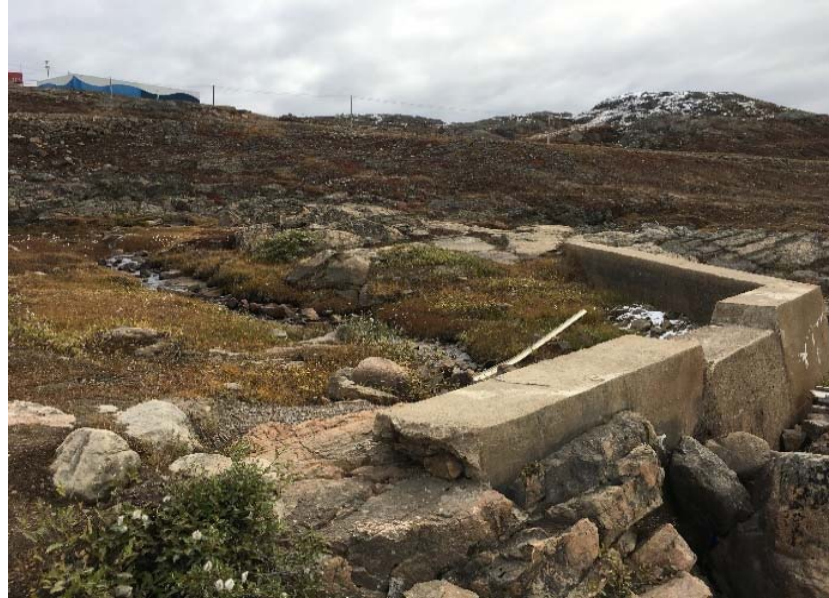
Upstream of Crossing 9 - Concrete dam, over 1 m drop.  
Complete barrier, no flow over structure, water flows  
through rock debris under structure

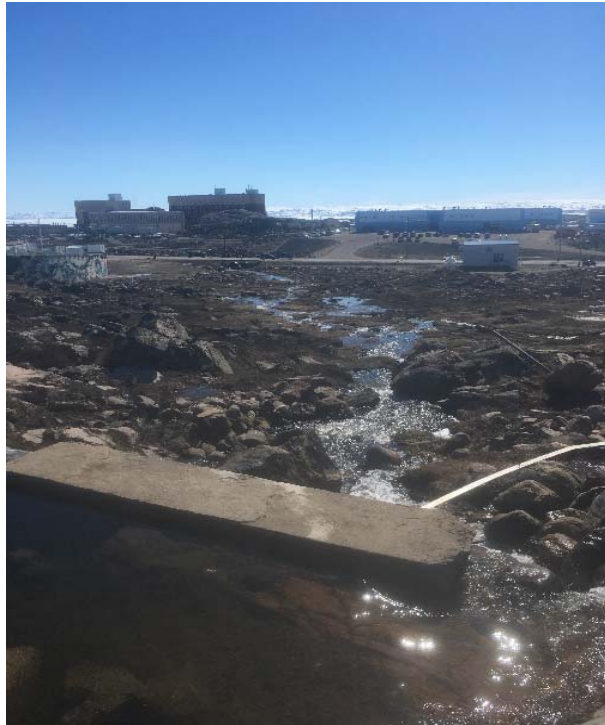
Crossing 9  
looking  
South -  
Concrete  
dam, over 1  
m drop.  
Complete  
barrier, no  
flow over  
structure,  
water flows  
through rock  
debris under  
structure

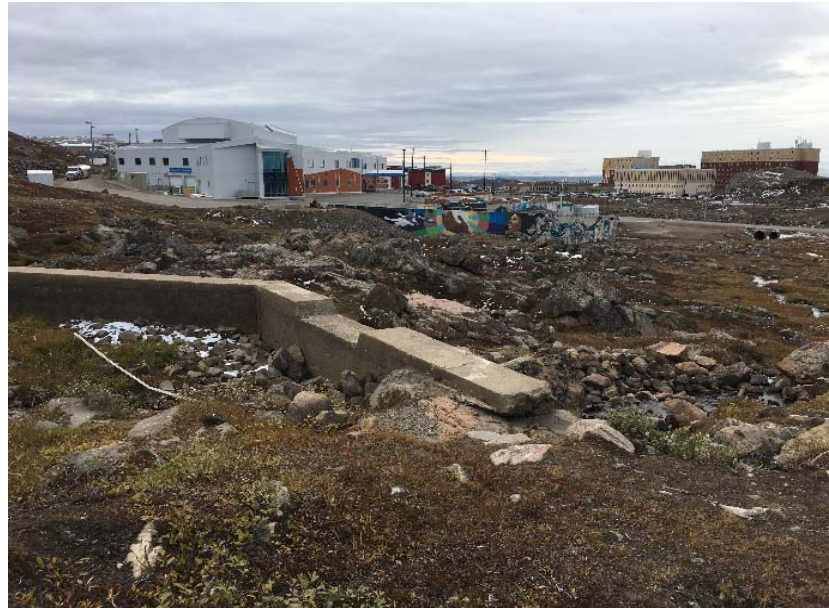
Downstream of Crossing 9 -Concrete dam, over 1 m drop.  
Complete barrier, no flow over structure, water flows  
through rock debris under structure

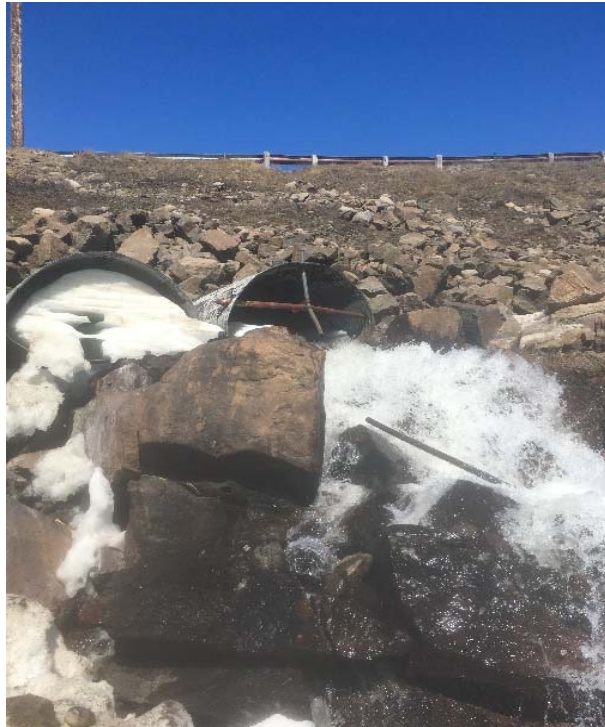
South of  
Crossing 10 (2x 1350 mm  
dia.) looking  
Downstream  
- 80 m long,  
steep  
installation

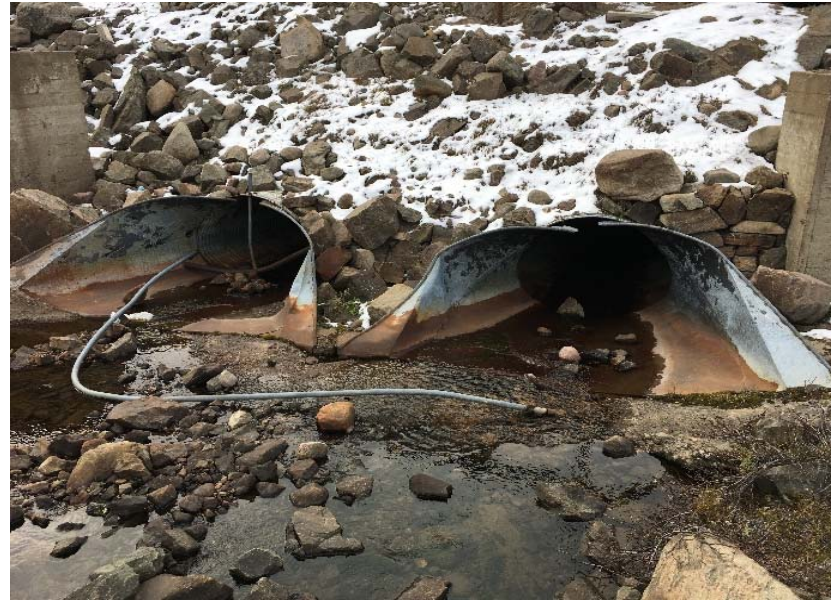
Upstream of Crossing 10 - 2 x 1350 mm dia., 80m  
long, steep installation

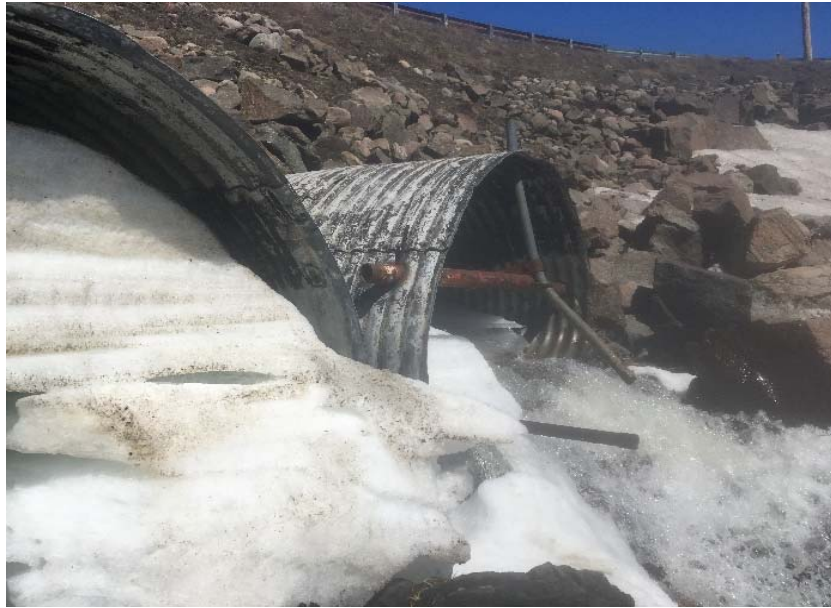
South of Crossing 10 (2 x 1350 mm dia.) looking  
Downstream - Blocked due to snow

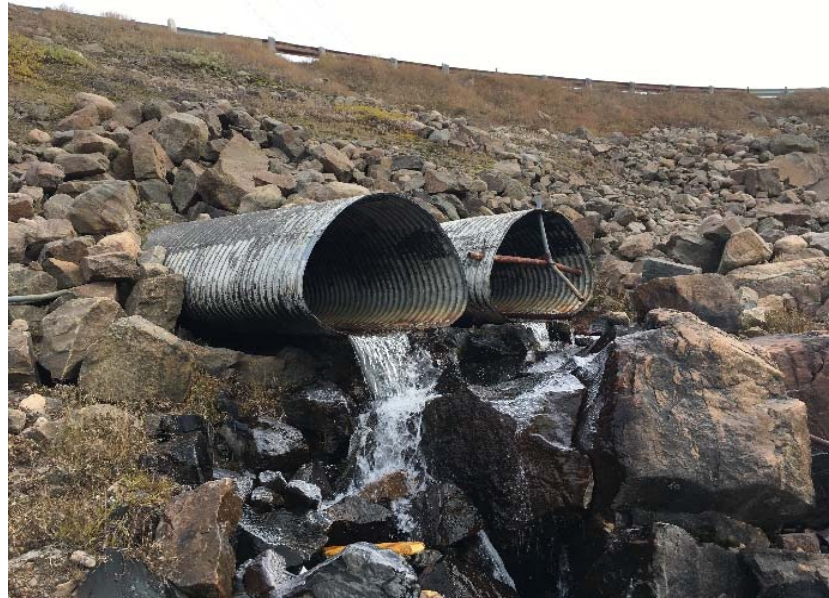
Downstream of Crossing 10 (2 x 1350 mm dia.)

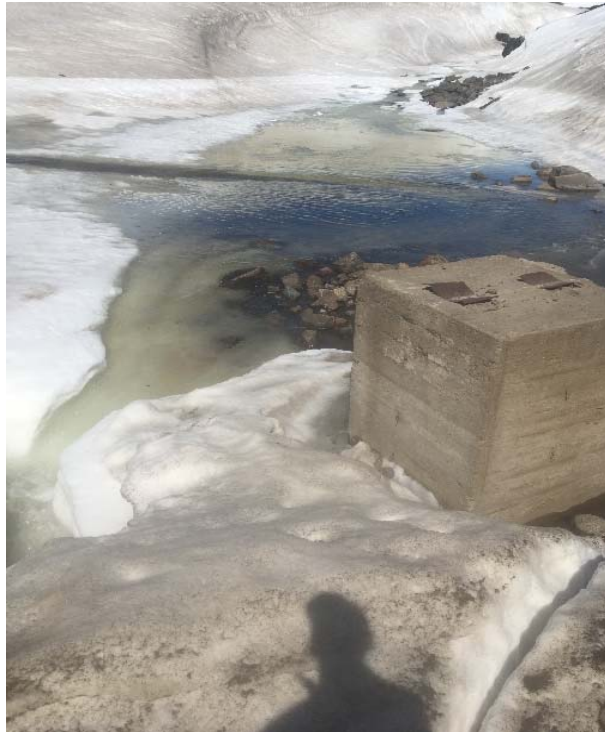
Upstream of  
Crossing 10  
Looking  
North -  
Wooden box  
identified on  
the stream

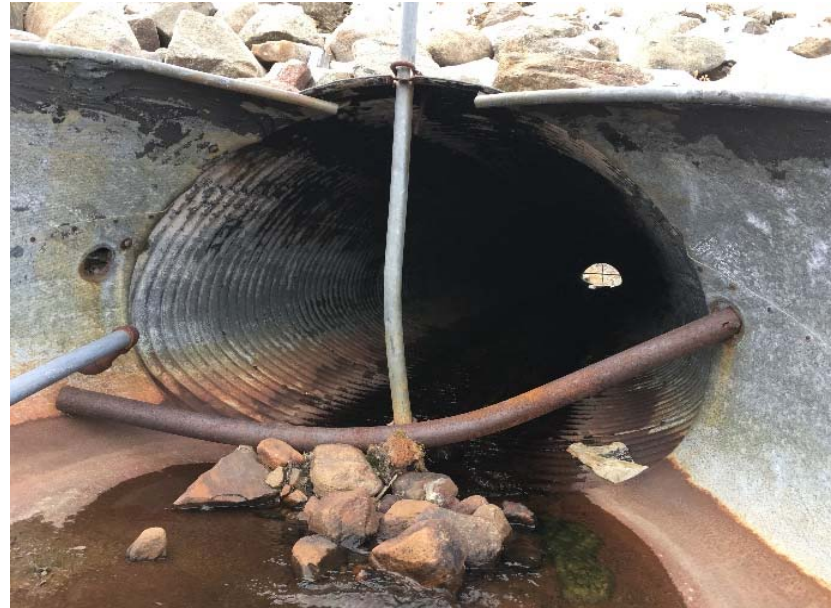
Upstream of Crossing 10 (1350 mm dia.) - Bars in  
the pipe

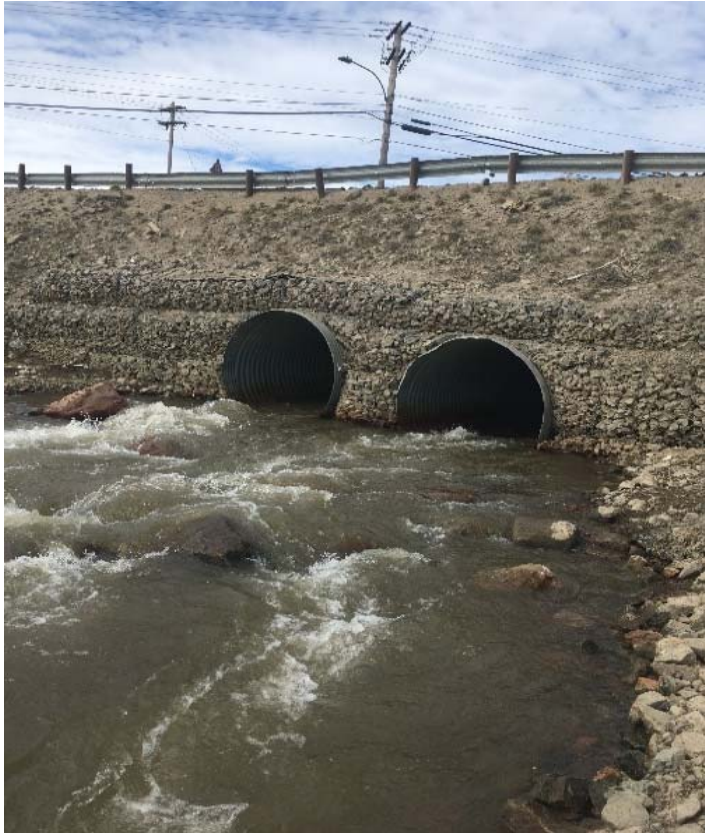
South of crossing 1 ( 2x 1800 mm dia.) – Early Spring Meltoff
