# DEVELOPMENT OF A MASTER DRAINAGE PLAN – FINAL SUBMISSION

City of Iqaluit

Nunami Stantec Ltd.  
1088C Noble House, PO Box 1779,  
Iqaluit NU X0A 0H0

144902610  
May 3, 2019

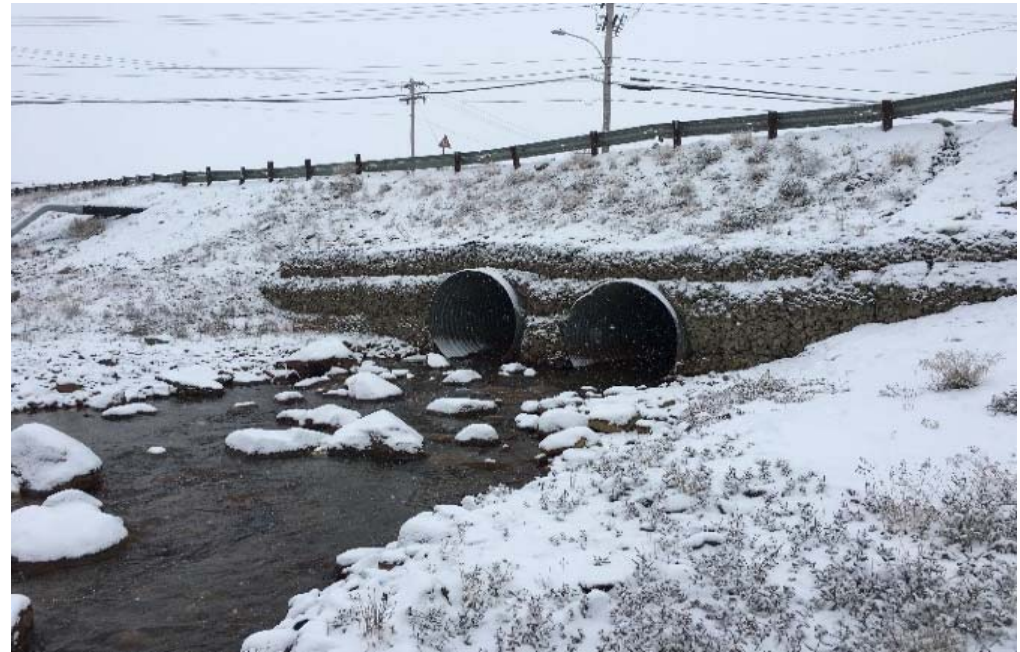
Crossing 1 (2 x 1800 mm dia.) - Early Fall

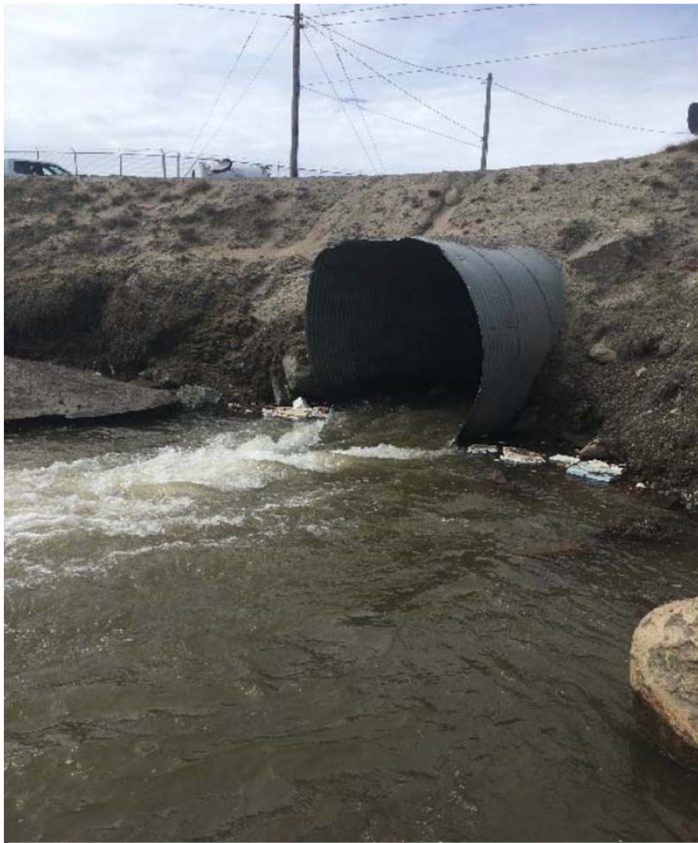
South of  
Crossing 2  
(2100 mm  
dia.) -  
Accumulated  
Garbage

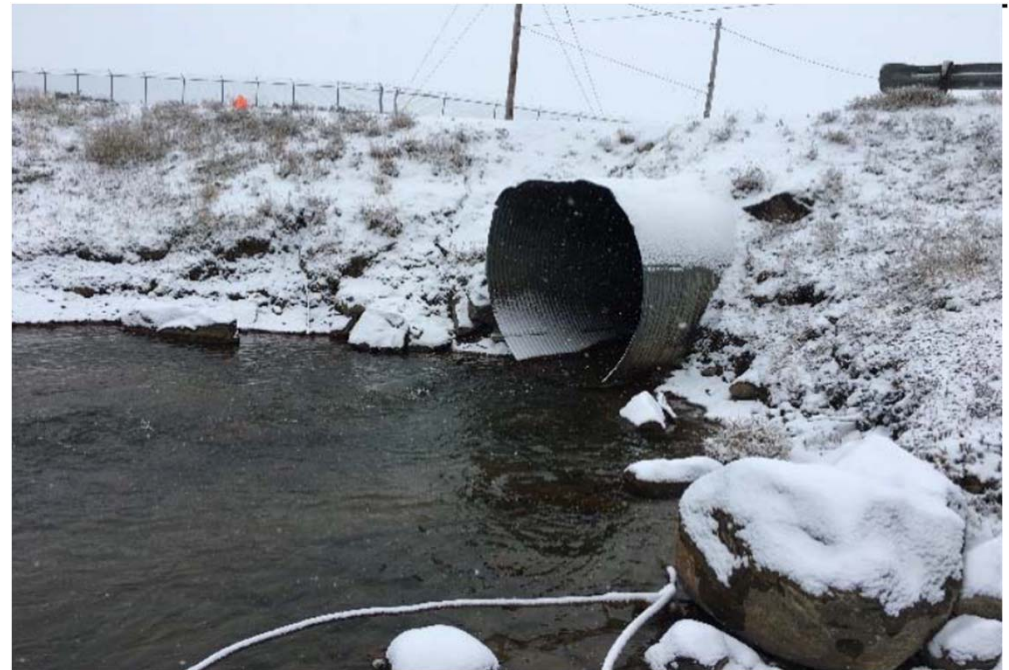
Crossing 2 (2100 mm dia.)

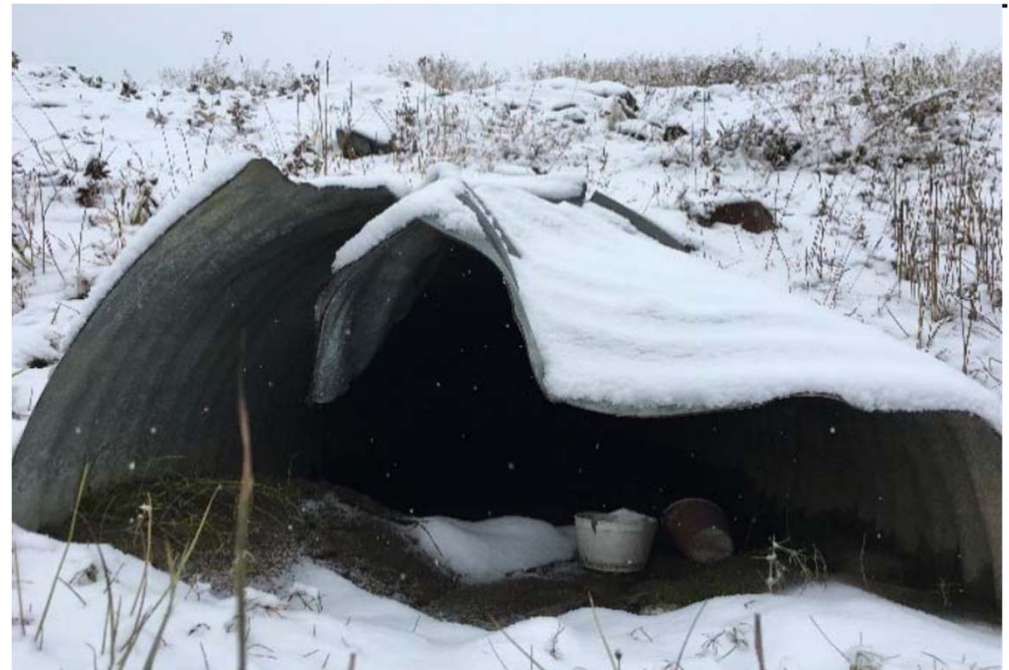
North of Crossing 3 - Deflected End

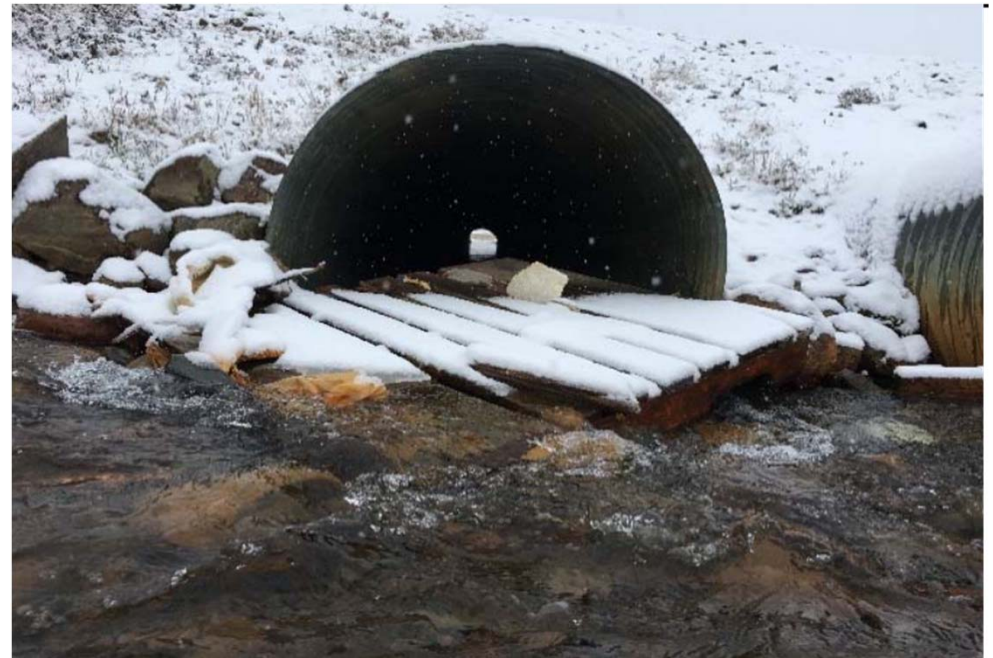
North of Crossing 3 - Wooden Pallet in Stream

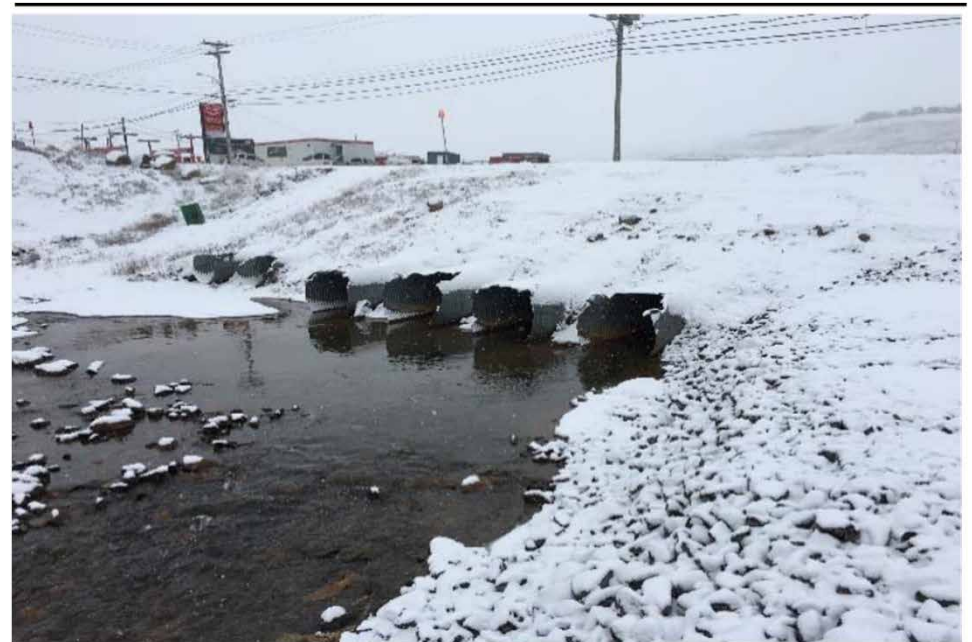
South of Crossing 3 (4 x 1200 mm dia. and 2 x 1000 mm dia.) - Early Fall

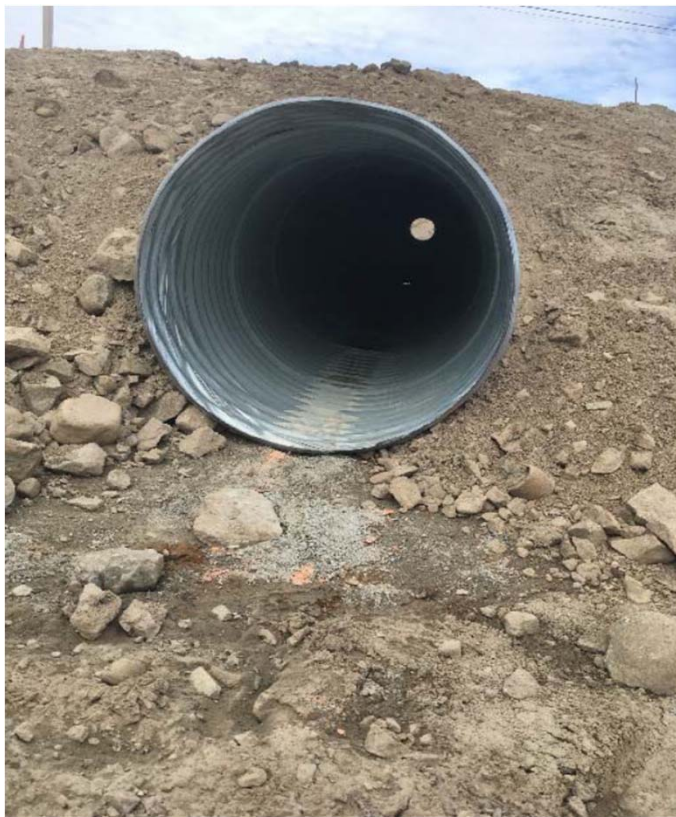
South of  
Crossing 4  
(800 mm dia.)  
-not  
receiving any  
flow

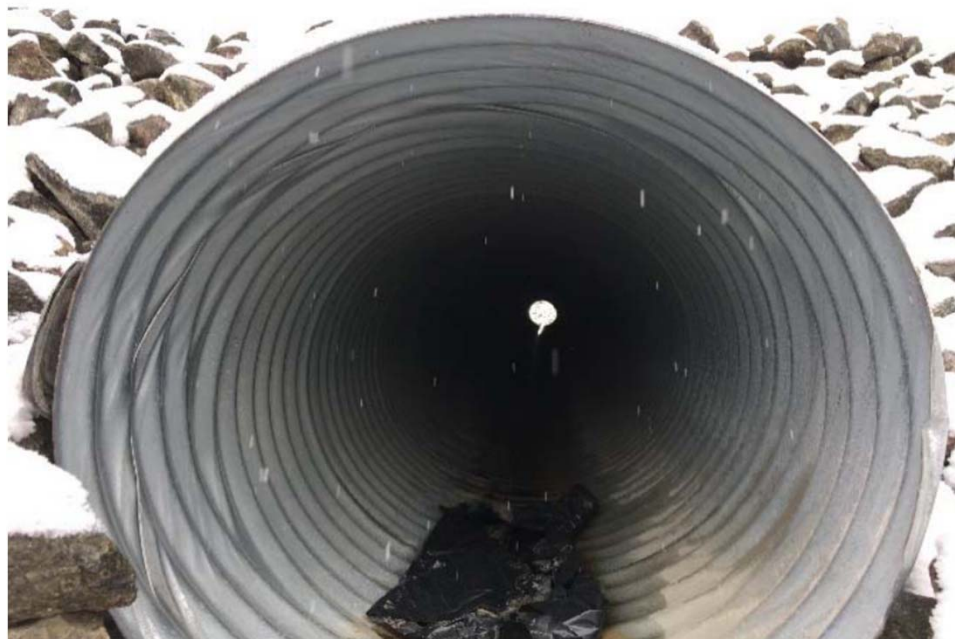
North of Crossing 4 (800 mm dia.) looking  
Upstream -Garbage in the pipe

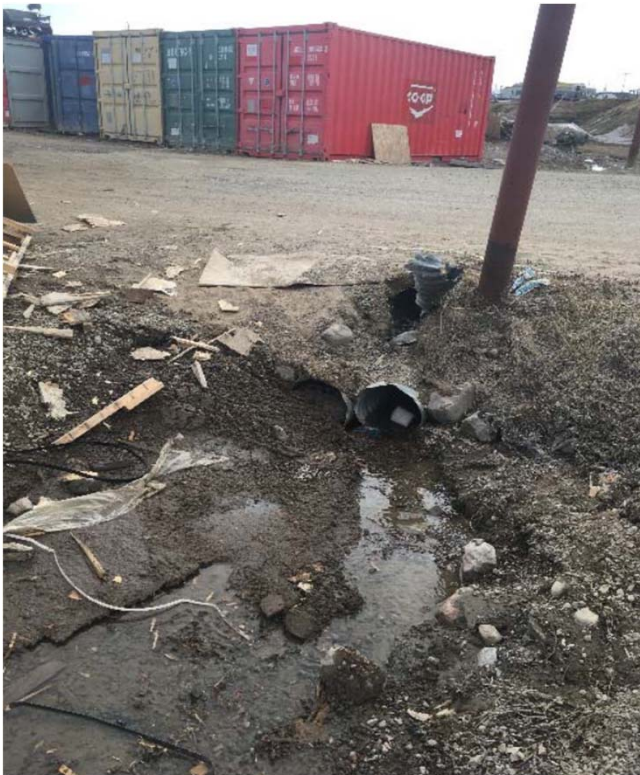
North of  
Crossing 5 (3  
x 300 mm  
dia.) -  
Garbage  
accumulated

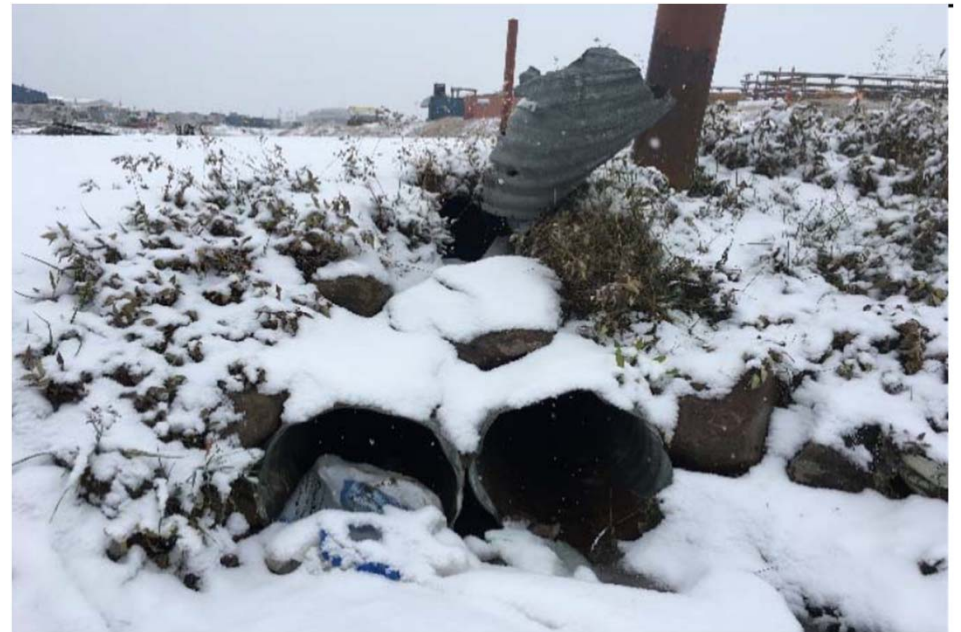
North of Crossing 5 (3 x 300 mm dia.) looking  
Upstream -Garbage in the pipe

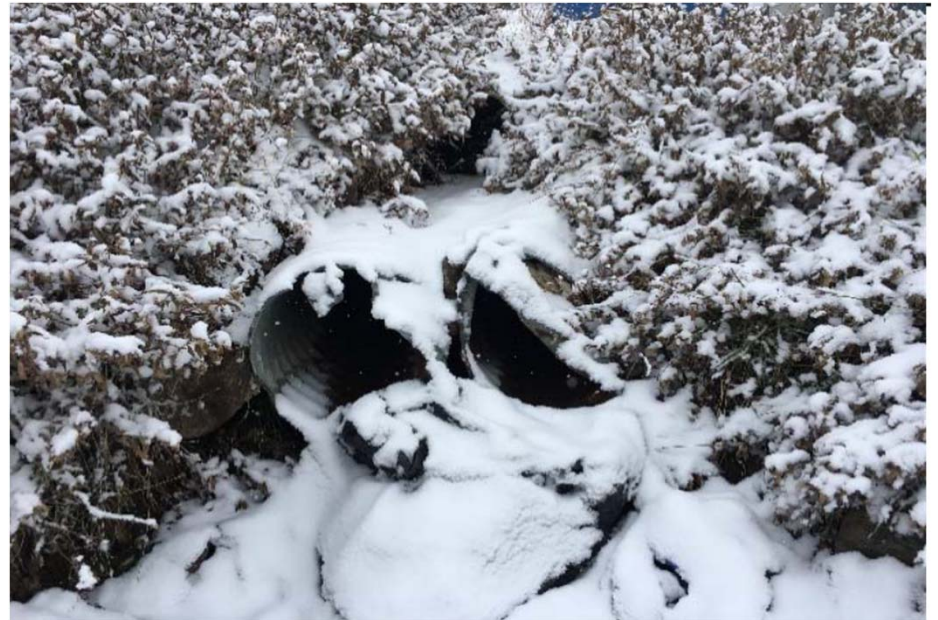
South of Crossing 5 (3 x 300 mm dia. ) looking Downstream -  
Garbage accumulated

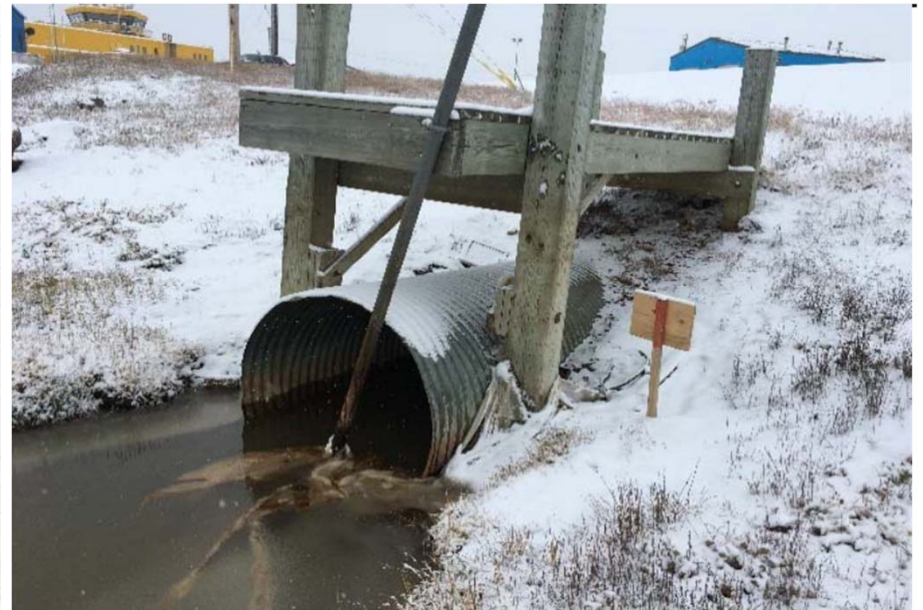
East of Crossing 6B (600 mm dia.) -Appears to be garbage in the stream

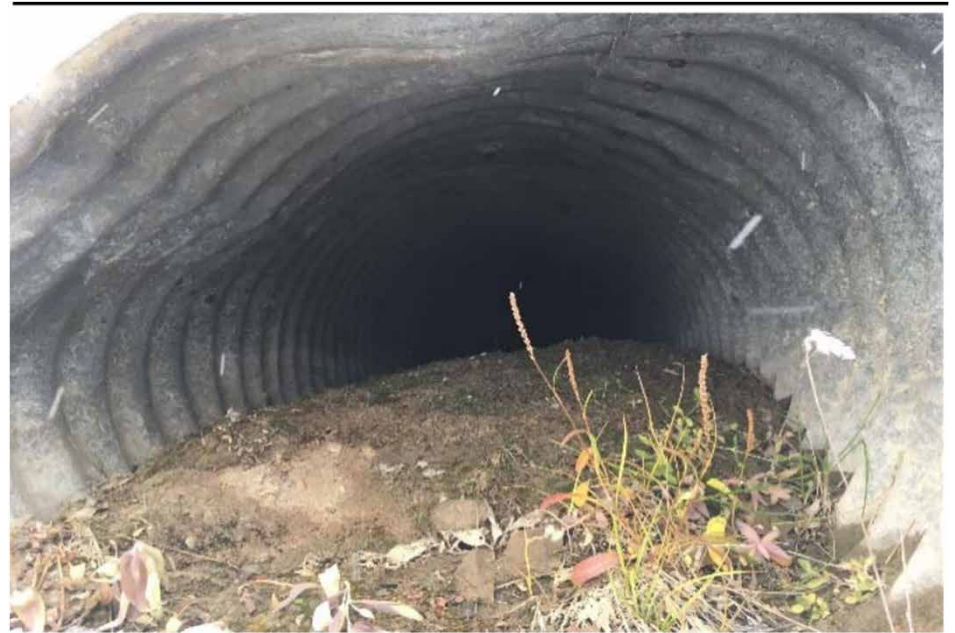
South of Crossing 7 (600 mm dia.) -Sediment buildup in the pipe

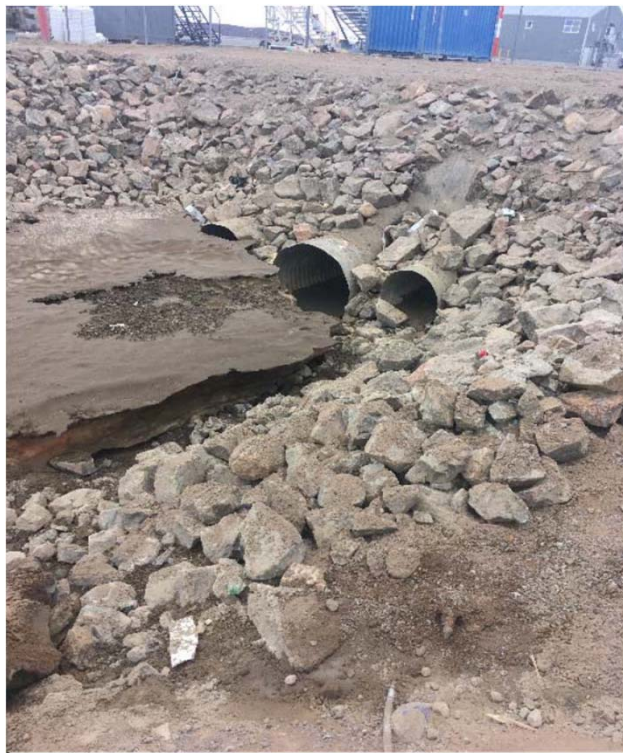
East of  
Crossing 8 (2  
x 1000 mm  
dia. and 1 x  
1600 mm  
dia.) -Snow  
about to melt

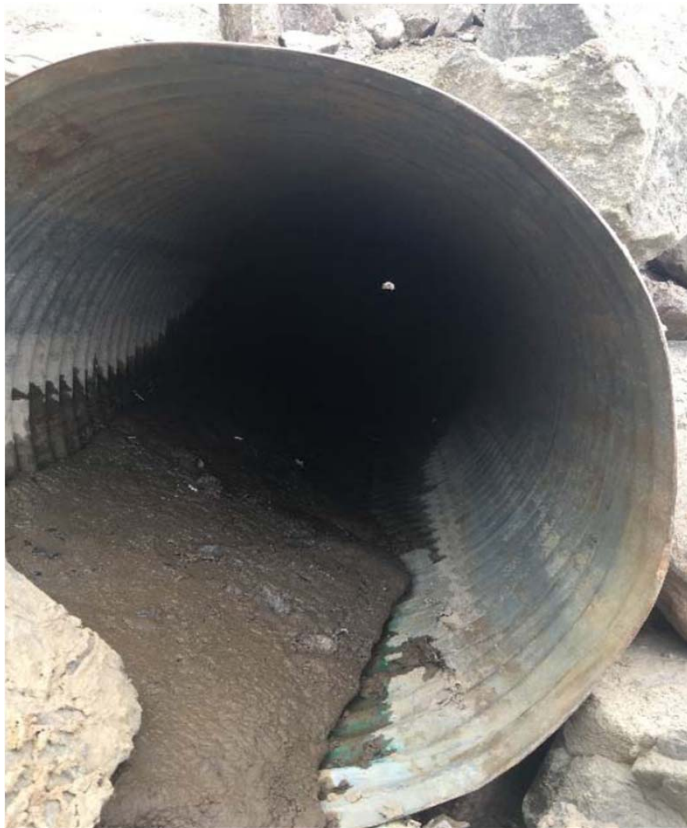
East of  
Crossing 8  
(1600 mm  
dia.) closeup -  
Sediment  
buildup inside  
the pipe

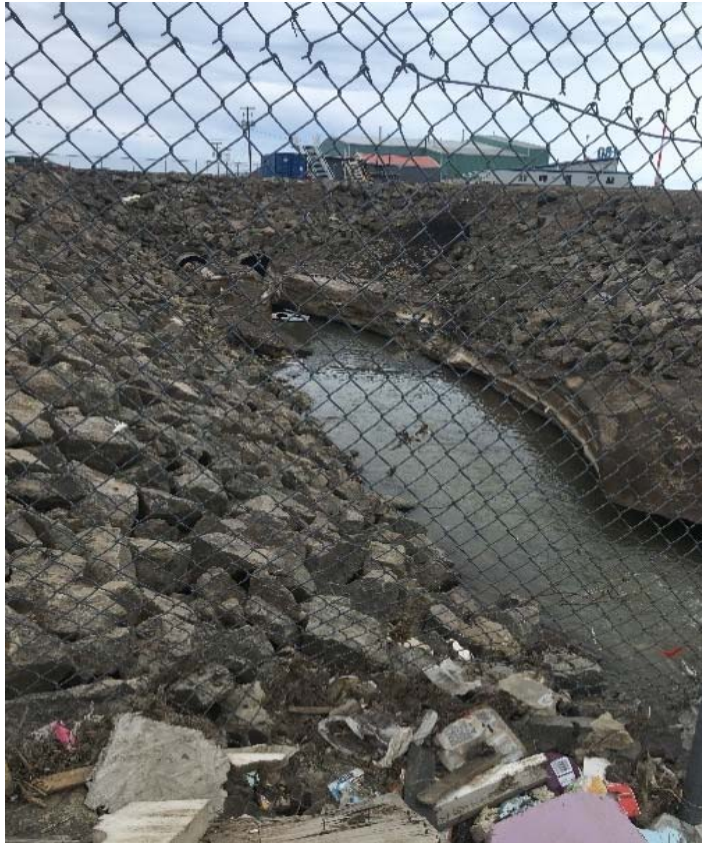
West of  
Crossing 8  
behind the  
fence -  
Garbage

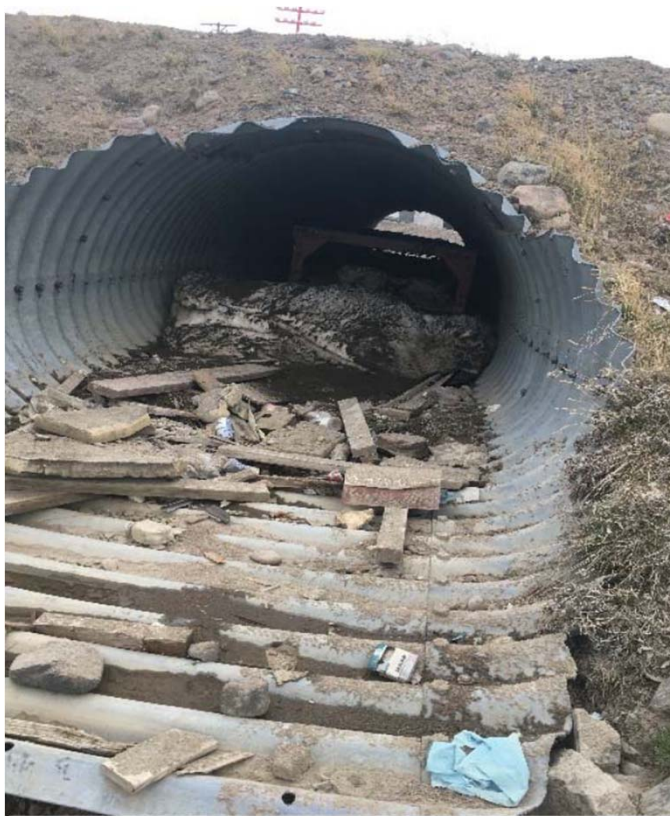
East of  
Crossing 9  
(2100 mm  
dia.)

X9	NE	SW	2100	Corrugated Steel	Circular	Projected	N	Torn out edges, significant amount of debris deposited at the upstream end. A furniture was identified in the Culvert	
X10a	NW	SE	3100	Corrugated Steel	Arch	Projected	N	Garbage deposits at the upstream end	
X10b	NW	SE	1600	Corrugated Steel	Circular	Projected	N		
X12a	N	S	1000	Corrugated Steel	Circular	Projected	N	Deformed Culvert, elliptical in shape, surface corrosion on floor	
X12b	N	S	1000	Corrugated Steel	Circular	Projected	N	Worn Out Edges, surface corrosion on floor	
X12c	N	S	1000	Corrugated Steel	Circular	Projected	N	Surface corrosion on floor	
X12d	N	S	2100	Corrugated Steel	Circular	Projected	N	Deformed Culvert, deflected sidewall at 2 O'clock, at the downstream end.	
X13	NW	SE	1600	Corrugated Steel	Circular	Projected	N	Deteriorated Edges at the downstream end

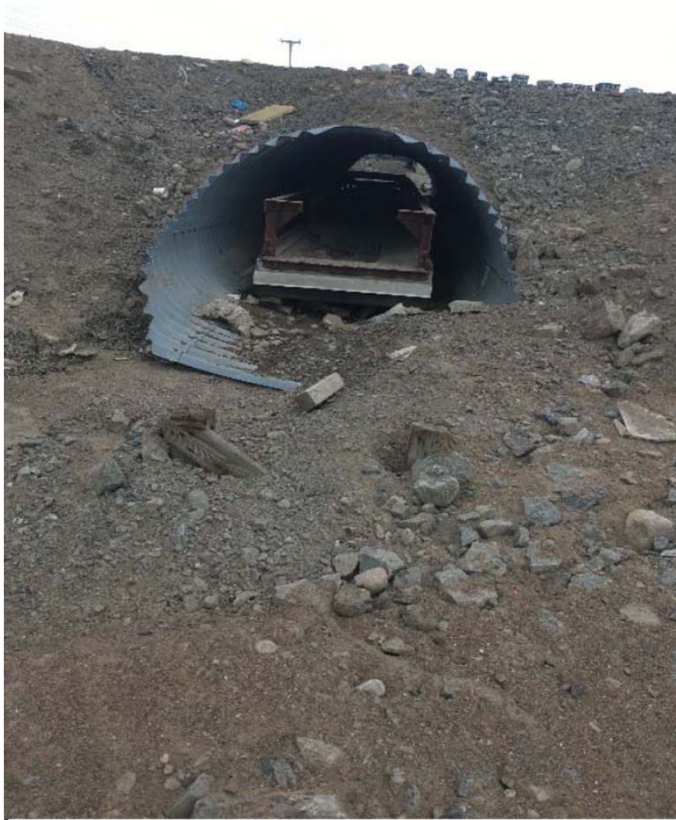
West of  
Crossing 9  
(2100 mm  
dia.) -  
Furniture  
inside the  
pipe

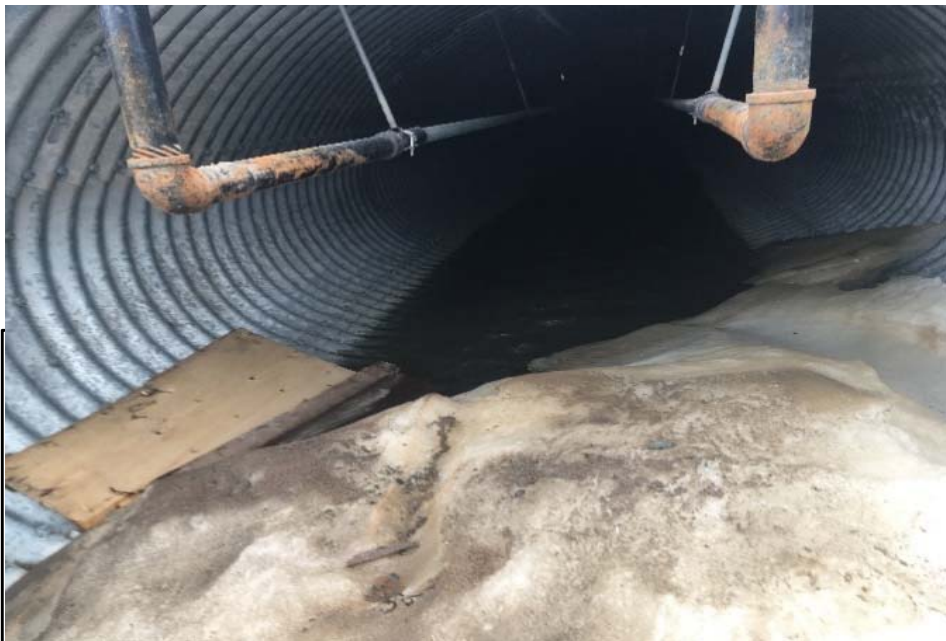
East of Crossing 10 (3100 mm dia.) -Snow melt

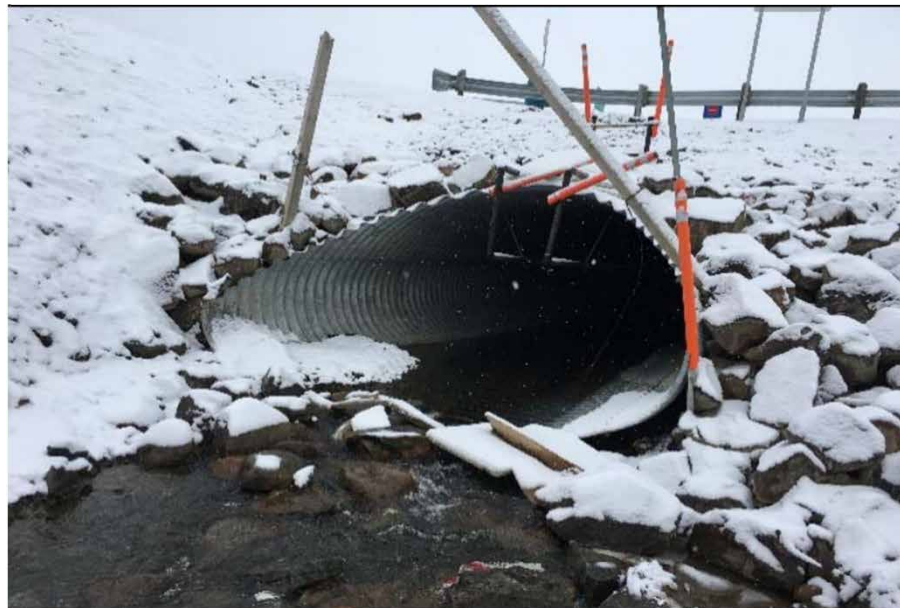
East of Crossing 10 (3100 mm dia.) -Deflected Pipe

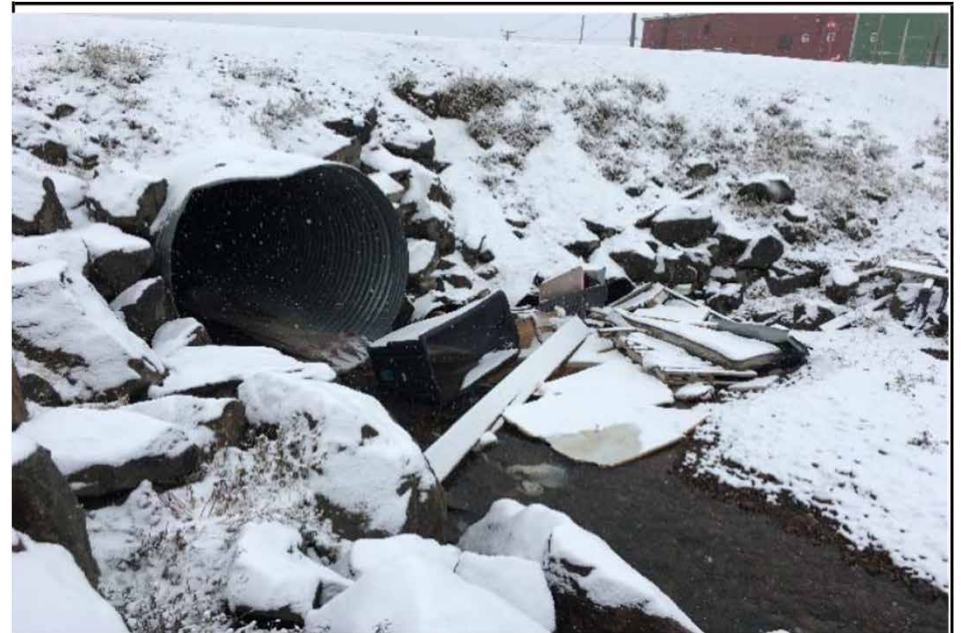
North of Crossing 12 (3 x 1000 mm dia. and 1 x 2100 mm dia.) looking  
Upstream -Garbage buildup infront of pipe

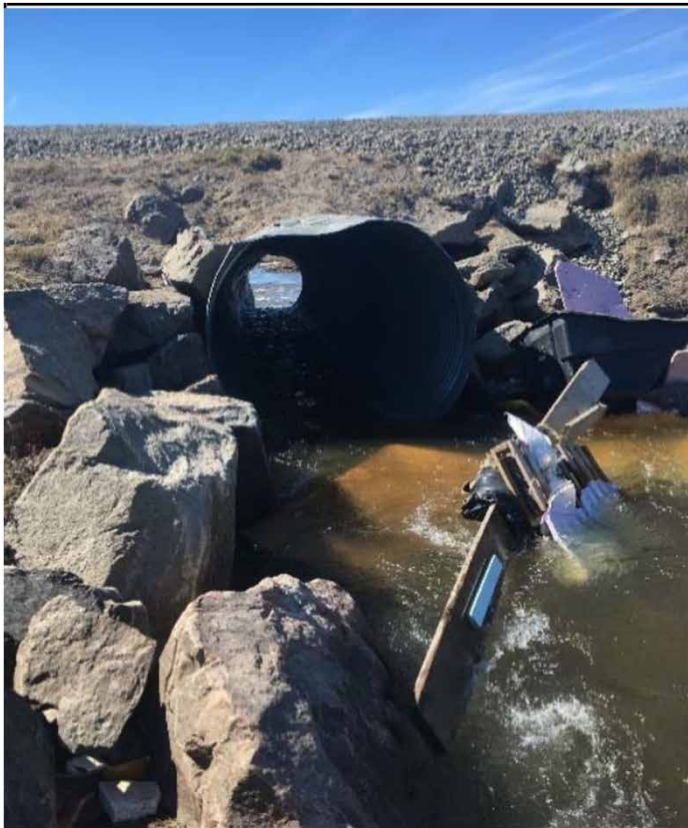
North of  
Crossing 12 (3  
x 1000 mm  
dia. and 1 x  
2100 mm  
dia.) -  
Garbage in  
the stream

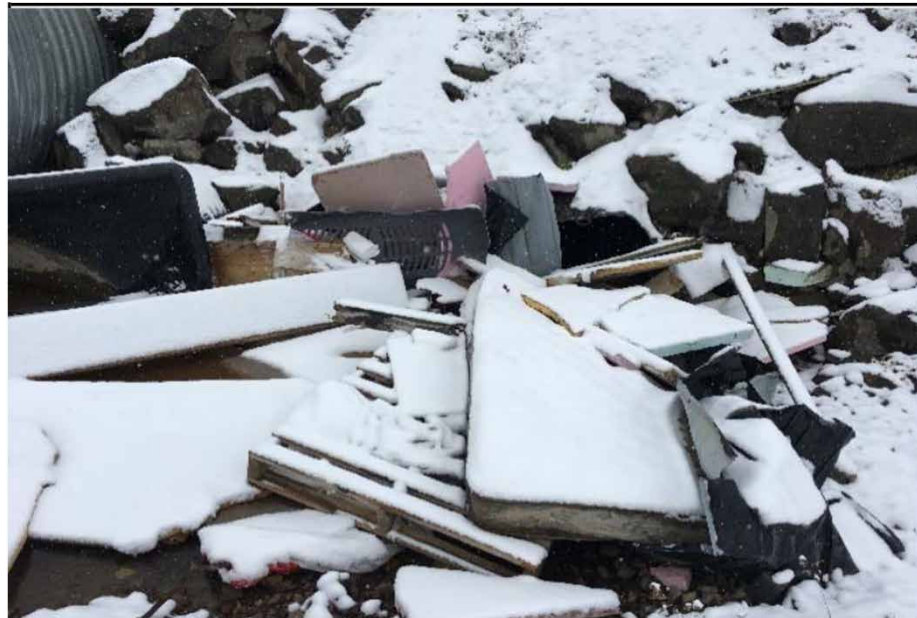
North of Crossing 12 (3 x 1000 mm dia. and 1 x 2100 mm dia.) looking  
Upstream -Wooden Pallets and Garbage

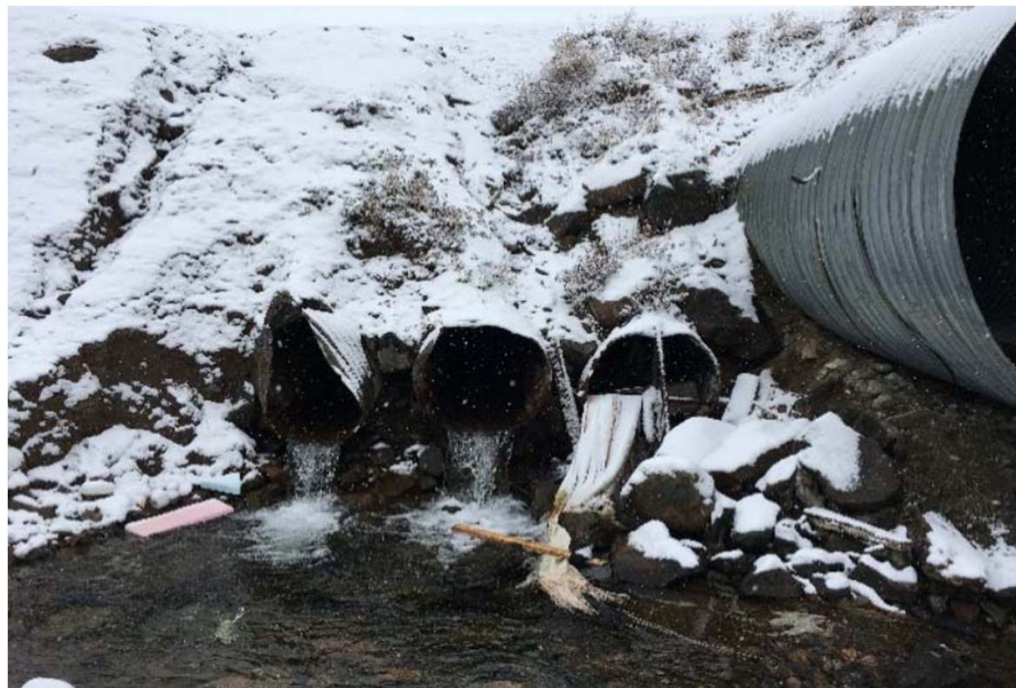
South of Crossing 12 (3 x 1000 mm dia. and 1 x  
2100 mm dia.) looking Downstream -Garbage in  
the flow

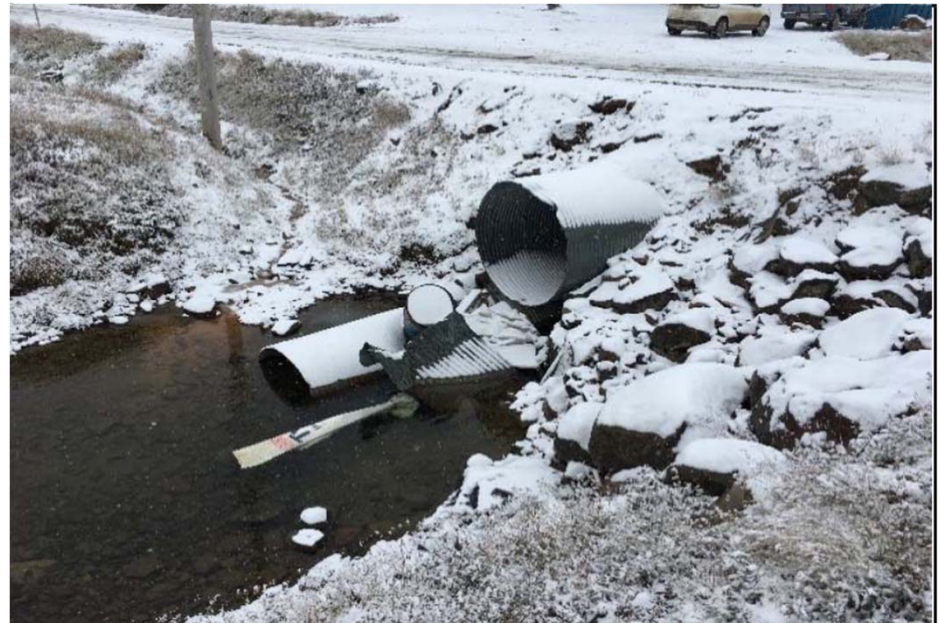
East of Crossing 13 (1600 mm dia.) looking  
Downstream -Garage in the stream

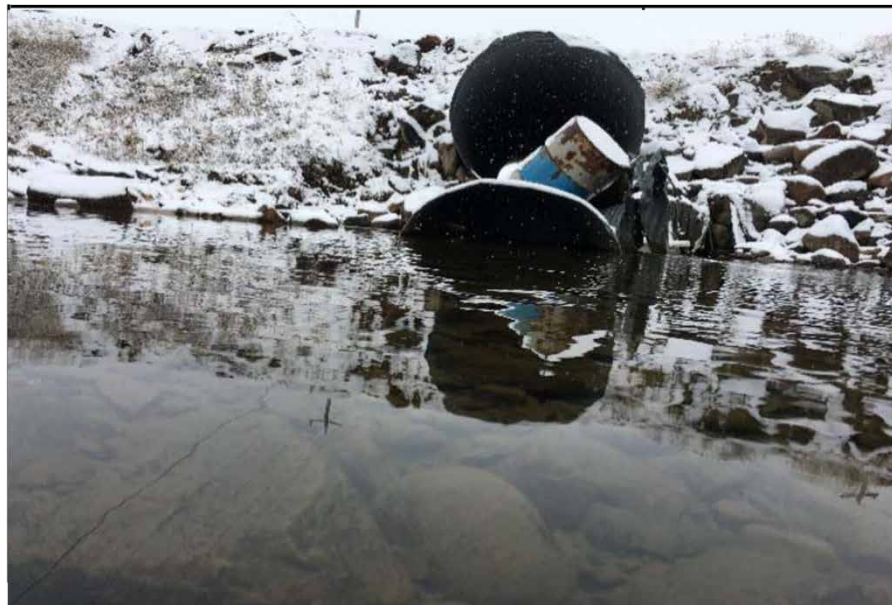
East of Crossing 13 (1600 mm dia.) looking Downstream -Barrel  
inside the pipe, probably received during the stream flow

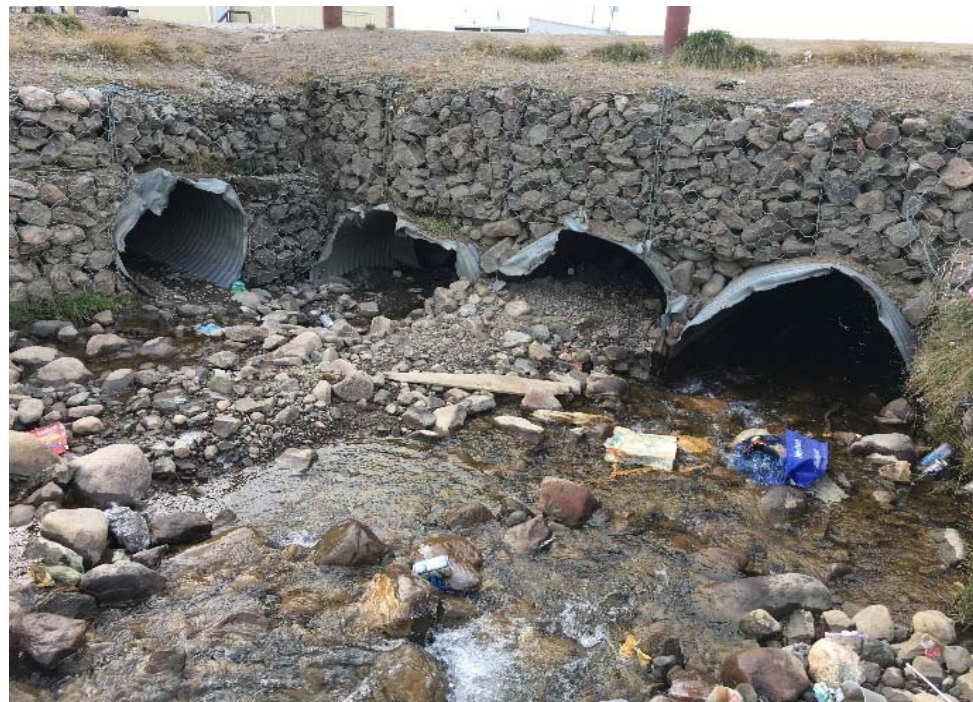
Upstream of Crossing 2 (3 x 1200 mm dia.) -  
Garbage in front of the pipe

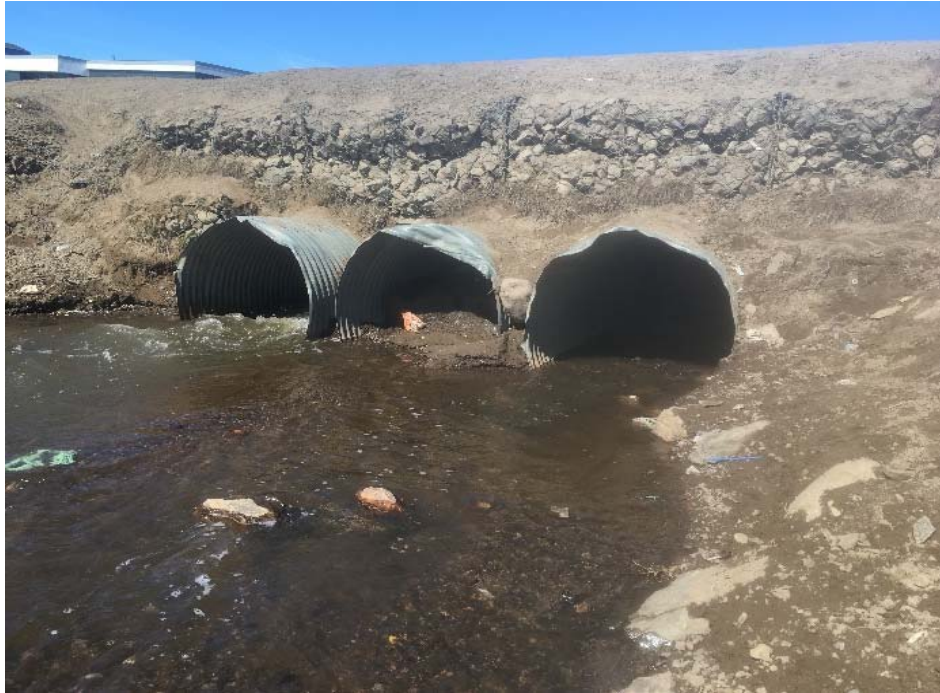
South of Crossing 2 (3 x 1200 mm dia.) - Garbage in the stream, pipe not in good shape

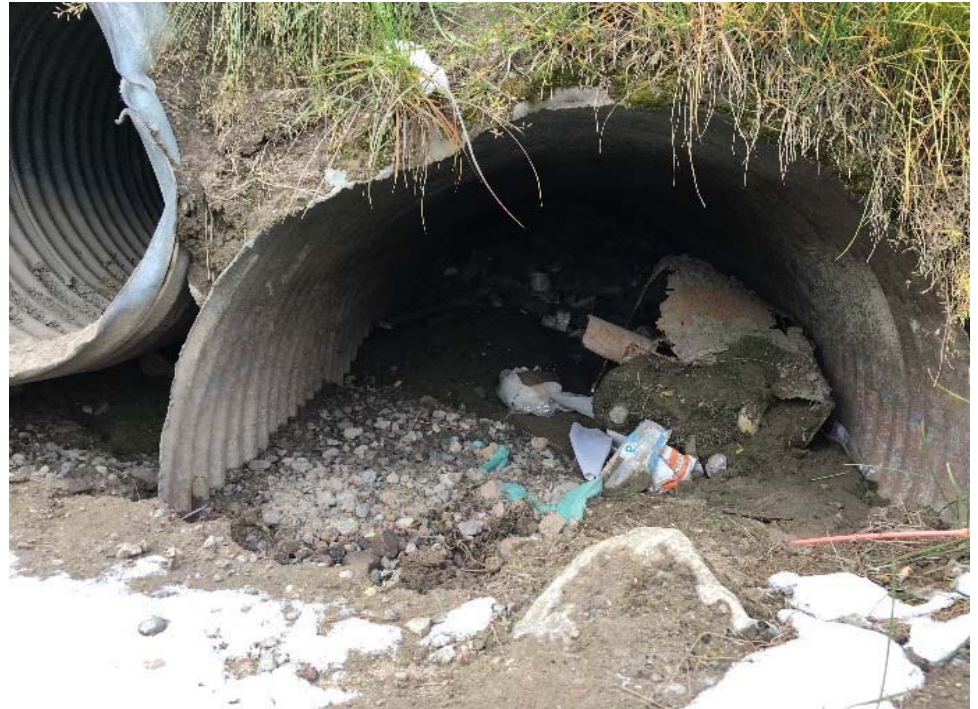
Upstream of Crossing 3 (1500 mm dia.) -Garbage and sediment buildup inside the pipe

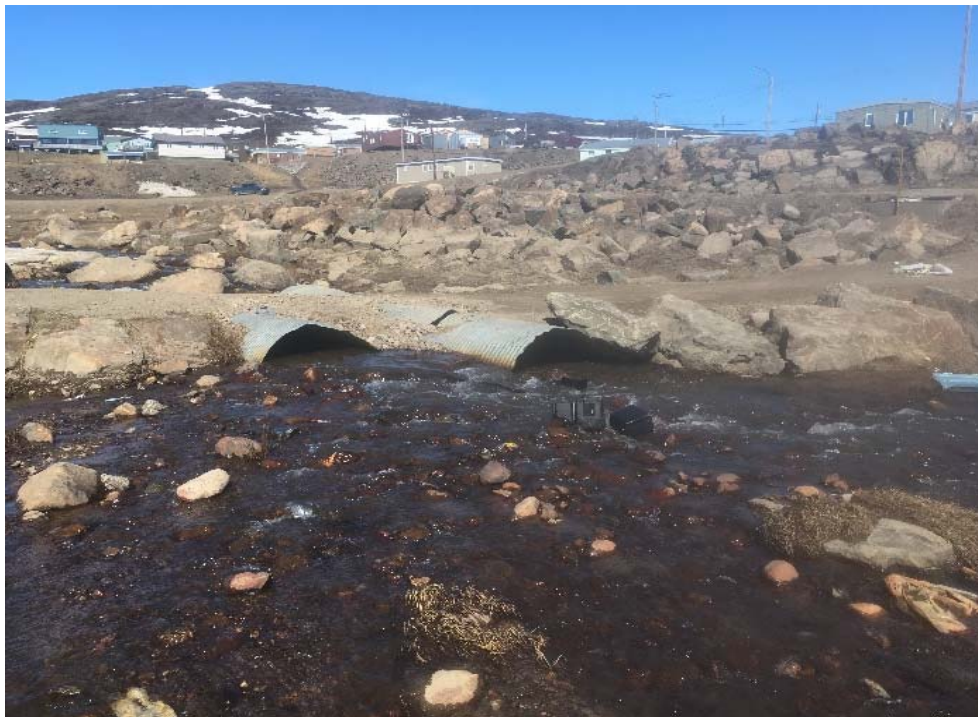
Crossing 4 (2 x 1350 mm dia.) looking North -Pipes half buried in the substrate

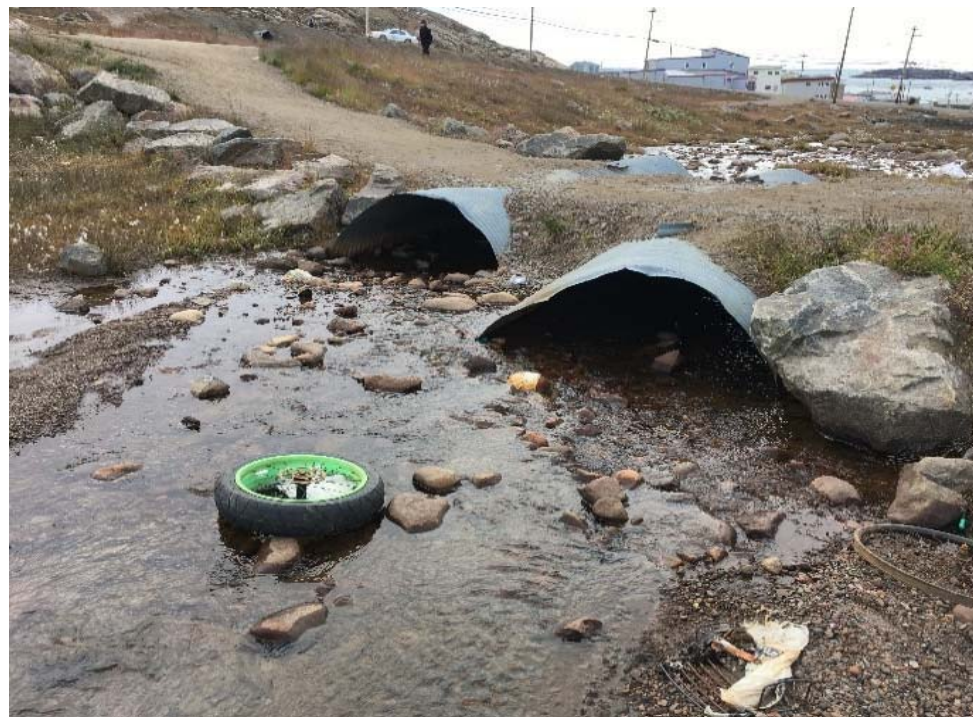
Upstream of Crossing 4 (2 x 1350 mm dia.) -Tire seen in the stream, pipes half buried in the substrate

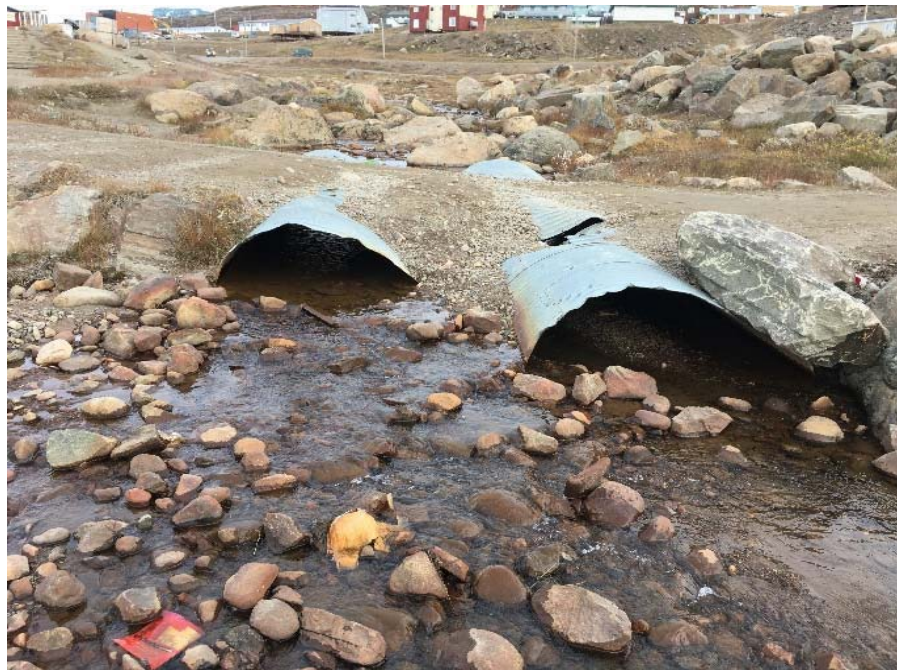
Downstream of Crossing 4 (2 x 1350 mm dia.) -  
Garbage in the stream

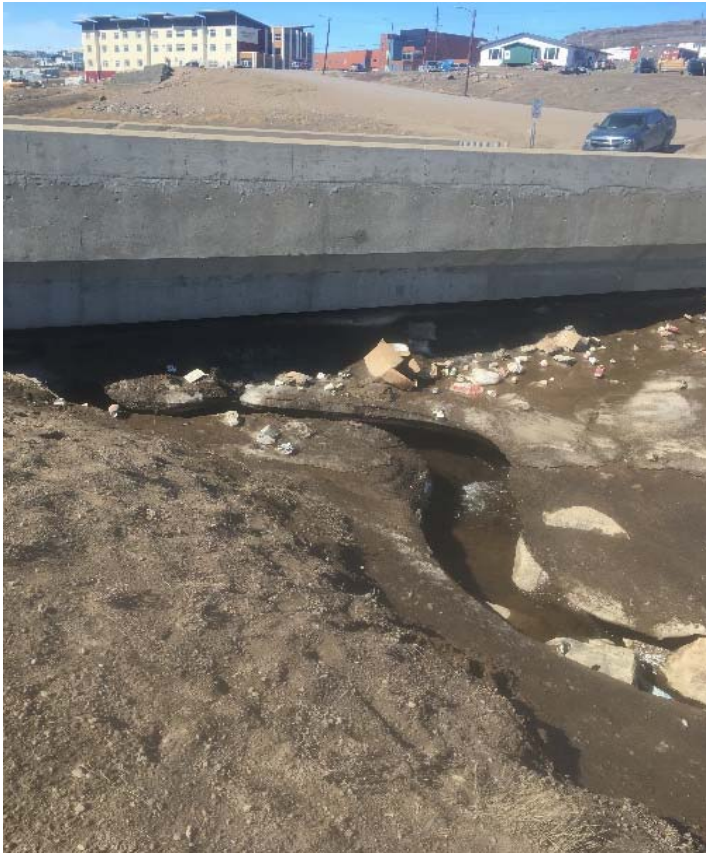
Crossing 5 looking  
West  
-Clear span bridge,  
13 m wide over a  
channel with 7m  
wide bankful.  
Unstable bank on  
downstream left

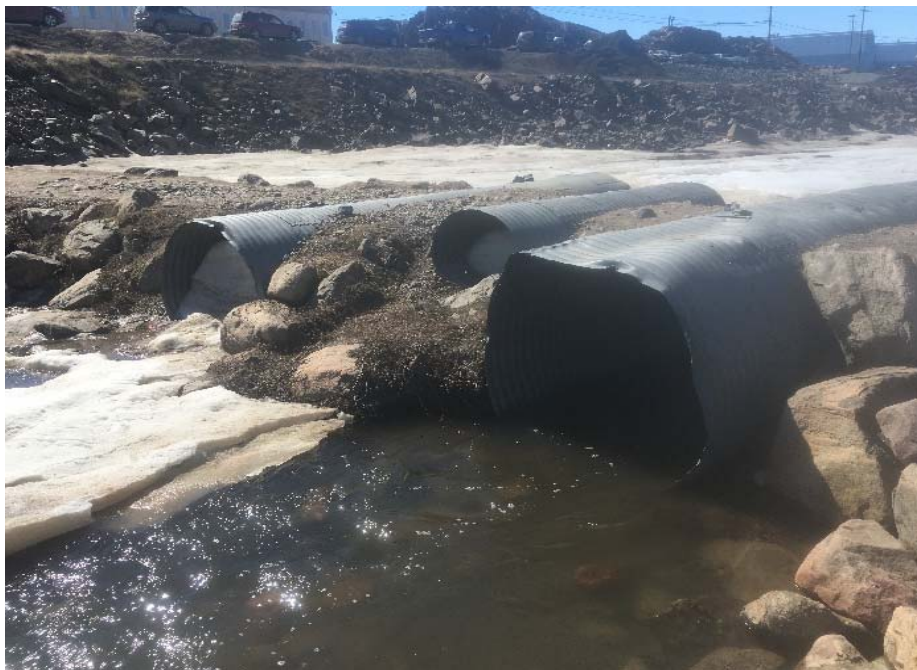
Crossing 6 ( 2 x 1300 mm dia. and 1 x 800 mm dia. overflow) looking South West -Blocked due to snow

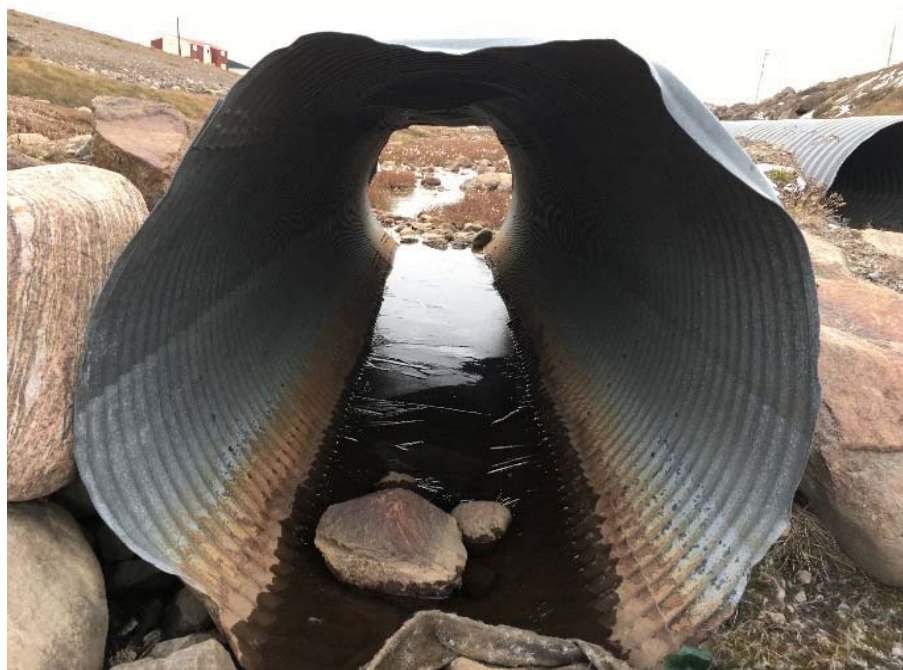
Upstream of Crossing 6 (1300 mm dia.) -Deflected Pipe

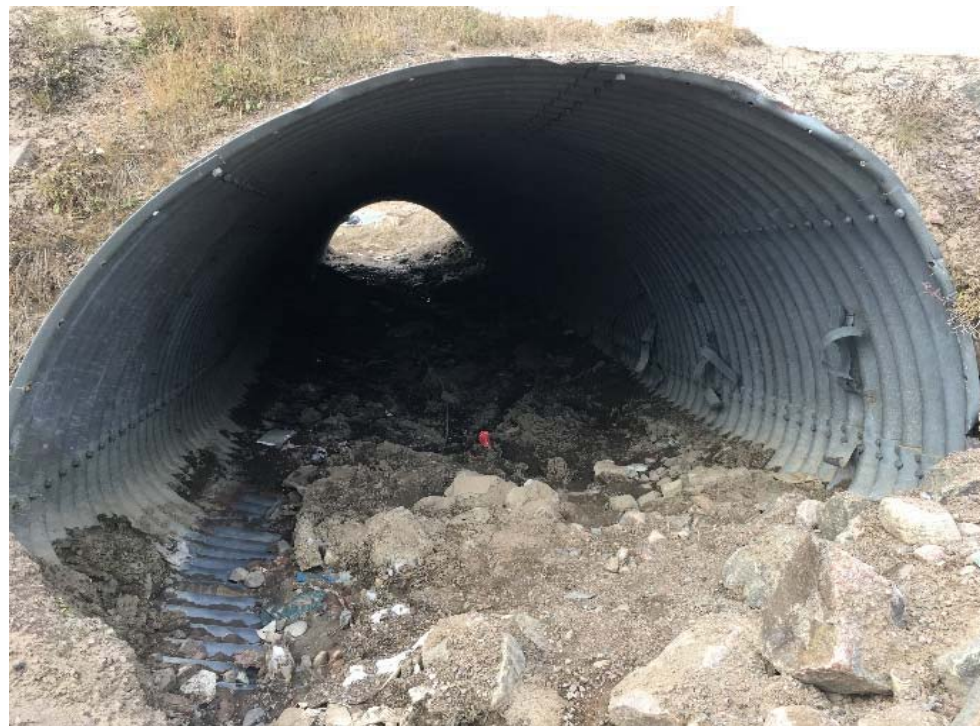
Upstream of Crossing 7 (3200 mm dia.) - Sediment  
Buildup inside the pipe

X7	Footings	NW	SE	3200	Wooden Cribs	Arch	Projected	Y	Significant amount of fine and rock deposits in the Culvert. Culvert inoperable.
X8a		N	S	1950	Corrugated Steel	Circular	Projected	N	
X8b		N	S	1950	Corrugated Steel	Circular	Projected	Y	
X9	Dam	N	S						Concrete wingwall is broken ,and not tied in long enough. Undermined structure. Further degradation of dam could result in possible collapse.
X10a		N	S	1350	Corrugated Steel	Arch	Beveled	N	Culvert significantly corroded at the floor, minor gravel deposits observed
X10b		N	S	1350	Corrugated Steel	Arch	Beveled	N	Culvert significantly corroded at the floor, minor gravel deposits observed
