# DEVELOPMENT OF A MASTER DRAINAGE PLAN – FINAL SUBMISSION

City of Iqaluit

Nunami Stantec Ltd.  
1088C Noble House, PO Box 1779,  
Iqaluit NU X0A 0H0

144902610  
May 3, 2019

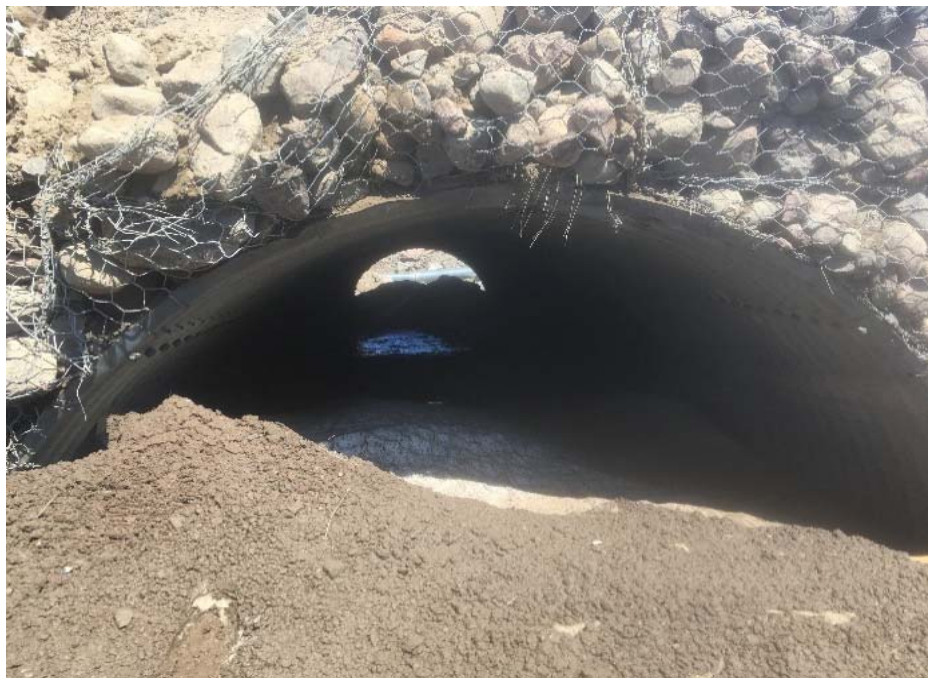
South of Crossing 7 (3200 mm dia.) looking North -  
Sediment Buildup

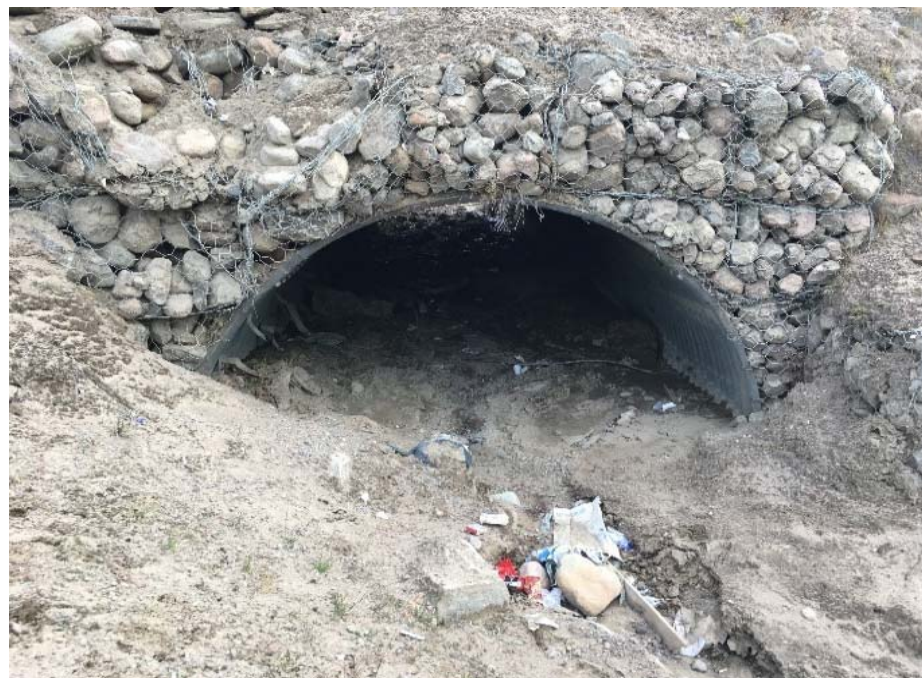
Downstream of Crossing 7 (3200 mm dia.) -Garbage infront of pipe

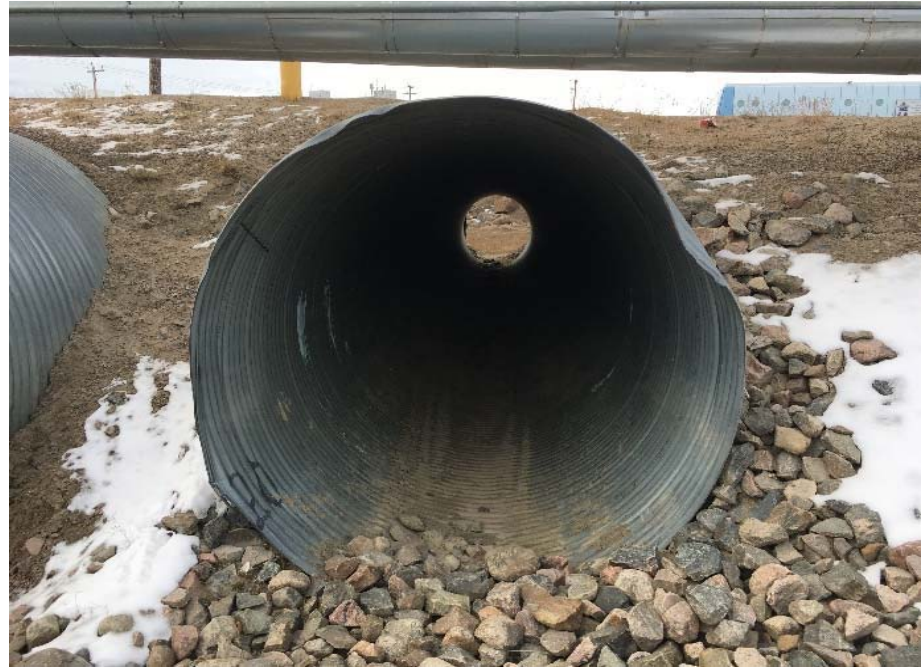
Upstream of Crossing 8 (1950 mm dia.) -Sediment buildup in front of pipe

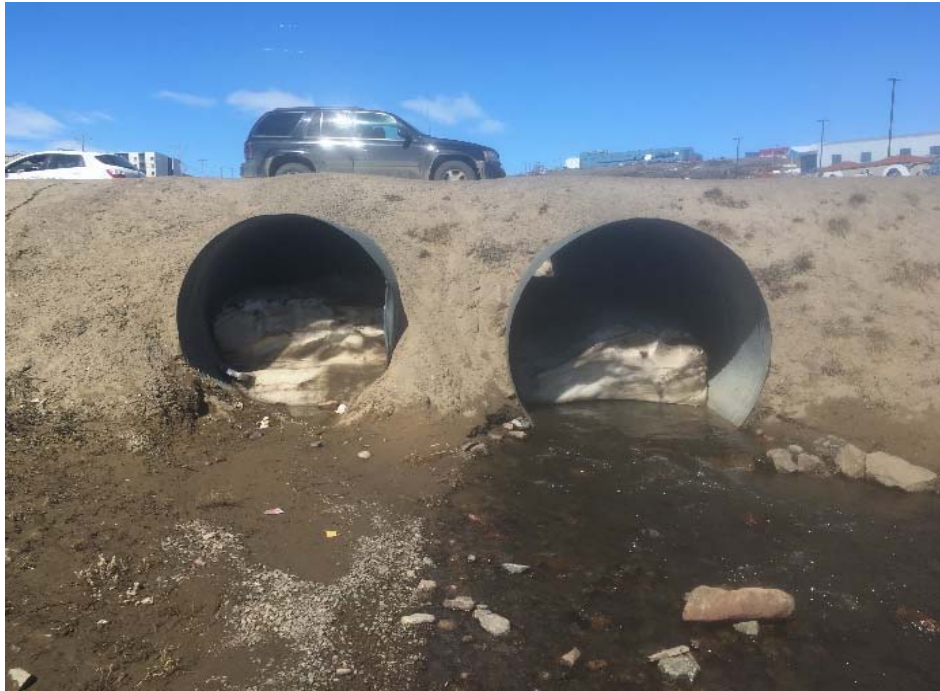
South of Crossing 8 (2 x 1950 mm dia.) looking North  
-Blocked due to snow

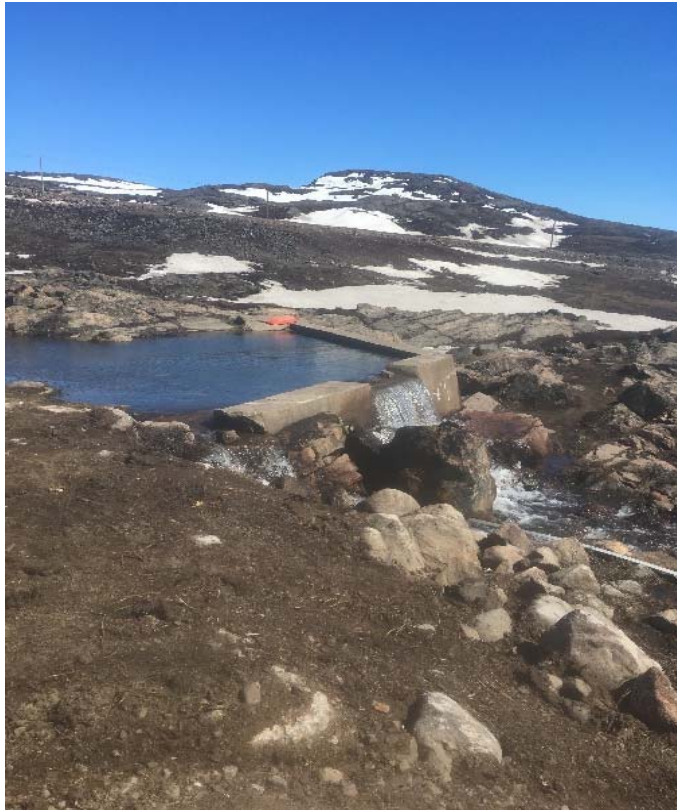
Crossing 9 looking South - Concrete dam, over 1 m drop. Complete barrier, no flow over structure, water flows through rock debris under structure

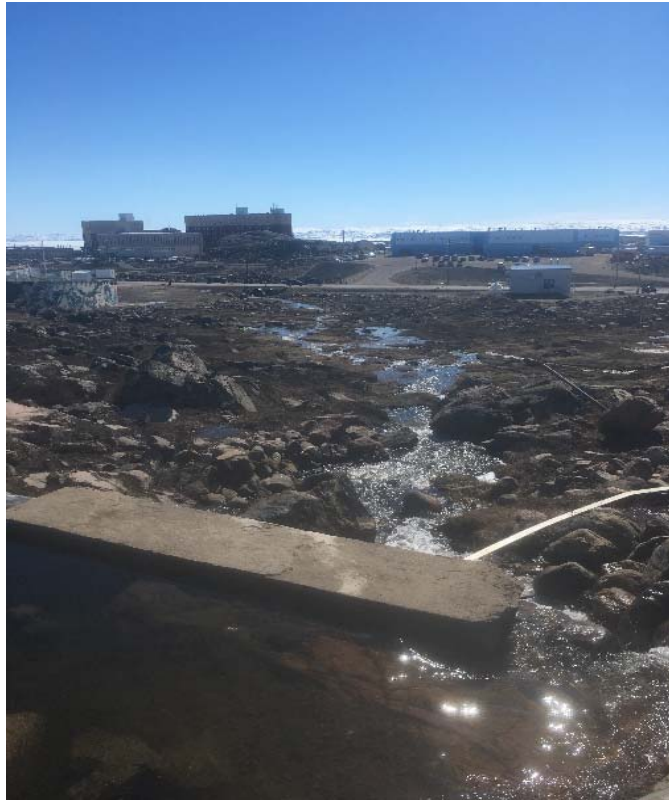
Upstream of Crossing 9 - Concrete dam, over 1 m drop. Complete barrier, no flow over structure, water flows through rock debris under structure

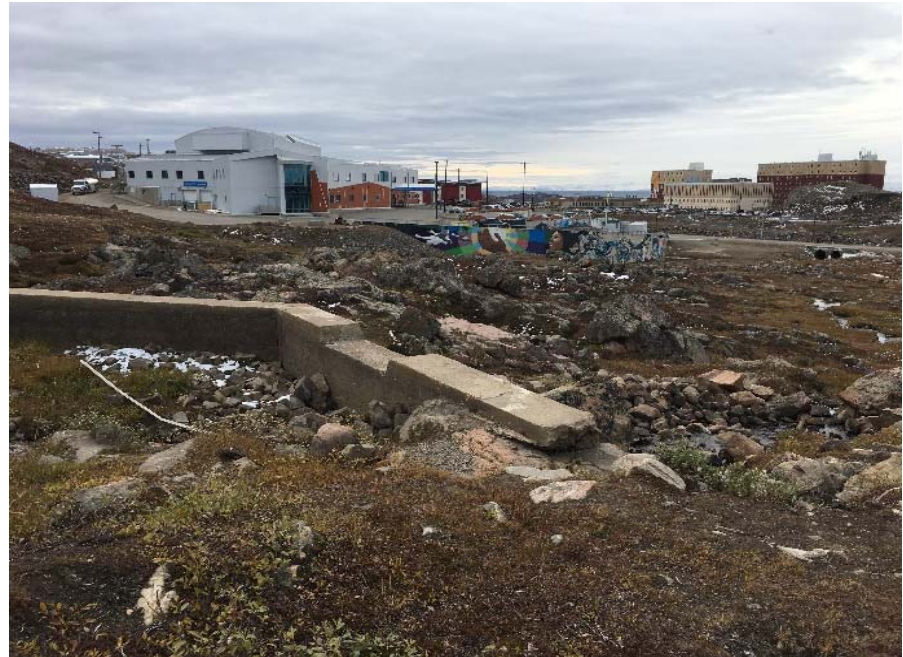
Crossing 9 looking South -Concrete dam, over 1 m drop.  
Complete barrier, no flow over structure, water flows through rock debris under structure

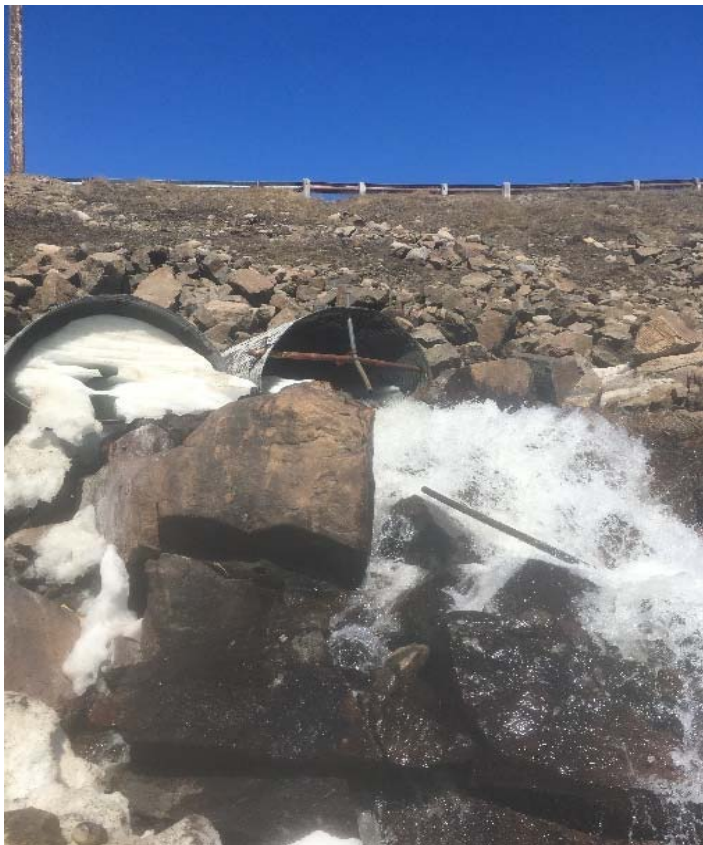
Downstream of Crossing 9 -Concrete dam, over 1 m drop.  
Complete barrier, no flow over structure, water flows through rock debris under structure

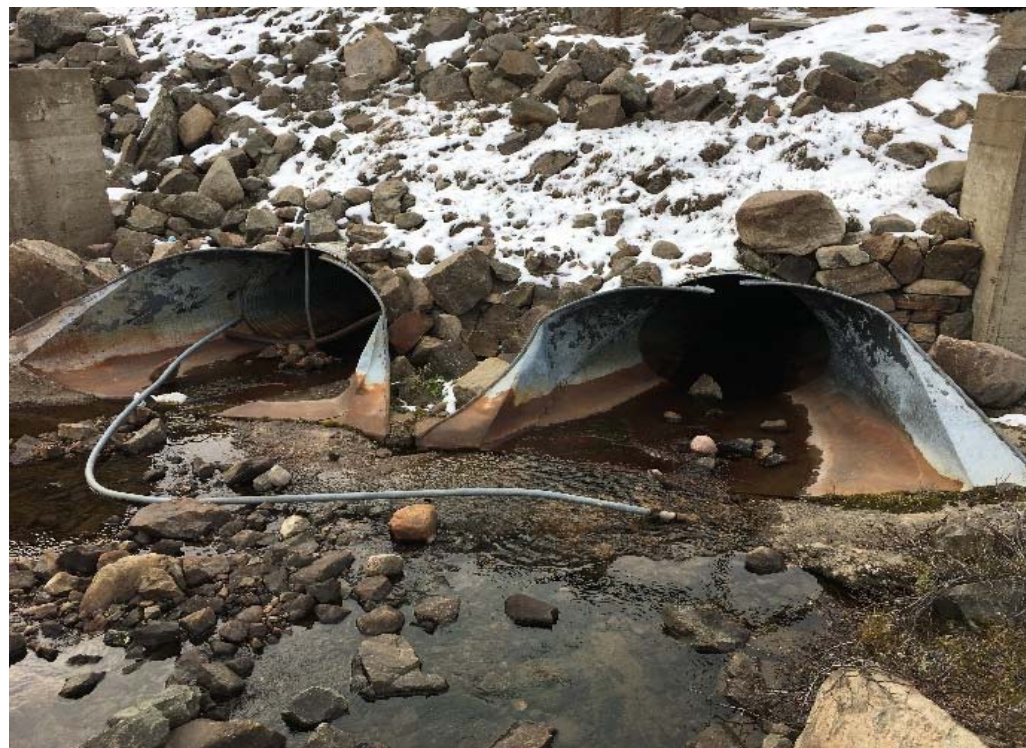
South of  
Crossing 10 (2x 1350 mm dia.) looking Downstream -80 m long, steep installation

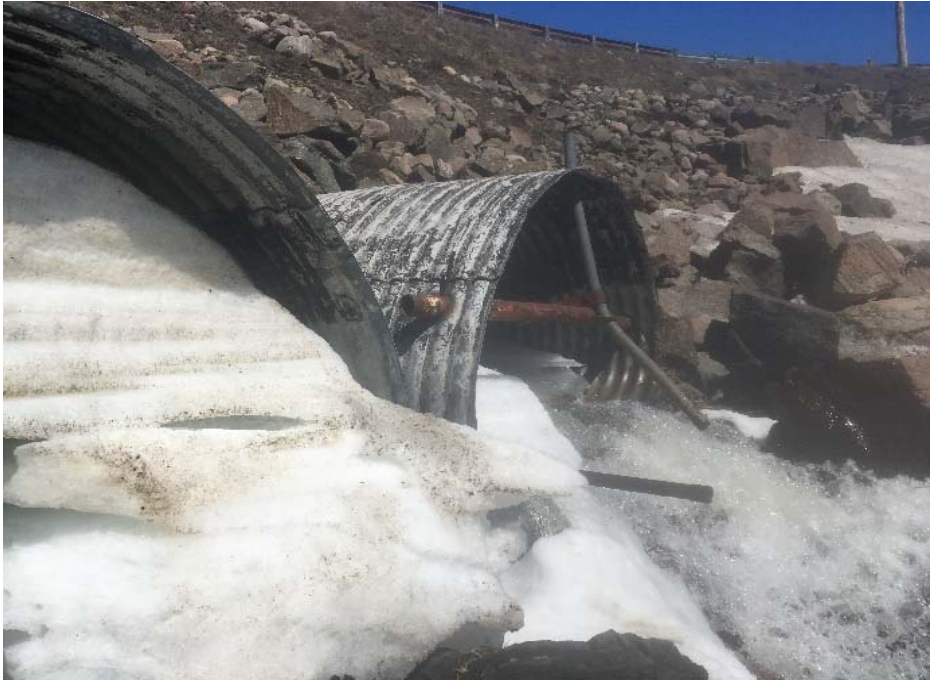
Upstream of Crossing 10 -2 x 1350 mm dia., 80m long, steep installation

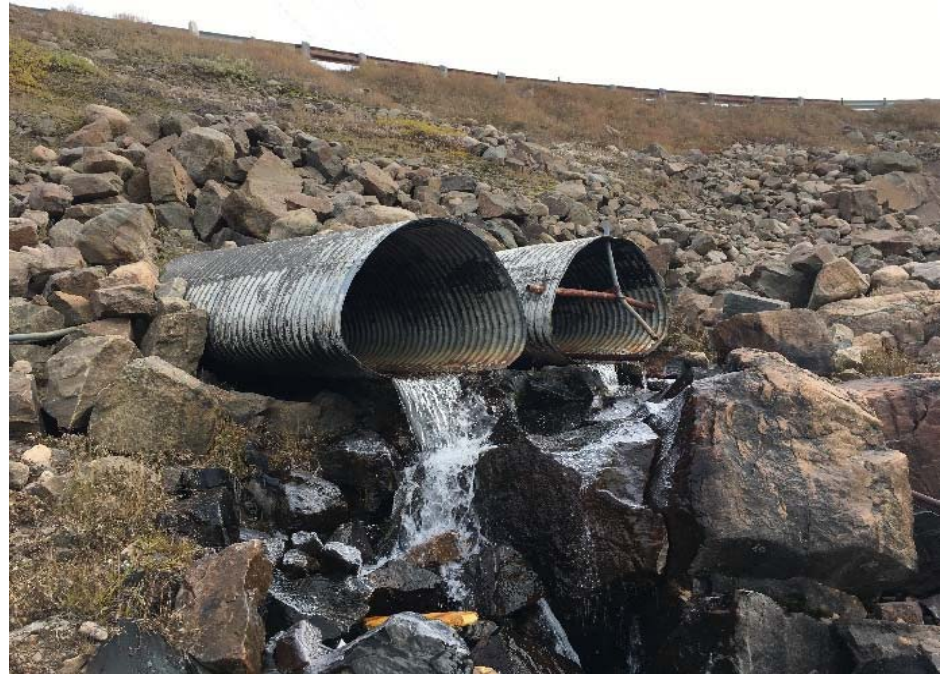
South of Crossing 10 (2 x 1350 mm dia.) looking Downstream -Blocked  
due to snow

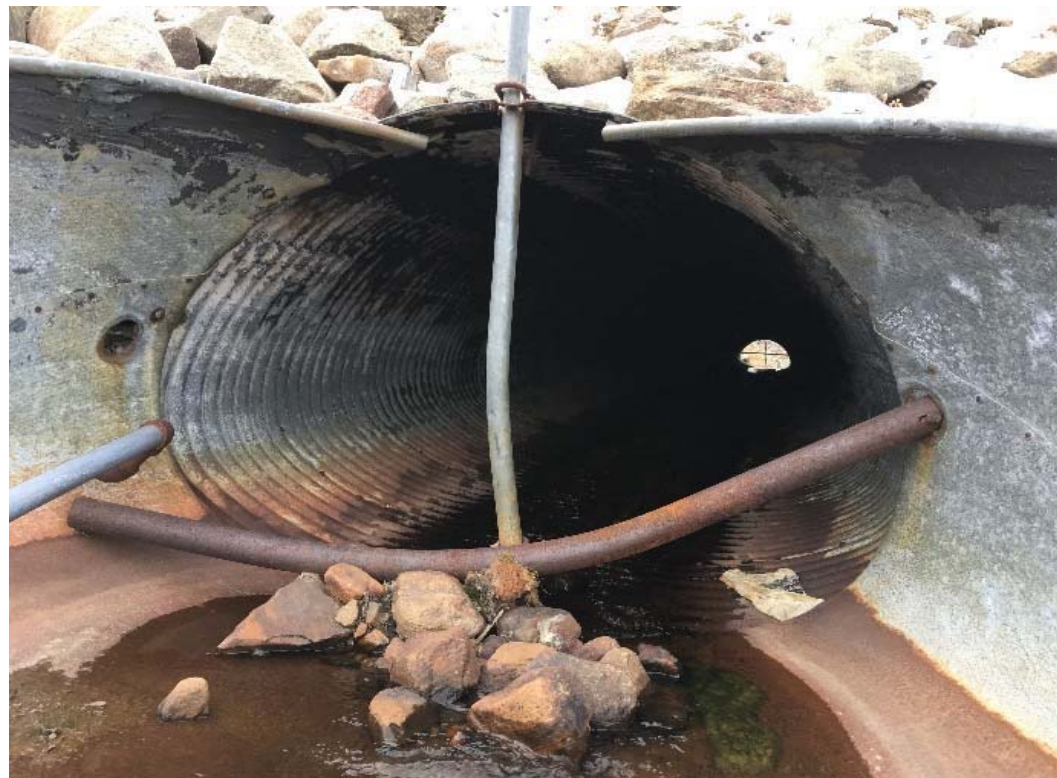
Upstream of  
Crossing 10  
Looking  
North -  
Wooden box  
identified on  
the stream

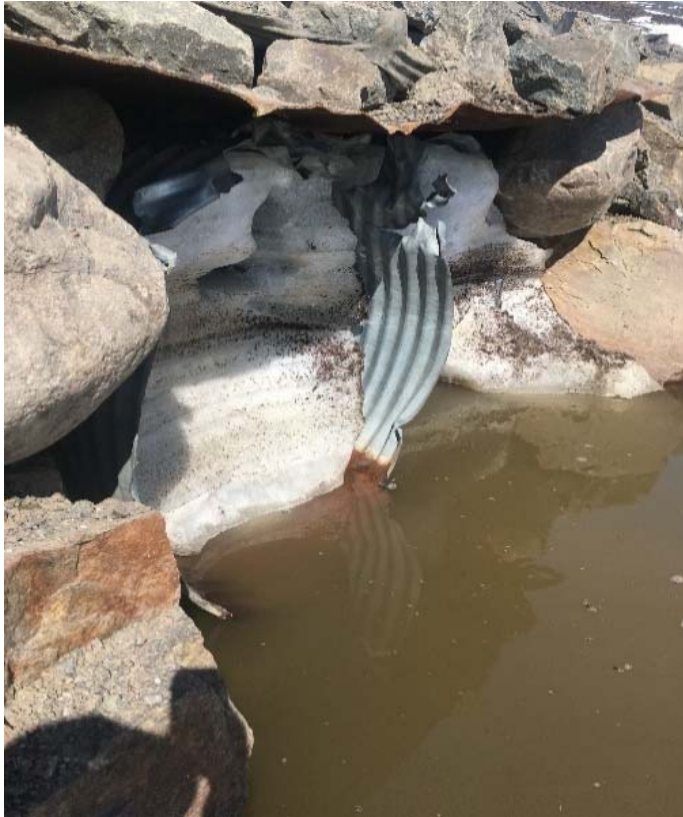
Eastern most culvert on south side of road - Blocked Pipe

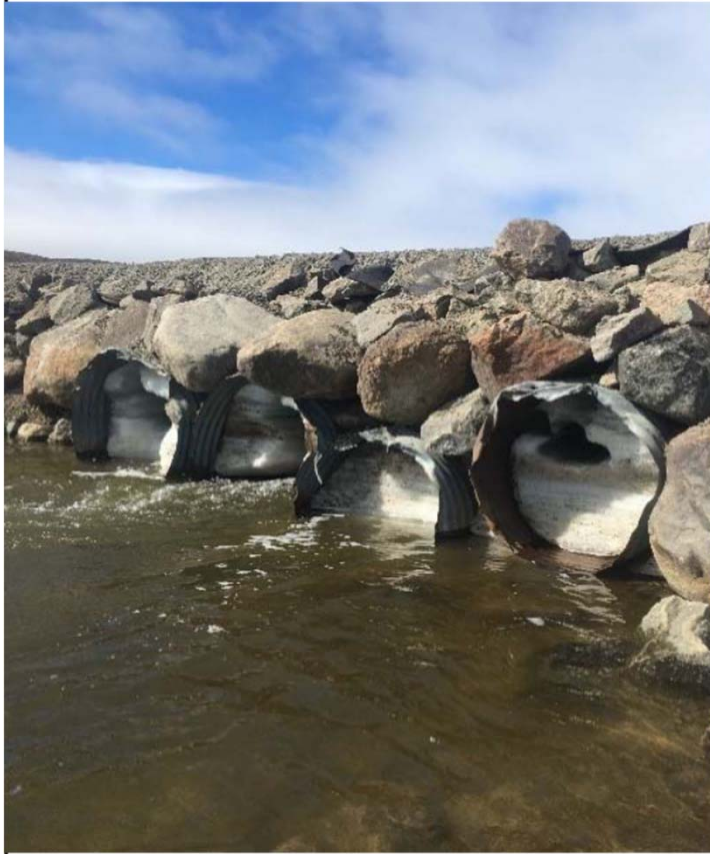
Cluster 1 of 4  
Culverts (4 x  
9400 mm  
dia.) on south  
side of road -  
Blocked due  
to snow

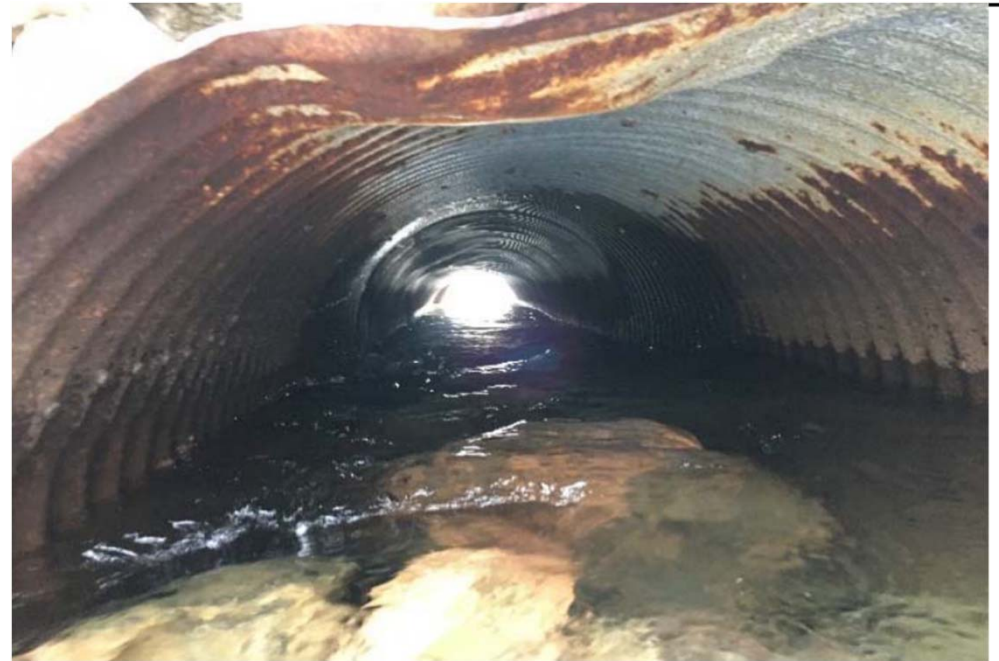
Cluster 2 of 3 Culverts (3 x 1100 mm dia.) on south  
side of road - Deflected on the top end

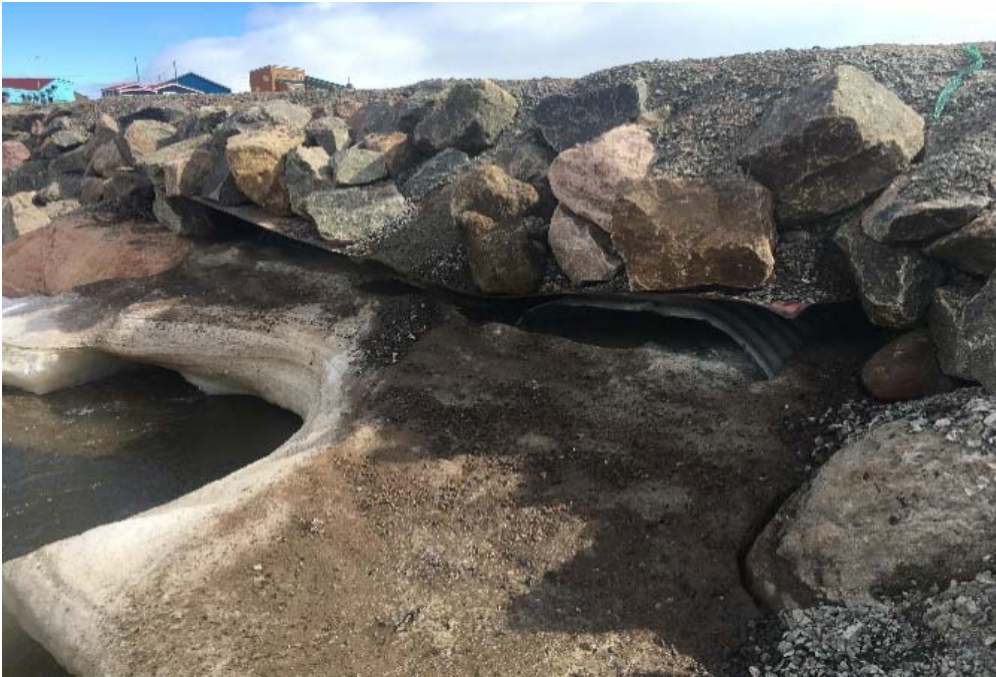
Cluster 2 (3 x 1100 mm dia.) taken from North side of road - Blocked due to snow

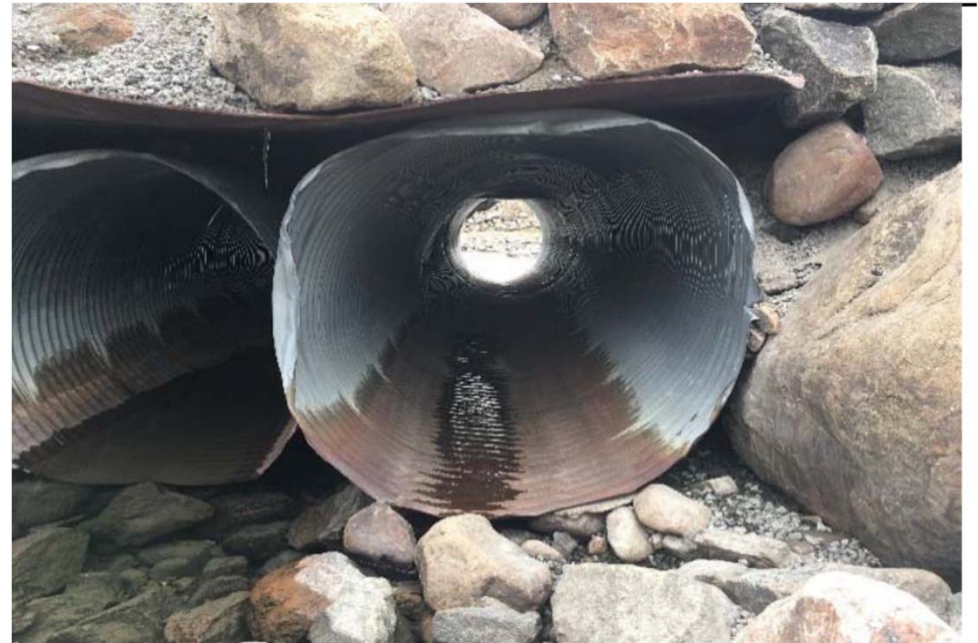
Northside of Cluster 3 - Deflected Pipe due to heavy loads

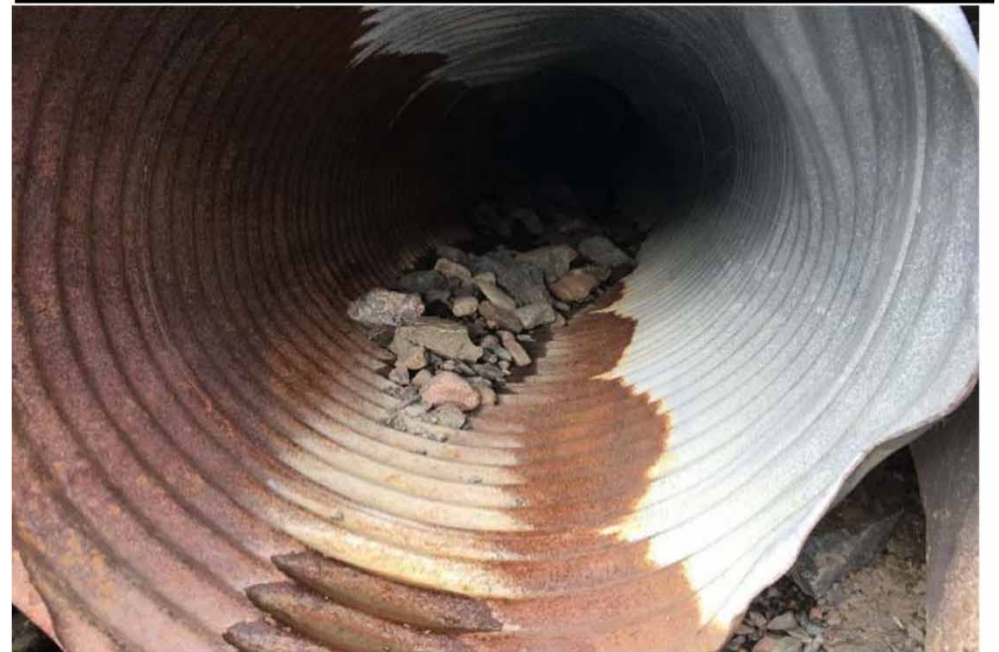
Southside of Cluster 3 - Debris due to sedimentation in the culvert
