CITY OF IQALUIT WATER LICENCE 3AM-IQA1626 2021 ANNUAL WATER LICENCE REPORT

JUNE 24, 2022

LAKE GERALDINE DAM
DAM SAFETY INSPECTION 2021 #1
IQALUIT, NUNAVUT

LAKE GERALDINE DAM
2021 DAM SAFETY REVIEW
IQALUIT, NUNAVUT

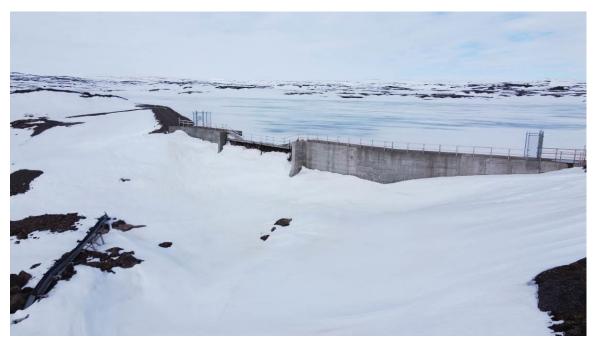
- Ice had formed on Lake Geraldine and snow accumulation was present on and at the base the berms, concrete structures, and Lake Geraldine (see photograph 1).
- The reservoir level (top of ice) was approximately 150 mm below the top of the spillway at the time of our review. The water level reported by Environment and Natural Resources Canada was 109.283 m, approximately 1.817 m below the level of the spillway.

Photograph 1 – Overview of concrete structure, center berm and north berm.

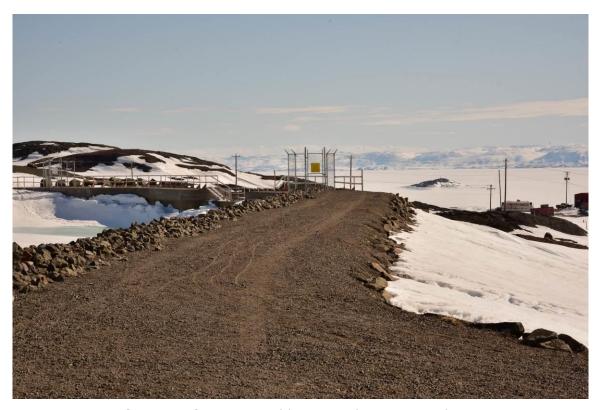
Photograph 2 – Typical berm condition, center berm.

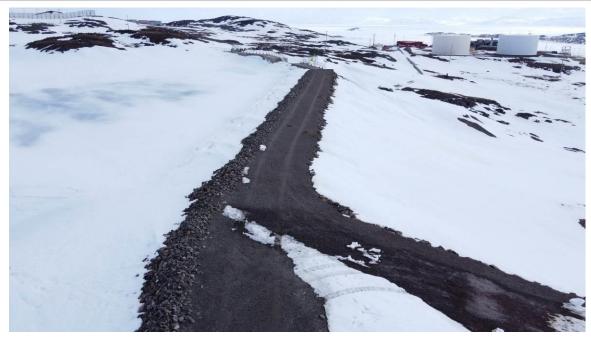
Photograph 3 – Typical berm condition, center berm and access ramp.

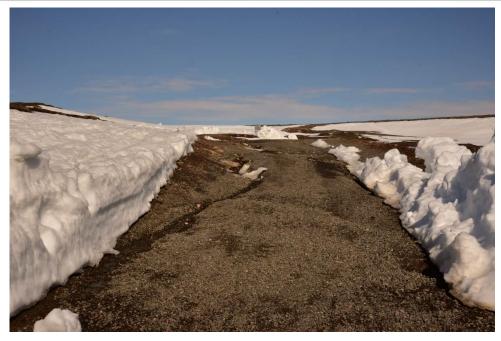
Photograph 5 – Typical erosion of the north access road.

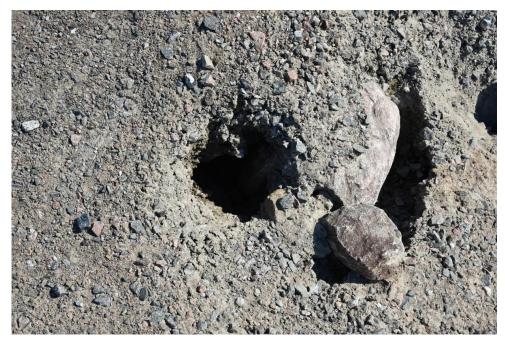
Photograph 6 – Small sink hole located in the center berm.

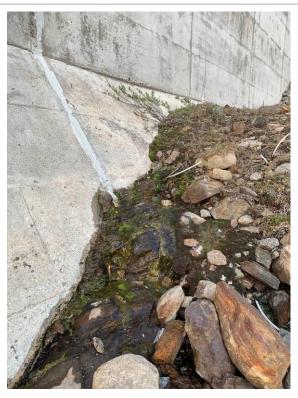
Photograph 3 – Water seepage at base of J5 joint, south of spillway.

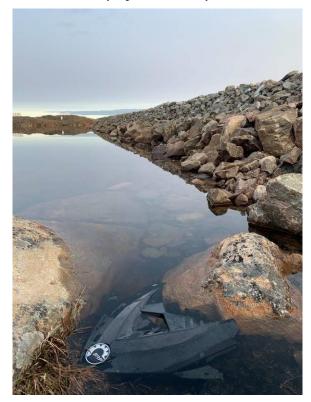
Photograph 8 –Steep slope of rip rap on upstream side of berm. Snowmobile debris within reservoir.

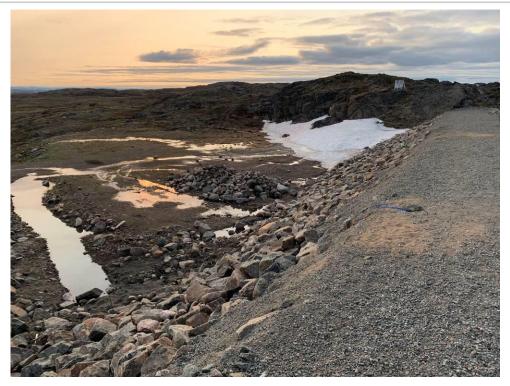
Photograph 9 – Surface water and snow cover, downstream of north berm.

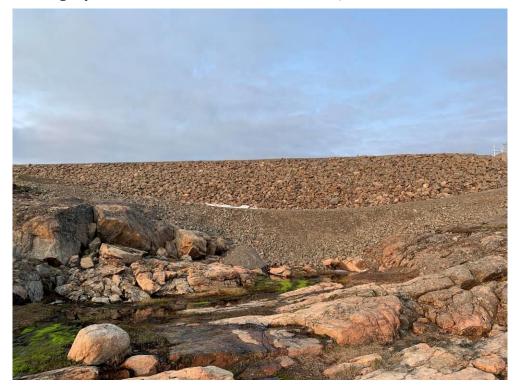
Photograph 10 – Seepage at valley of center berm.

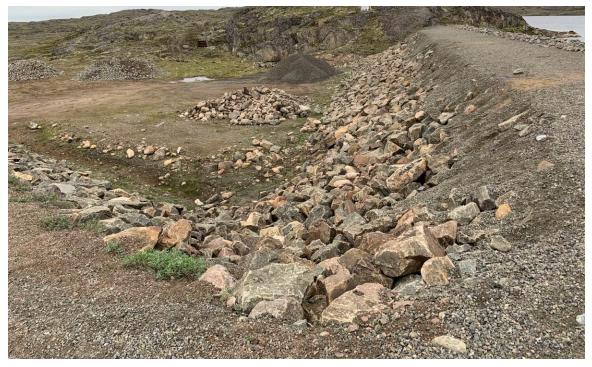
- No active seepage through the berms was observed within the North and south berms (see photograph 8).
- Standing water and minor seepage was noted in the of the valley at the base of the center berm, Environment Canada weather data indicates that intermittent rain fall occurred on and the days preceding up to our site review on August 18. The center berm spans a small valley and typically we see a small amount of seepage at this location. We estimate the flow to have been <2 liters per second which is consistent with historical seepage at this location.

Photograph 8 – Downstream face of the north berm, no active seepage was noted during our site visit.

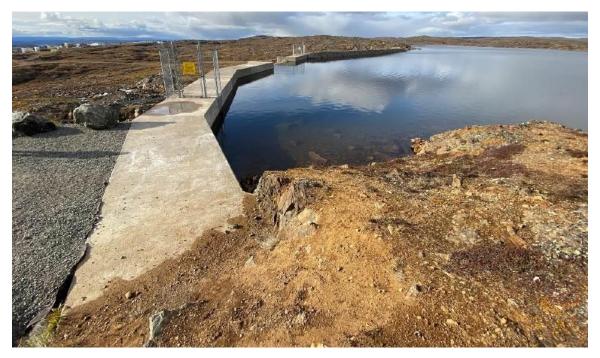
- The reservoir level was at the top of the spillway at the time of our review. The water level reported by Environment and Natural Resources Canada was 111.296 m (see photograph 1 & 2).

Photograph 1 – Overview of upstream concrete section, looking northwest.

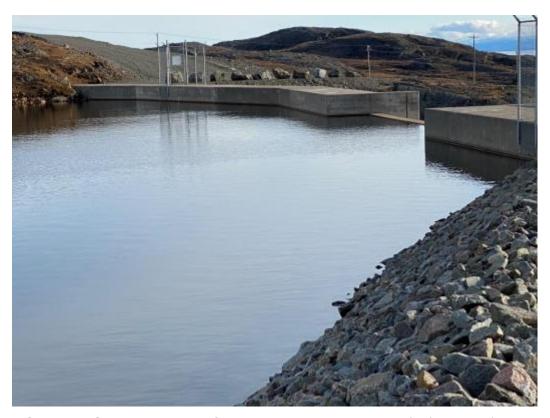
Photograph 2 – Overview of upstream concrete section, looking southeast.

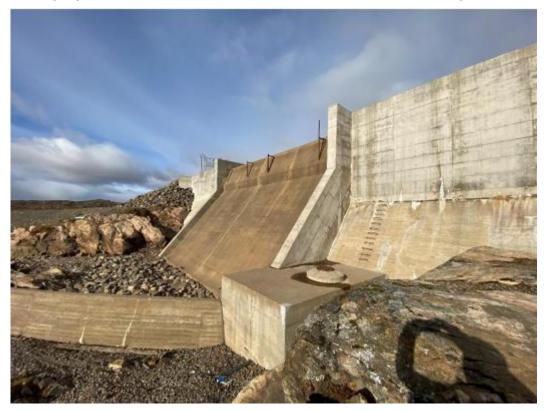
- No significant changes were noted in the general condition of the concrete structures (see photograph 3 & 4).
- Typical litter and refuse was noted throughout the site.

Photograph 4 – Overview of downstream concrete section, looking northwest.

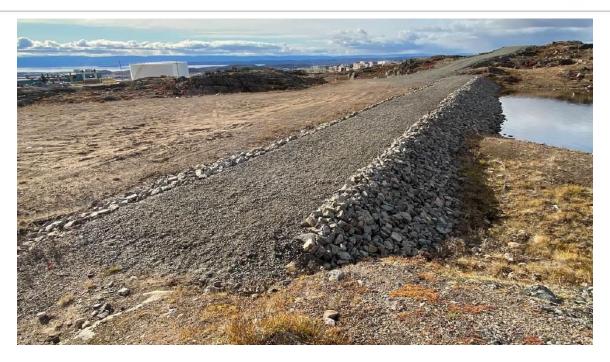
- No active seepage through the berms was observed within the North and south berms (see photograph 11 & 12).
- The edge of the roadway atop the north berm is susceptible to erosion on the downstream (west) slope of the berm (see photograph 13).

Photograph 11 – Overview of south beam, looking northwest.

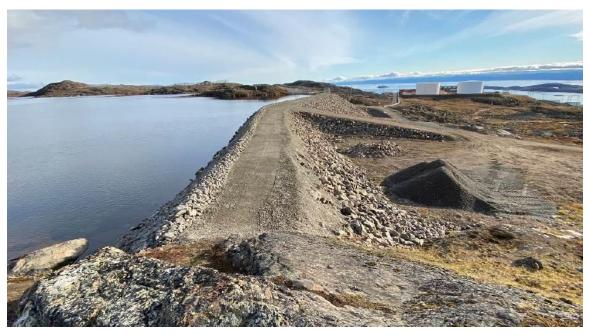
Photograph 12 – North and center berms and north access road ramp, looking southeast.

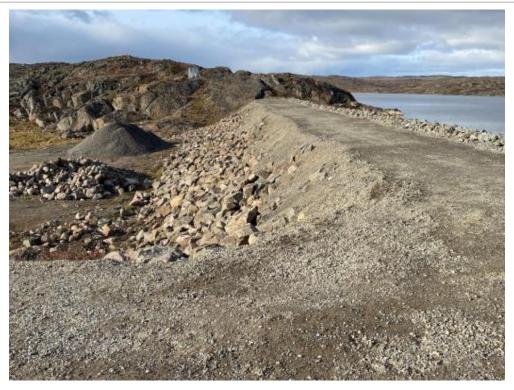
Photograph 13 – North beam looking northwest, edge of roadway susceptible to erosion.

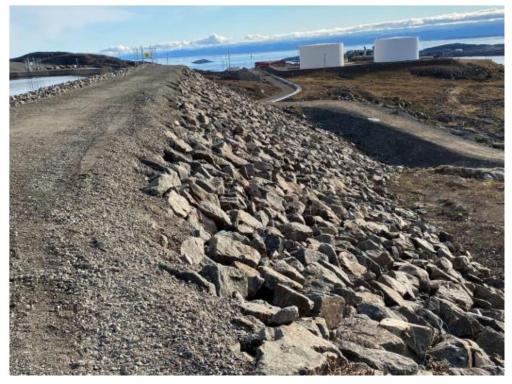
- The edge of the roadway atop the center berm is susceptible to erosion on the downstream (west) slope of the berm (see photograph 14).
- No significant changes such as sloughing, slides, bulging or displacement were noted in the earthen berms.

Photograph 14 – Overview of center berm, note steel slope and edge of roadway susceptible to erosion.

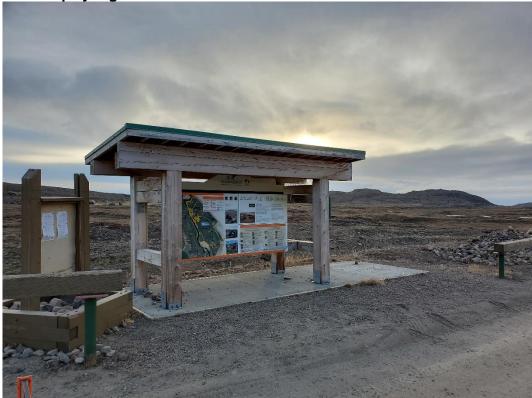
4. Site – Looking West from East Side of Site

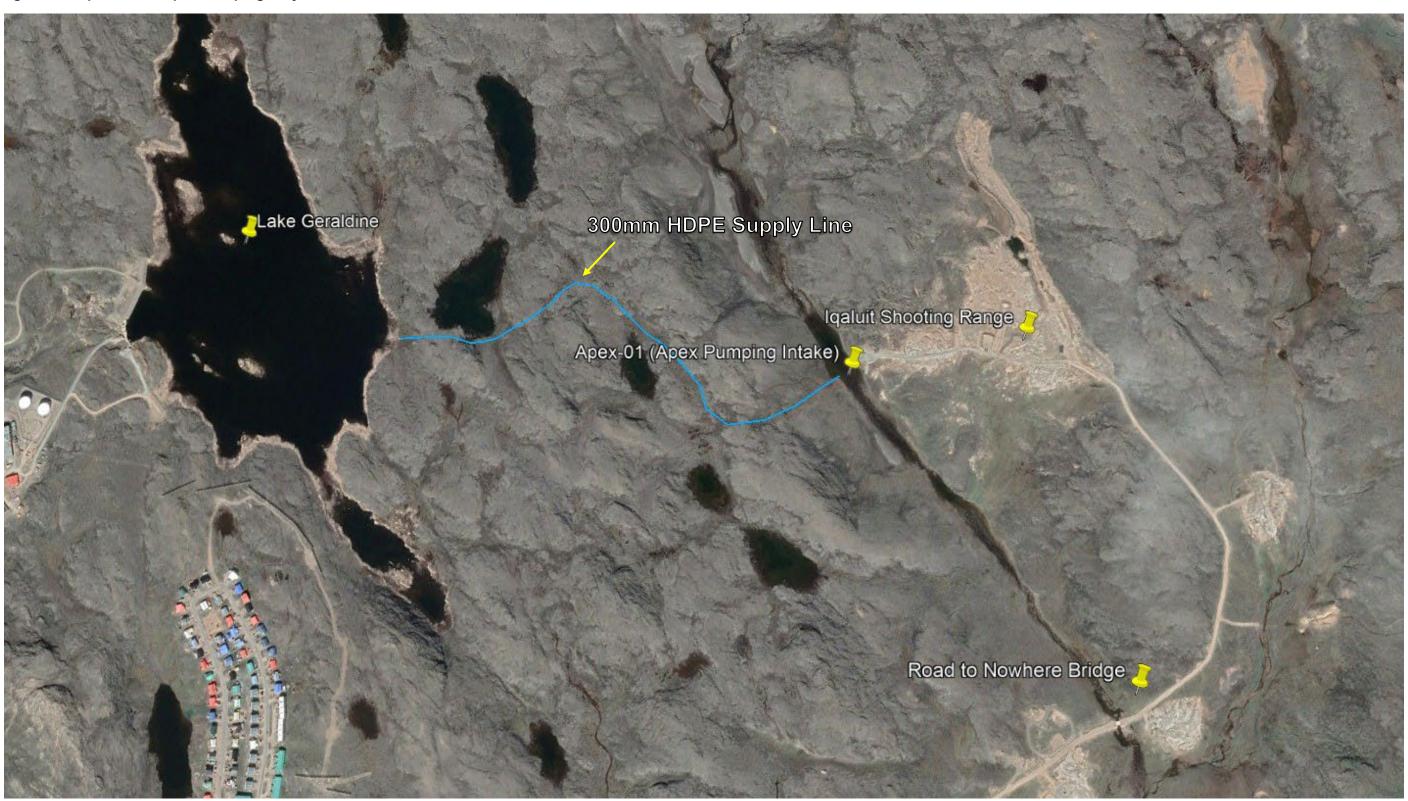
Figure 2-1 Iqaluit 2021 Apex Pumping Project Site Overview

The location of works and activities is shown in Figure 2-1. The Niaqunguk River pumping site was previously setup in 2018 and 2019, and the location in 2020 was fixed by the need to connect to a semi-permanent pipeline installed in 2019, and the location of a Water Survey of Canada (WSC) hydrological monitoring station located immediately upstream of the pumping site. The 2021 SPP followed the same protocol and operation as in 2020.
