Project Title: Pangnirtung WWTF

Project No.: FRE-00232735-A5

Aftercare Service – Site Visit #16 (SUMMARY REPORT)

Site Visit: Sept 19-28, 2023

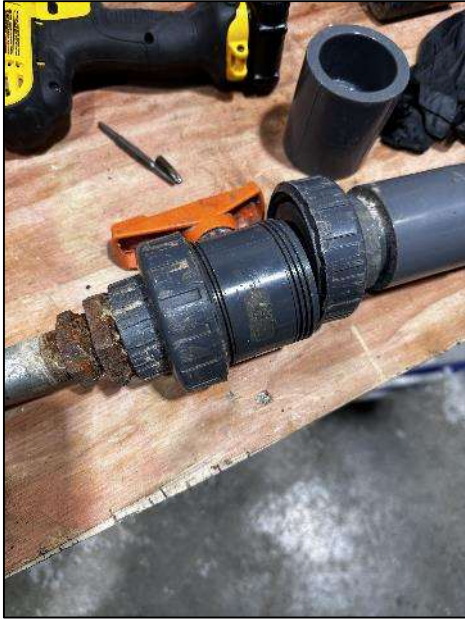
Figure 12: 1 1/2" PVC Valve for Wash Bar
Figure 13: 1 1/2" PVC Fittings for Wash Bar

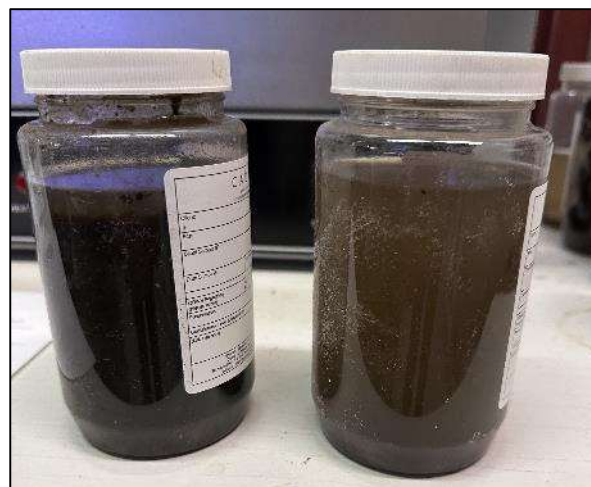
Sept 21, 2023	Sept 24, 2023	Sept 27, 2023
Aerobic	779 mg/L	793 mg/L	1,049 mg/L
Anoxic	12,545 mg/L	16,646 mg/L	15,405 mg/L

Figure 40: TSS Samples from Anoxic and Aerobic Tanks

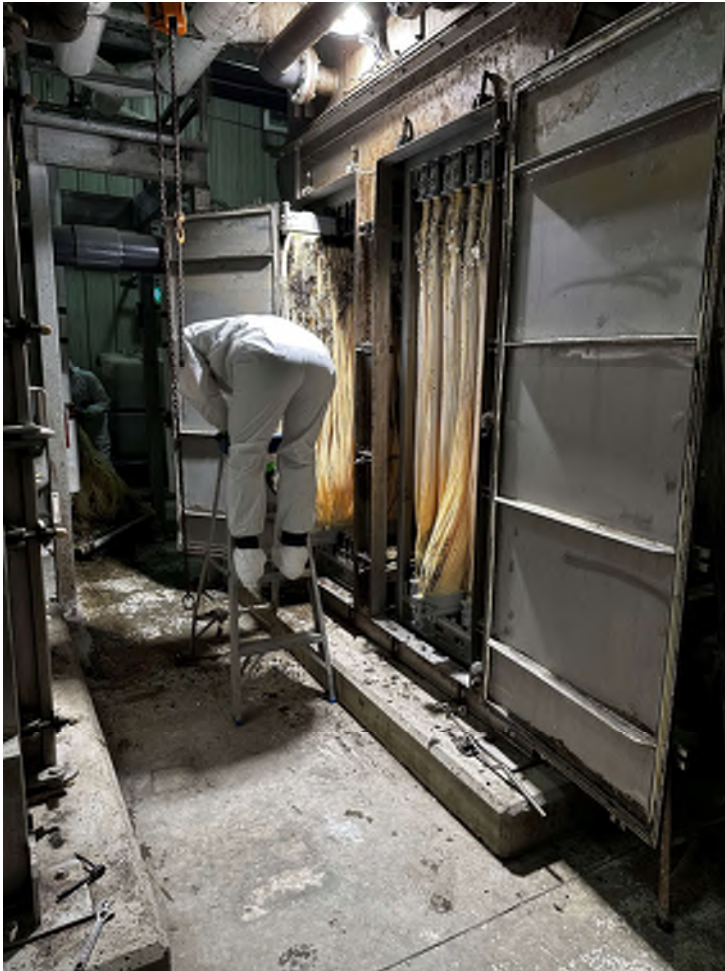
Inspecting Existing Membranes (1)

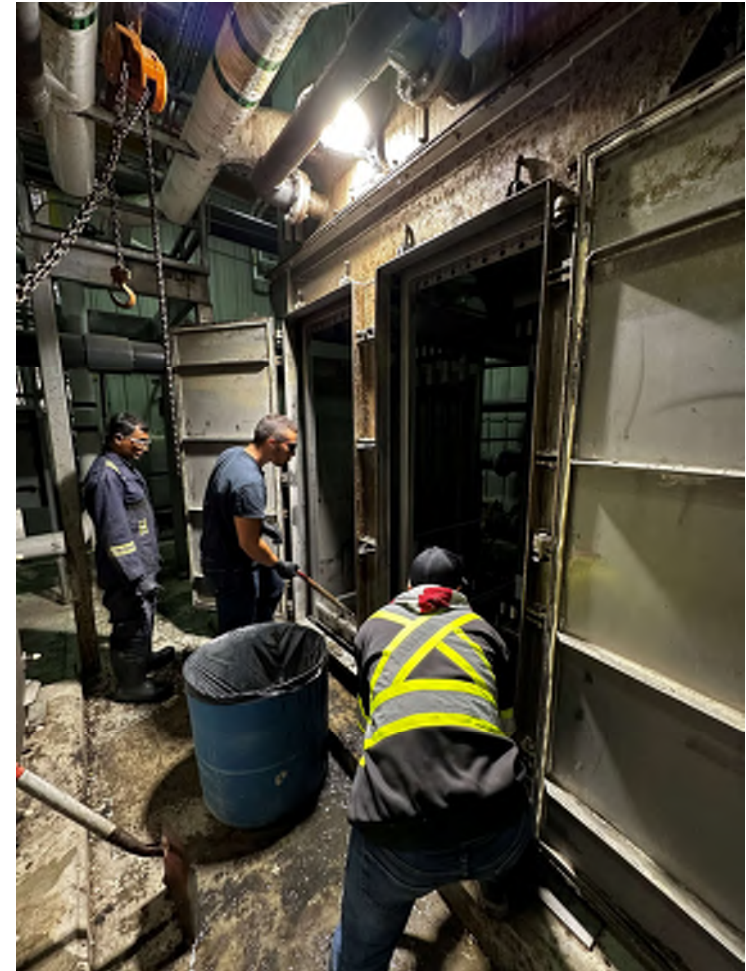
Clearing Membrane Tank of Accumulated Sludge

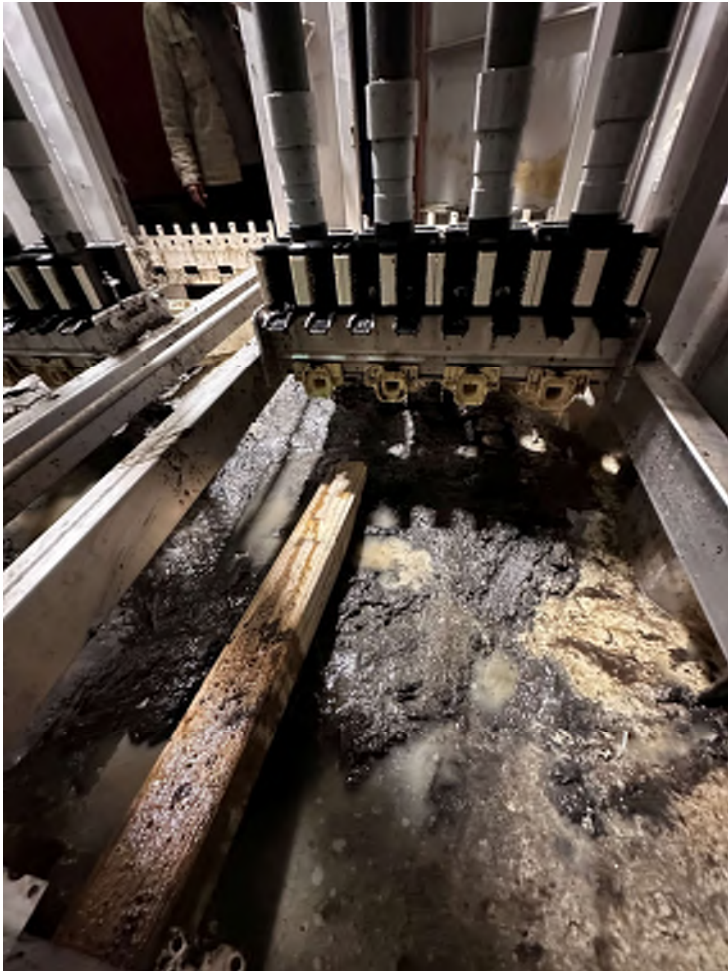
Membrane Tank Sludge Accumulation (1)
