Golder Associates Ltd.

**AIR PHOTO INTERPRETATION, SITE
RECONNAISSANCE, MAPPING, AND SAMPLING:
TEHEK LAKE ACCESS ROAD,
MEADOWBANK GOLD PROJECT
NUNAVUT**

September 13, 2005

05-1413-021/2000

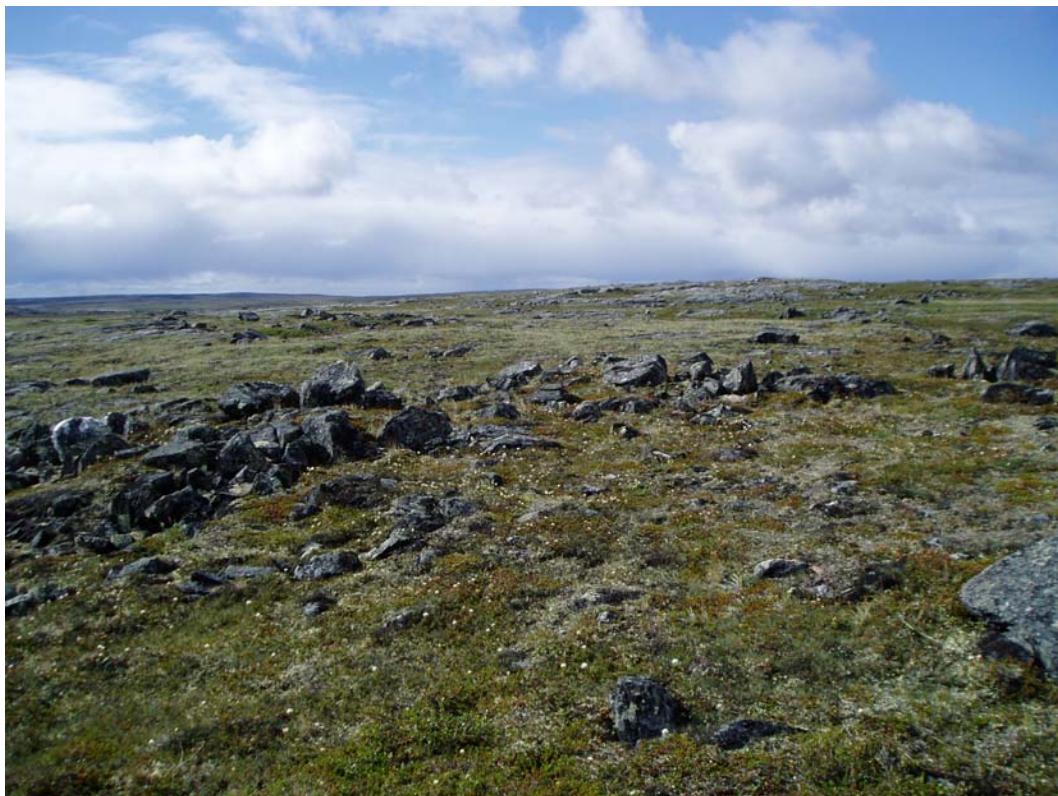
Photo 2: Terrain type 1 in granitic bedrock near kilometre 22.

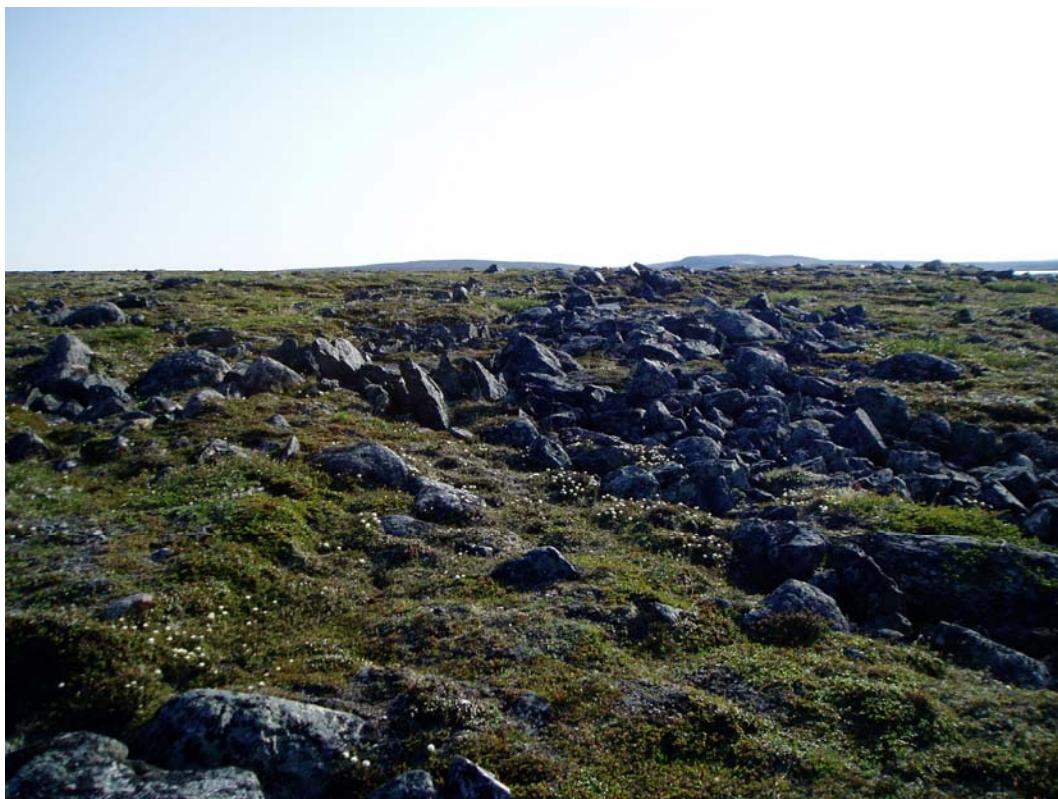
Photo 3: Type 2 terrain in an area dominated by granitic bedrock west of kilometre 22.

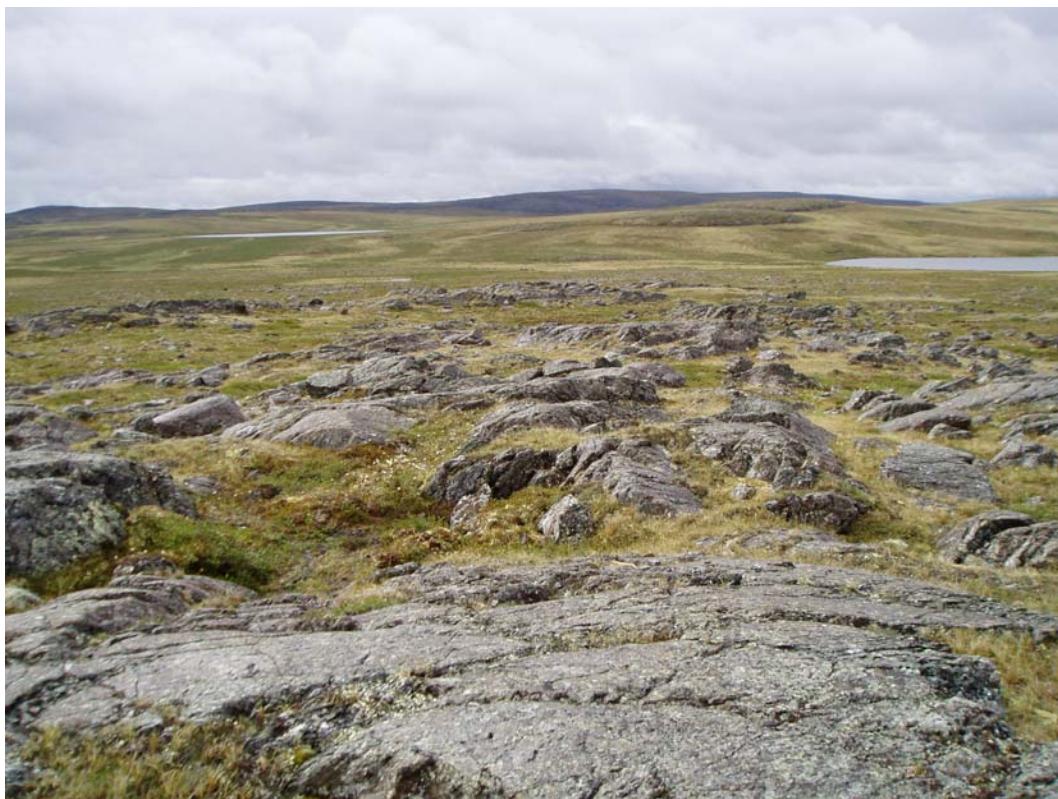
Photo 4: Type 2 terrain in an area of volcaniclastic bedrock near kilometre 105.

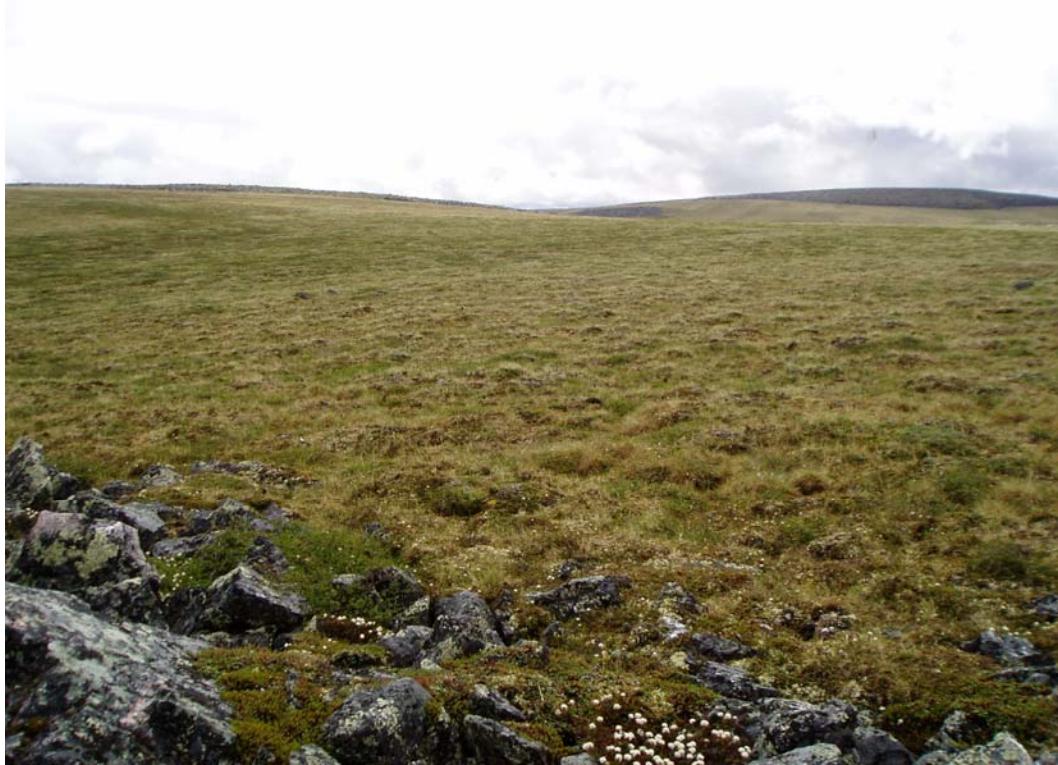
Photo 5: Type 2 terrain in an area dominated by volcanics near kilometre 49.

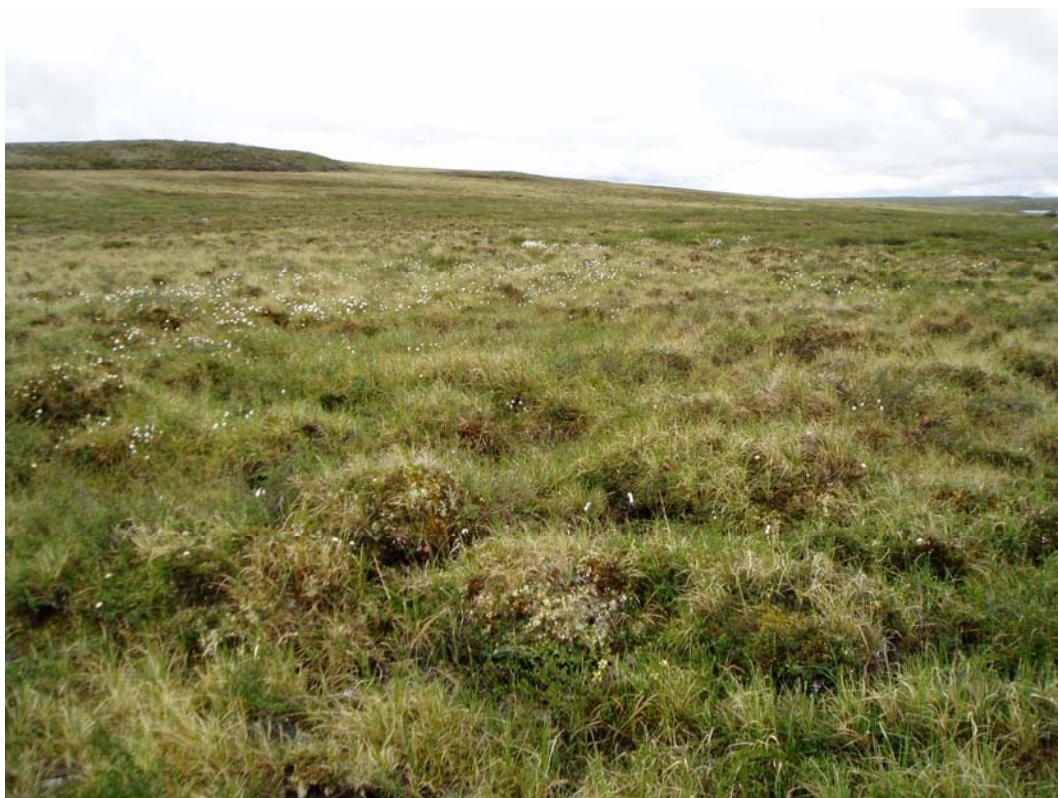
Photo 6: Type 3 terrain near kilometre 43.

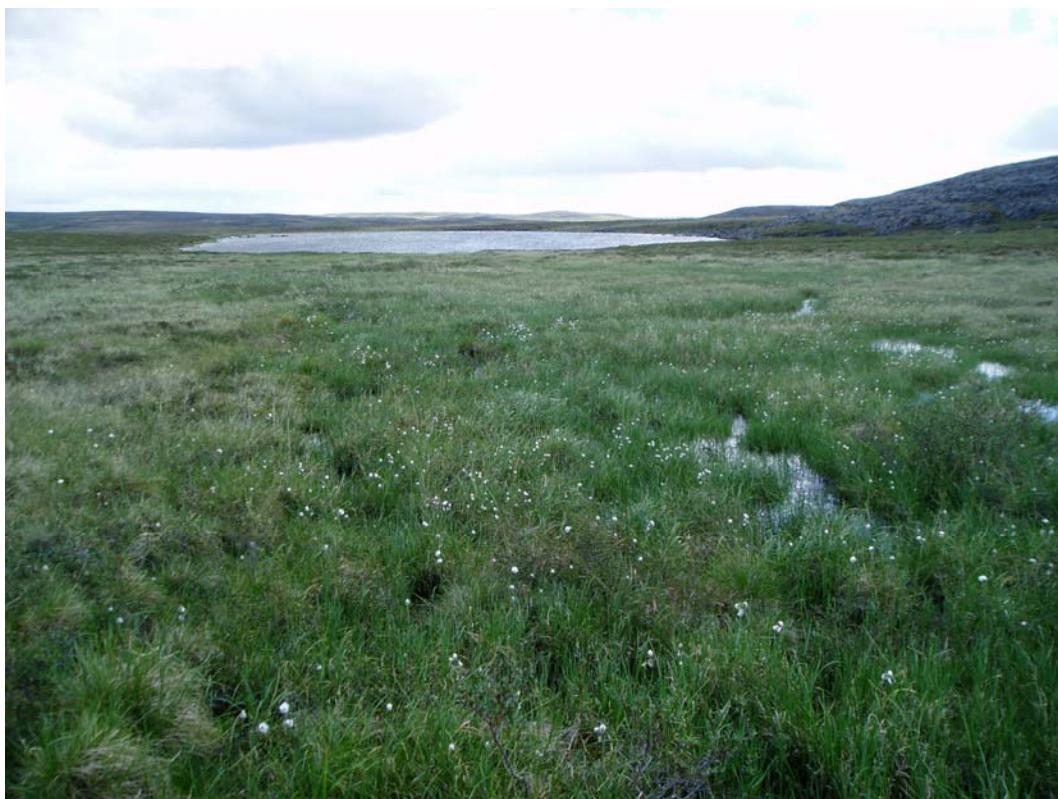
Photo 7: Type 4 terrain near kilometre 43.

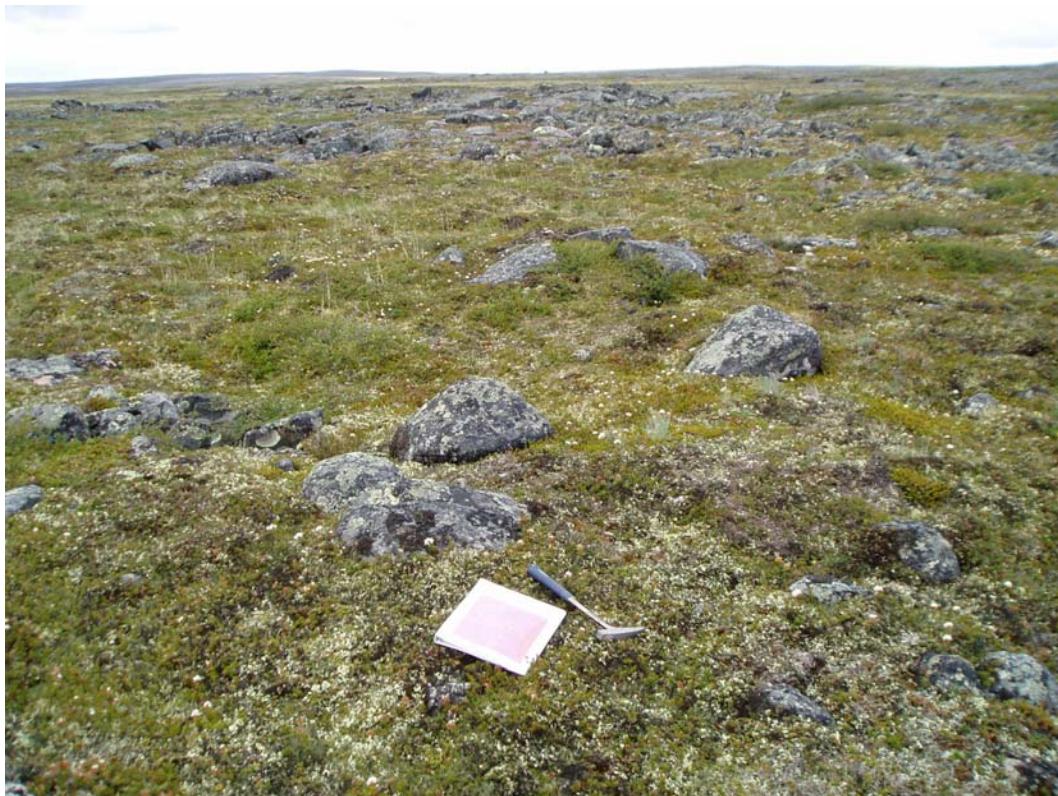
Photo 9: Small beach deposit on a bedrock ridge southeast of kilometre 9.
